**37<sup>TH</sup> INTERNATIONAL  
No-DIG  
FLORENCE 2019**

Unique Horizontal Drain Installation under a Building  
Using Pilot Tube Guided Auger Bore Methods

Michelle Macauley - Macauley Trenchless  
Steve Torgerson - Trenchless Construction Services

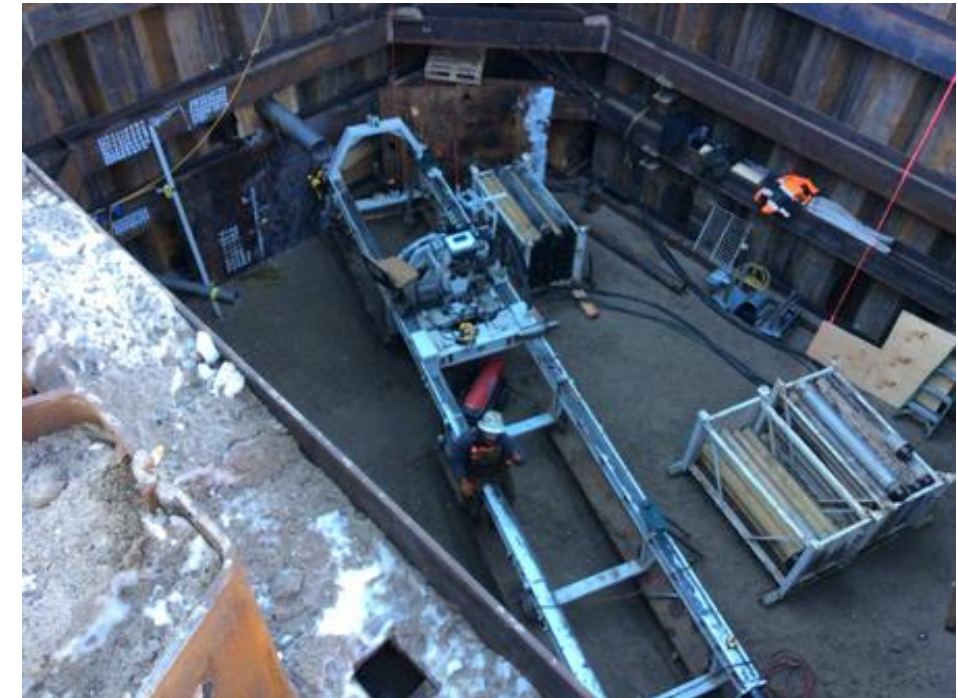
- Started on December 15th
- Very oblique angle. The waler near the bottom of the excavation resulted in a long section of exposed pipe
- Within 15 feet of progress, well casing became cross-threaded
- Tried to pull casing, even though machine not geared for it; damaged pipe further
- Tried innovative approach to push the damaged drain casing out

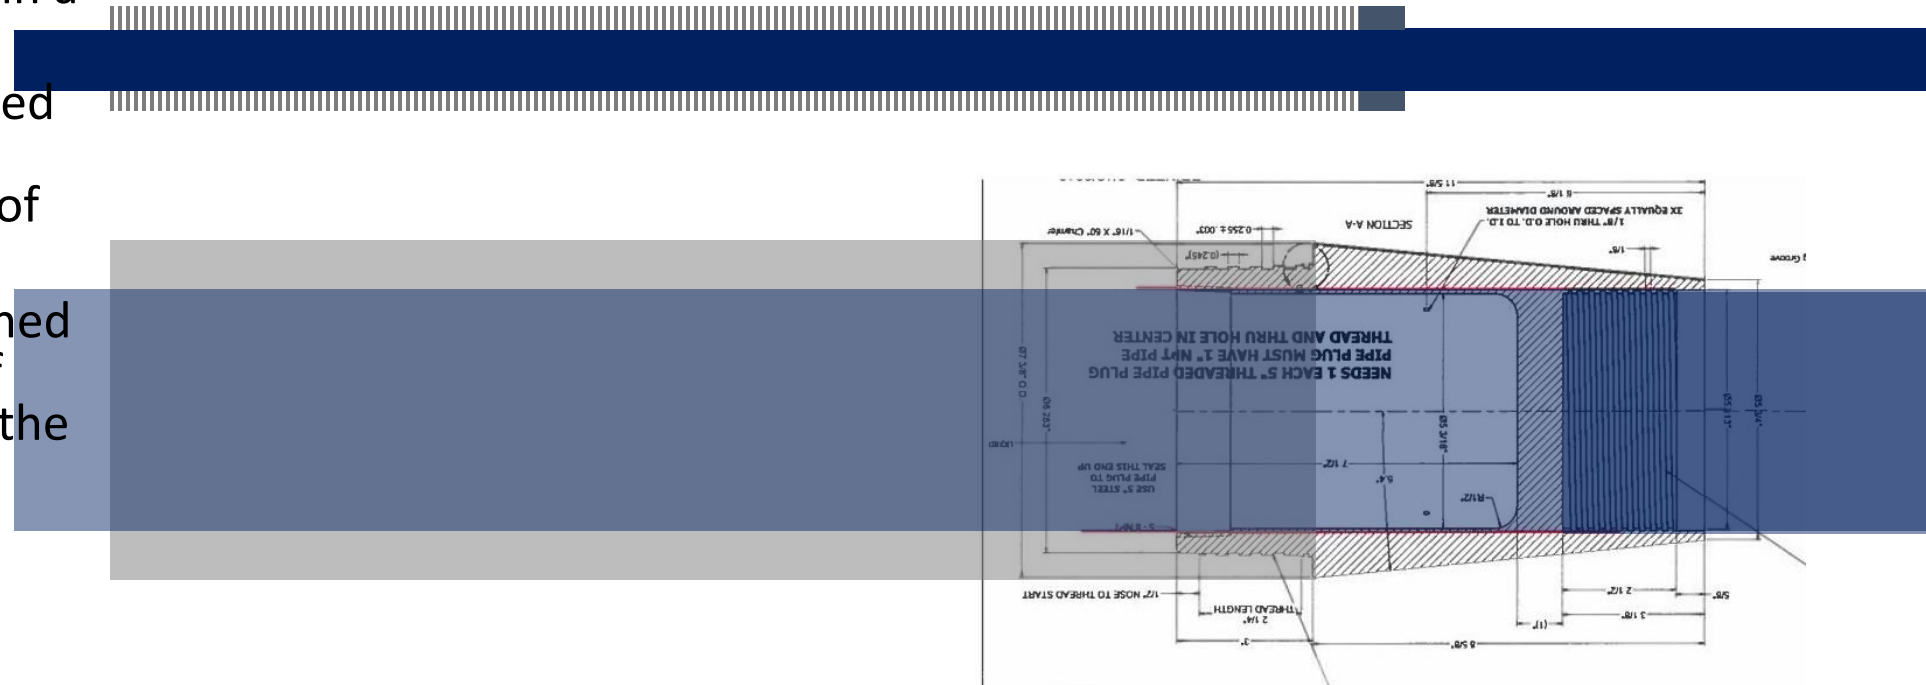
- Innovative approach
  - Cut off exposed tail end of horizontal drain
  - Cut off threaded end of pilot tube resulting in a blunt end
  - Pilot tube was pushed inside remaining (damaged) portion of the horizontal drain
  - Pilot tube then pushed damaged section of drain screen out of the alignment

## Horizontal Drain

## Adapter

## Pilot tube

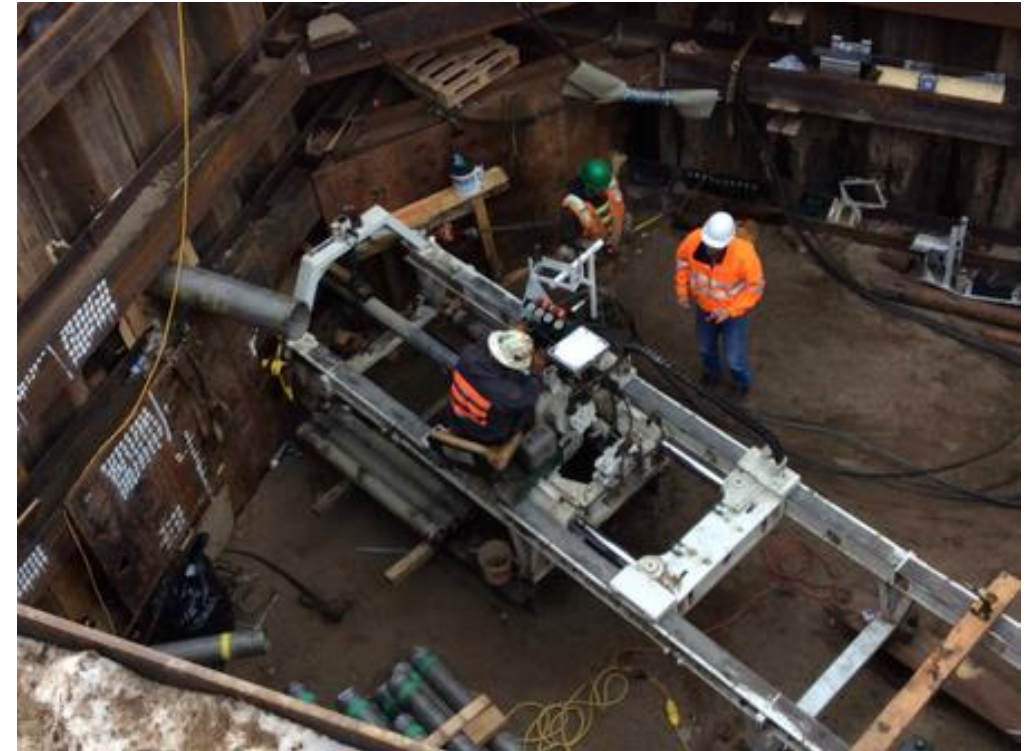
- Unexpected benefit: the damaged section of screen acted like an HDD pre-ream
- The installation of second screen was very easy
- Entire installation took 4 days
  - With a quick trip to Johnson Screen
