**37TH INTERNATIONAL
NO - DIG
FLORENCE 2019**

**DESIGN&BUILDING CONTRACTS AS A PERFORMING
OPPORTUNITY TO C.I.P.P. SEWERS REHABILITATION –
BRIANZACQUE CASE STUDY**

Simone M. Cellitti
Mauro Pozzi
Fuselli Federica

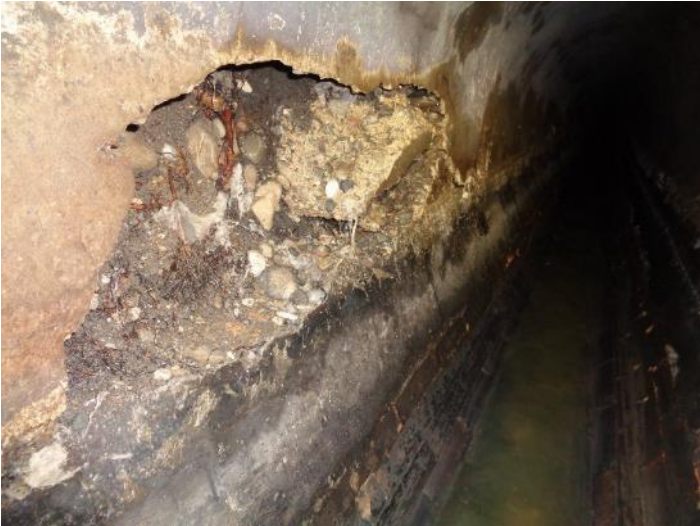
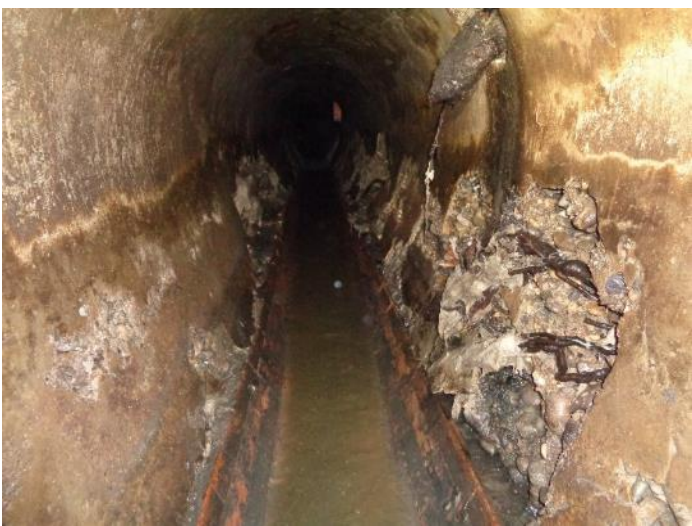
Structural problems

Punctual Collapses

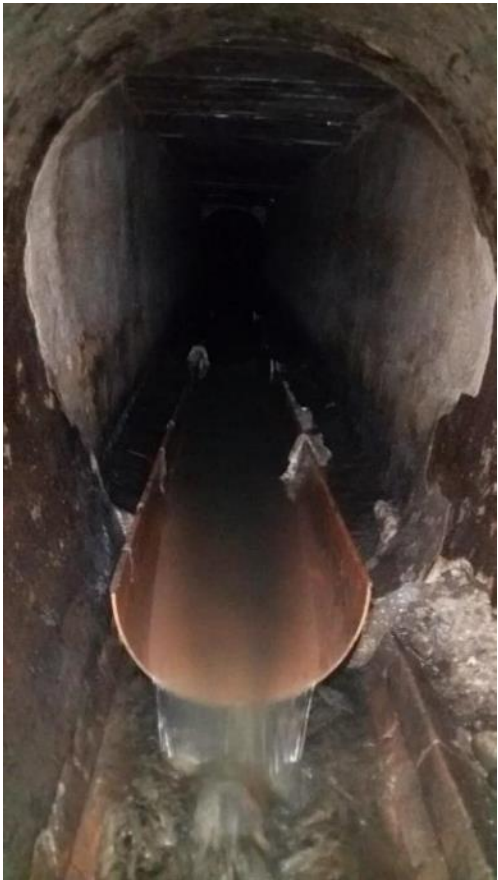
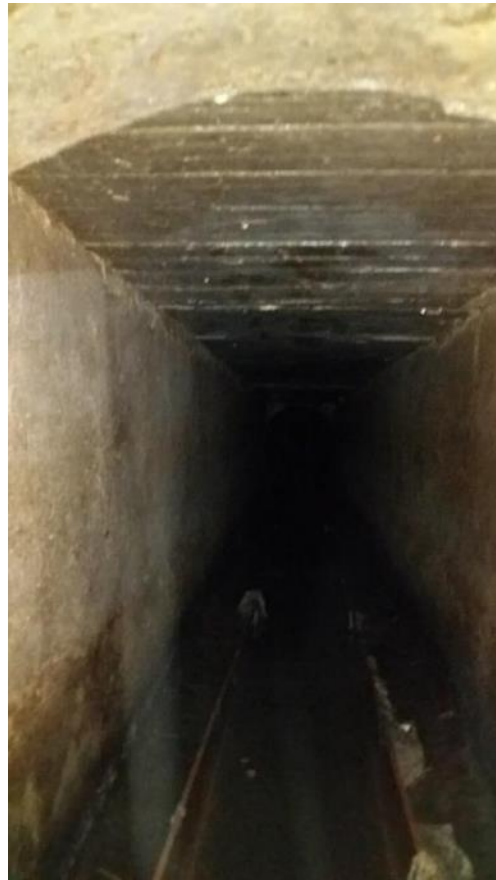
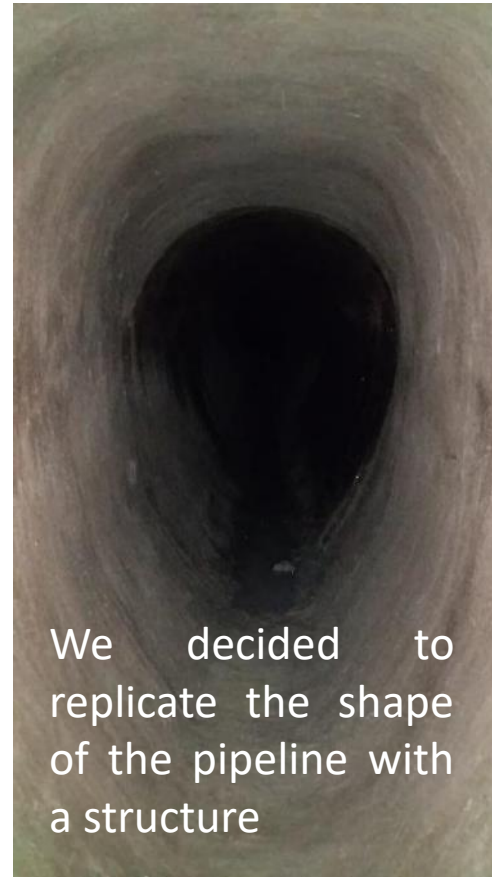
Different Diameters

We decided to replicate the shape of the pipeline with a structure

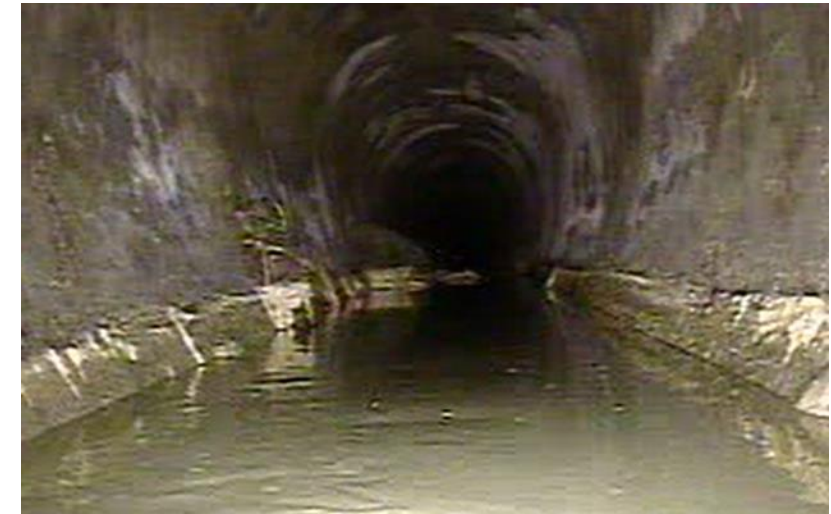
Problems with video-inspection

Important wastewater flow

Not all the pipelines was investigated

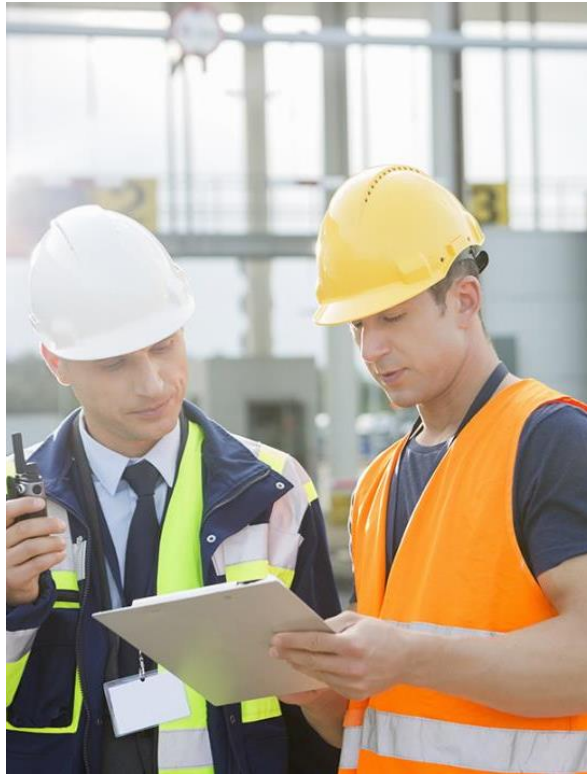
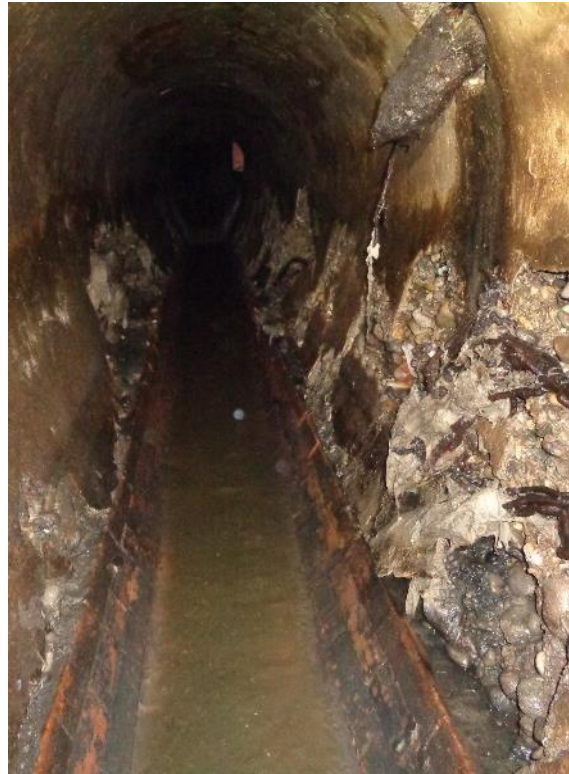
In the building site – **2 check before inserting the liner**

After the cleaning

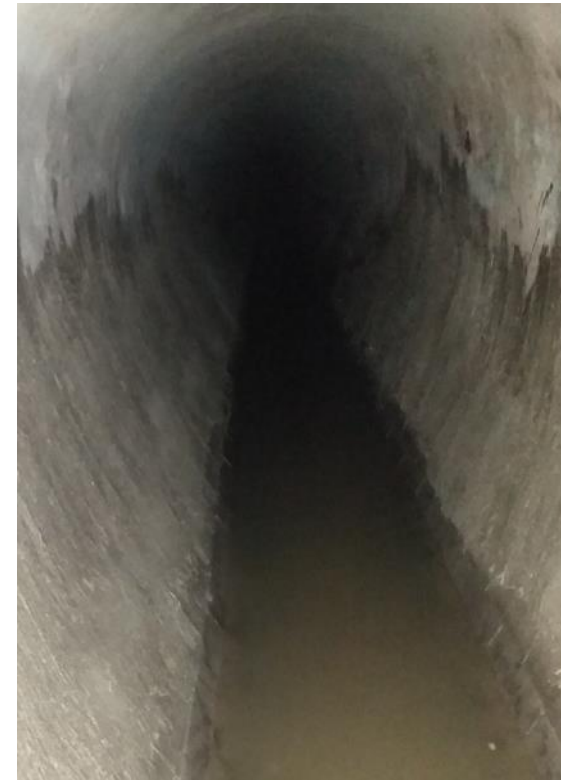
Before the insertion

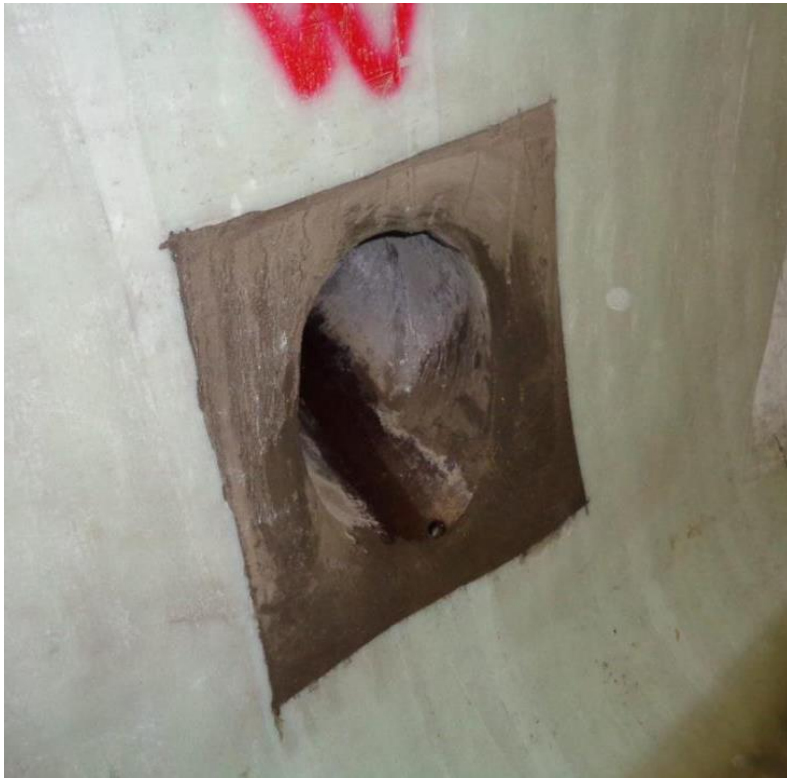
finishing and sealing of the connections

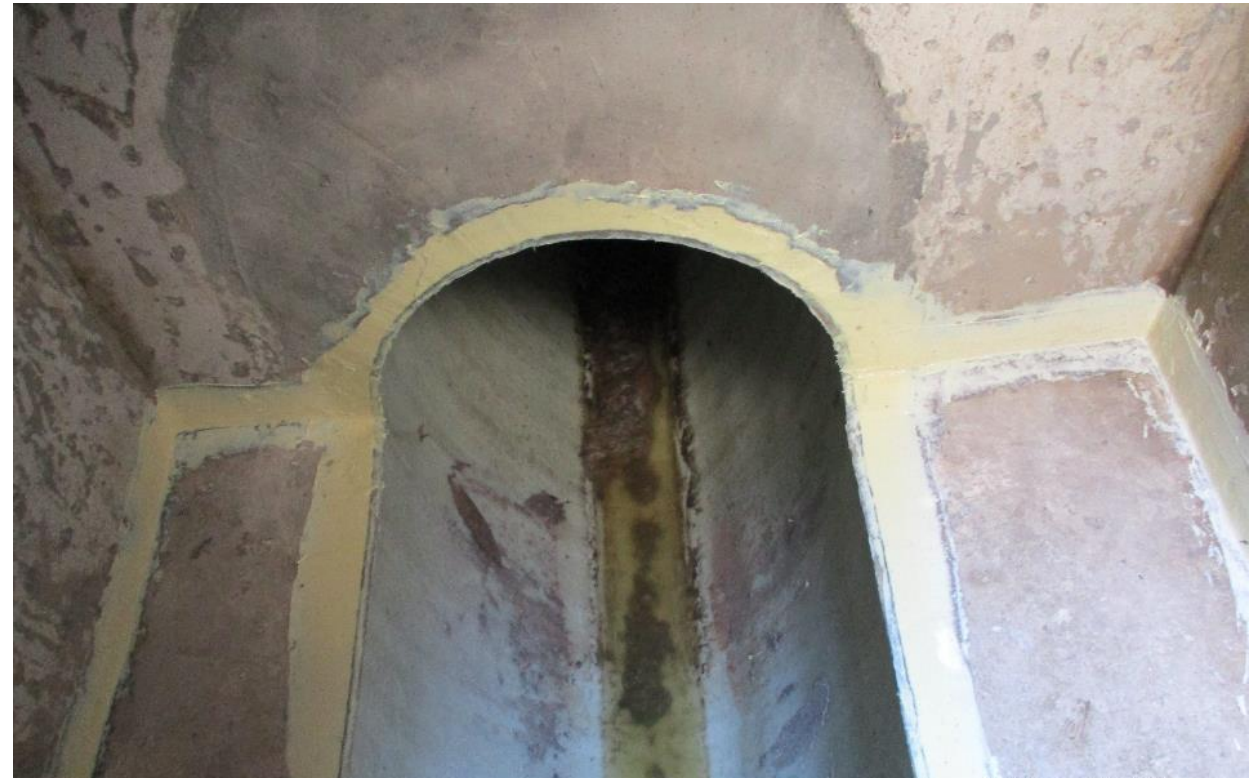
finishing and sealing of the liner

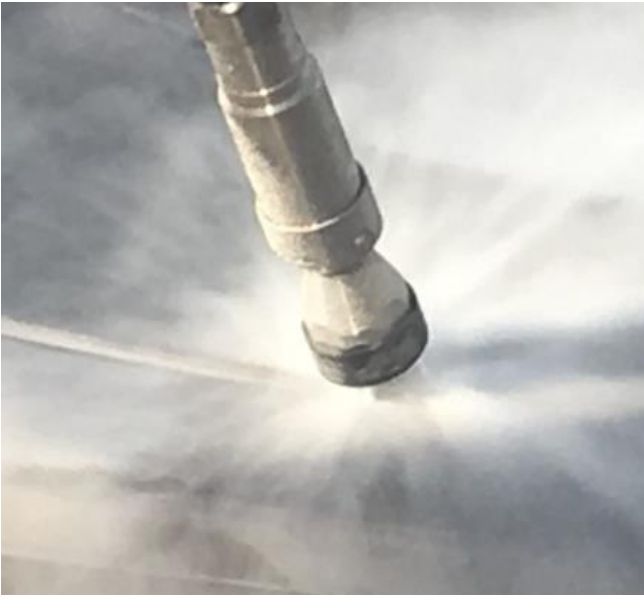
hydro-scarifying 400 Bar

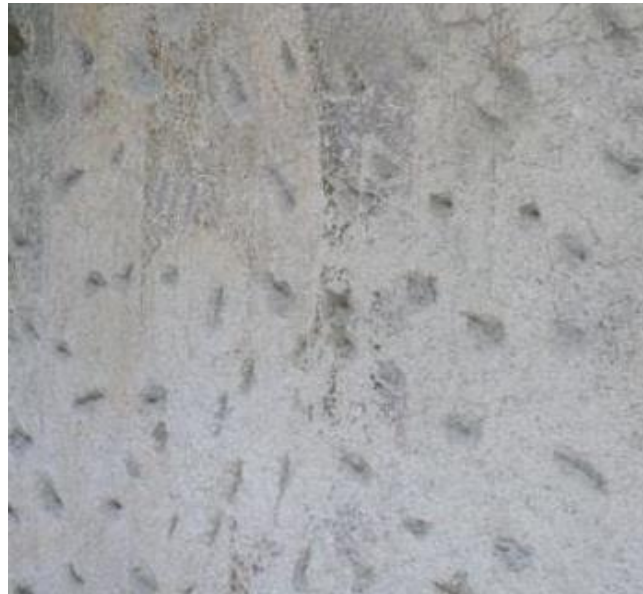
stakeout the Walls

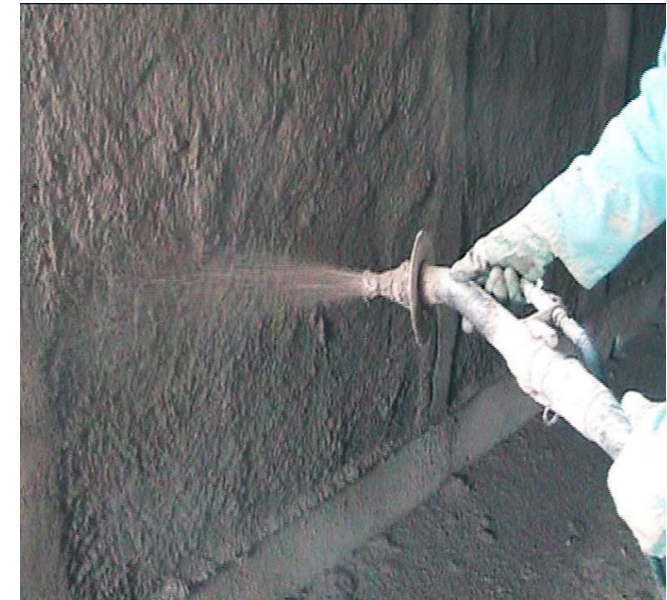
mortar spraying 2 times

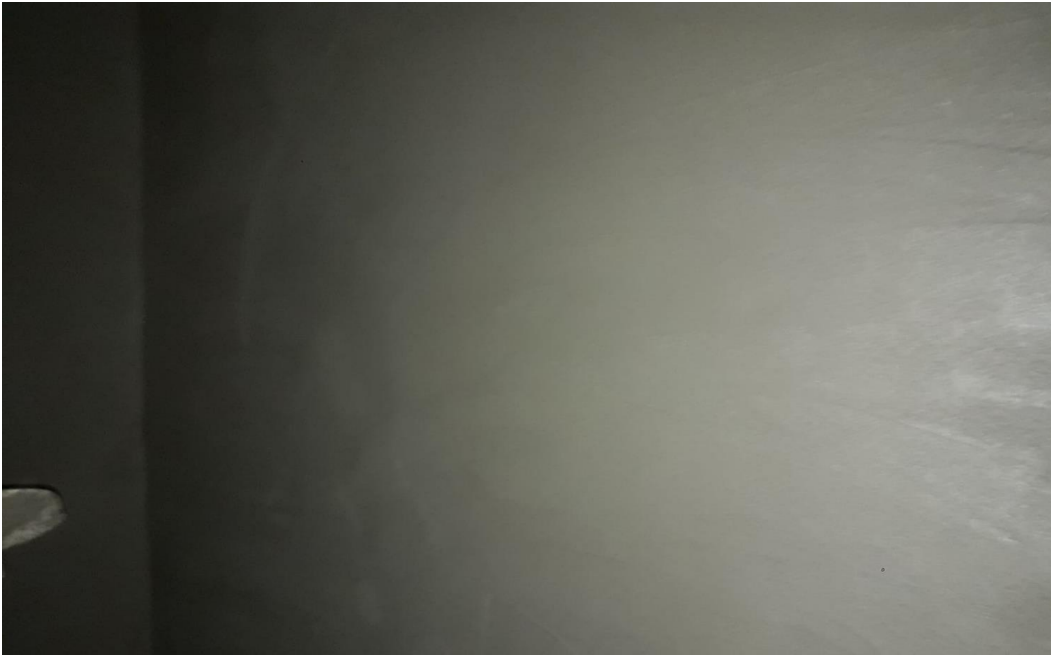
Wells restored

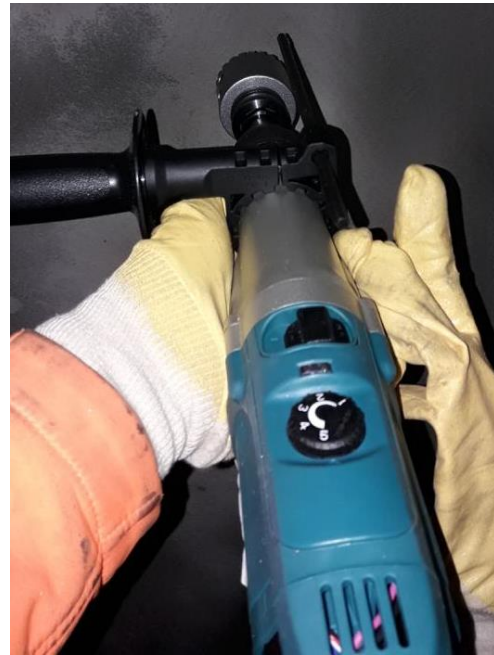
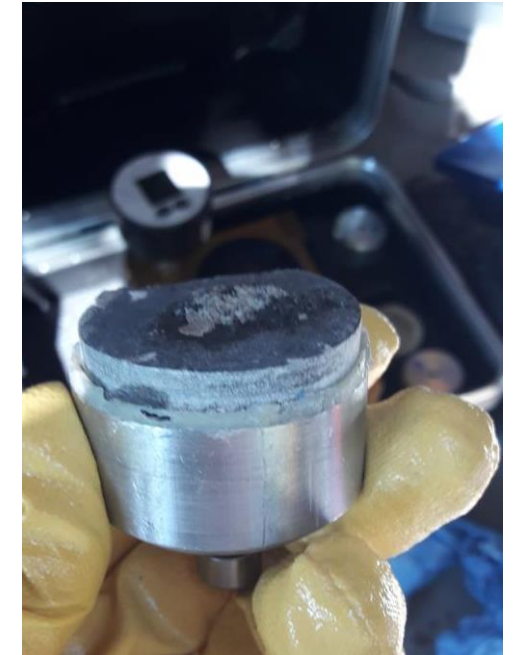
Tear test on grout for wells recovery

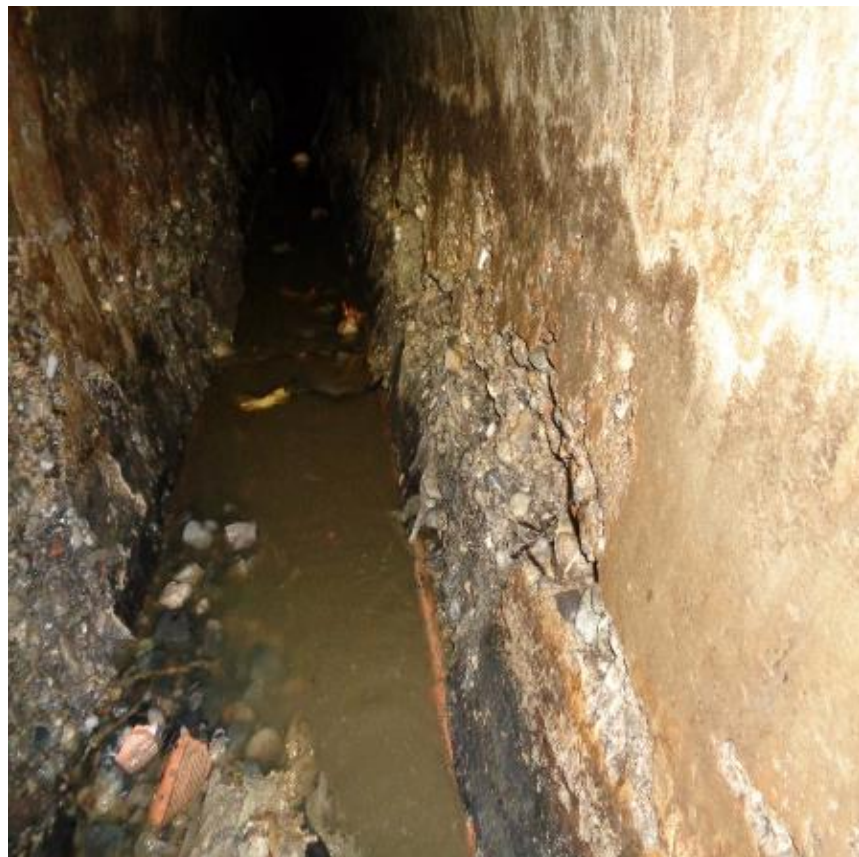
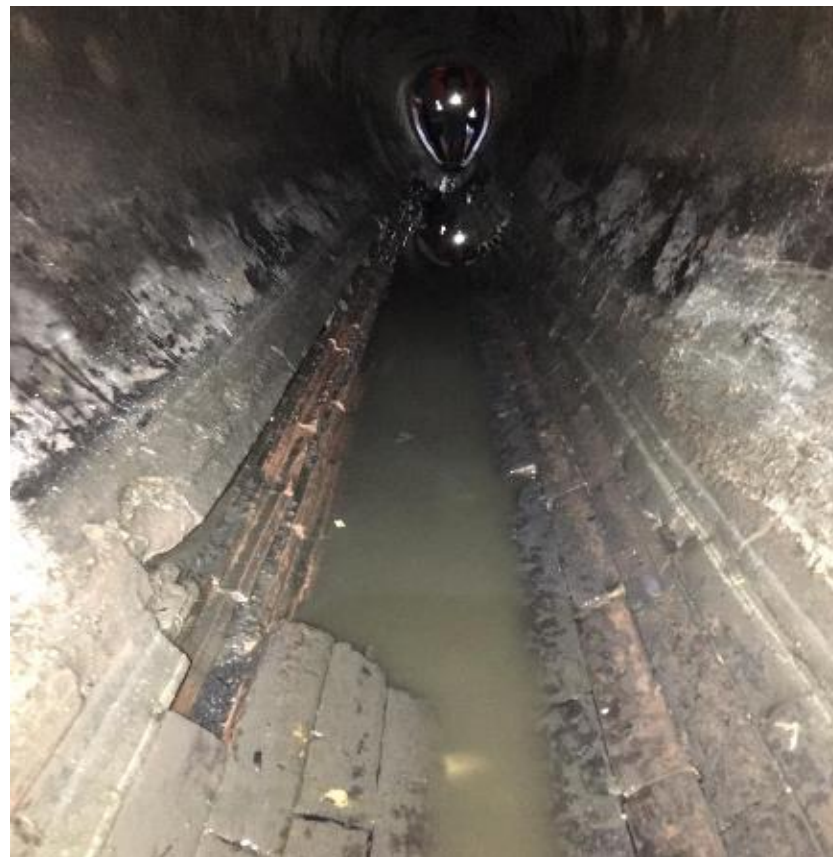
Problems on going: Erosion of the pipeline more than we thought

estimated in the
project

20% of the pipelines

Reconstruction with
bricks and cement

Costs about 3% of
the contract
