37TH INTERNATIONAL
NO - DIG
FLORENCE 2019

Investigation of Cracks Found in the Circumferential Direction on Jacking Pipes

TEPCO Power Grid Inc.
Yuki KANESHIRO

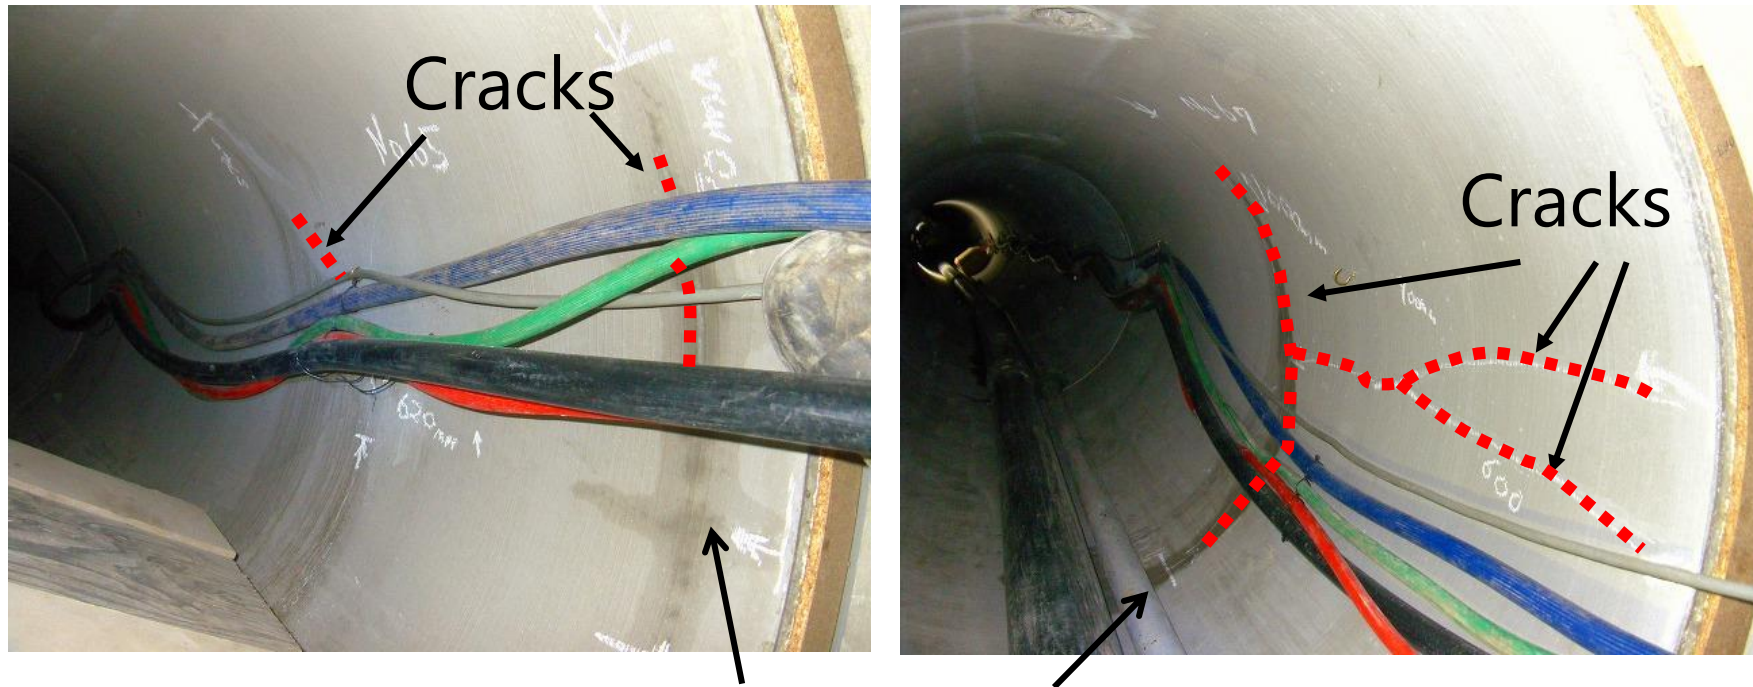
Cracks involved water leakage were found in a total of 8 pipes around curves section when drilling 195.6 m from the departure shaft.

Water leakage

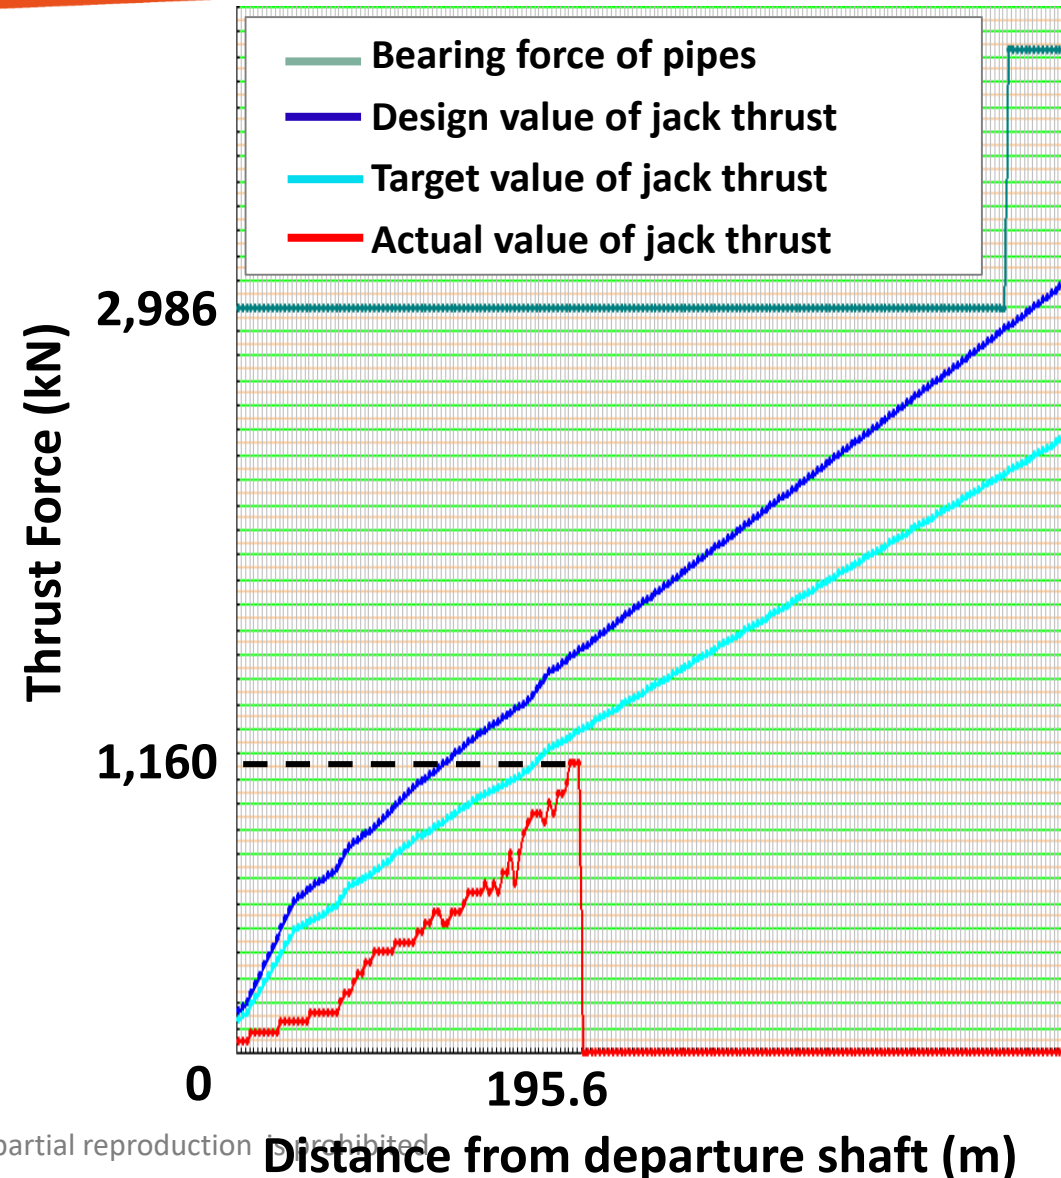
The designed value and the actual value of the jack thrust were much lower than bearing force of the pipes

Jack thrust was not the direct cause of the cracks.

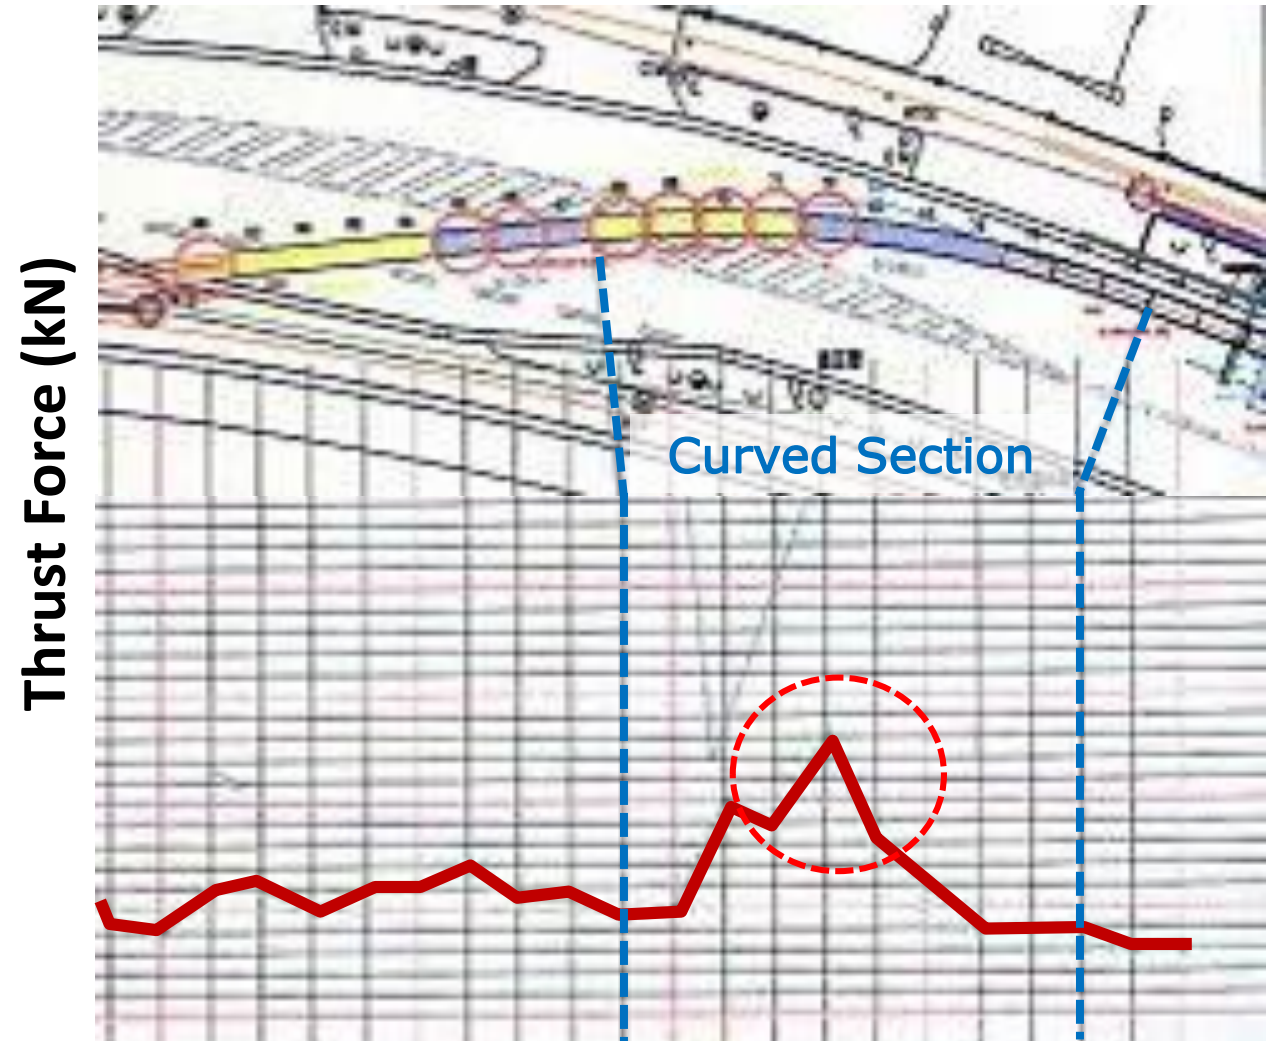
Torque value of the pipejacking machine

The torque value went up for a temporary period of time when the pipejacking machine was drilling through the curved section.

The ground might have been harder soil than predicted

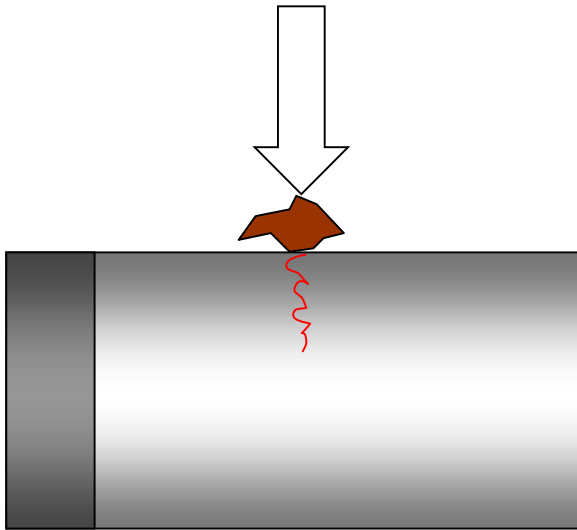
Possibility of stress concentration

Stress concentration
due to existence of gravel

From surplus soil, it was confirmed that gravel was included in the ground.

However, this was not be an option any more by the reasons described as follows:

1. No cracks occurred between the cracks and the jacking machine.
2. No cracks occurred after use of half-length pipe as a countermeasure of cracks.

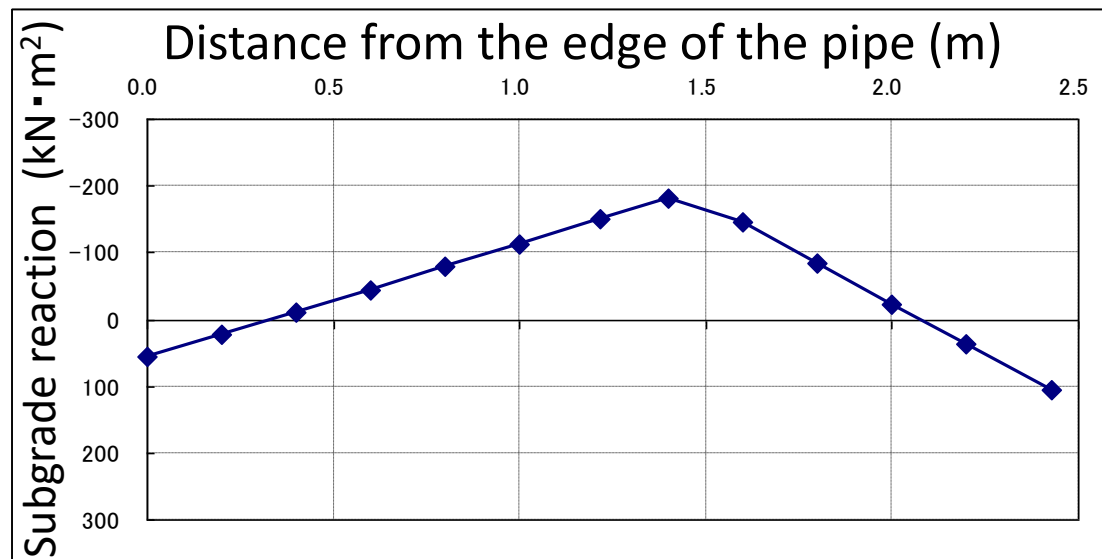
The maximum bending moment was 275 kN·m in the middle of the jacking pipe.
It indicates that **generated bending moment was larger than cracking moment of the pipe.**

Distribution of subgrade reaction
to the pipe in curved section

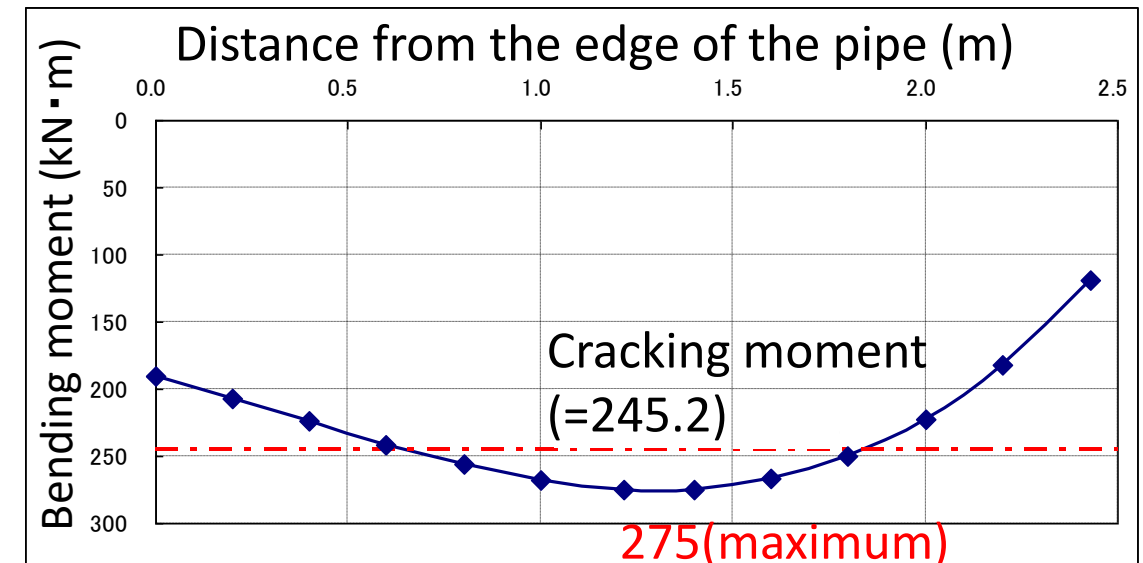
Bending moment
acting on the pipe in curved section

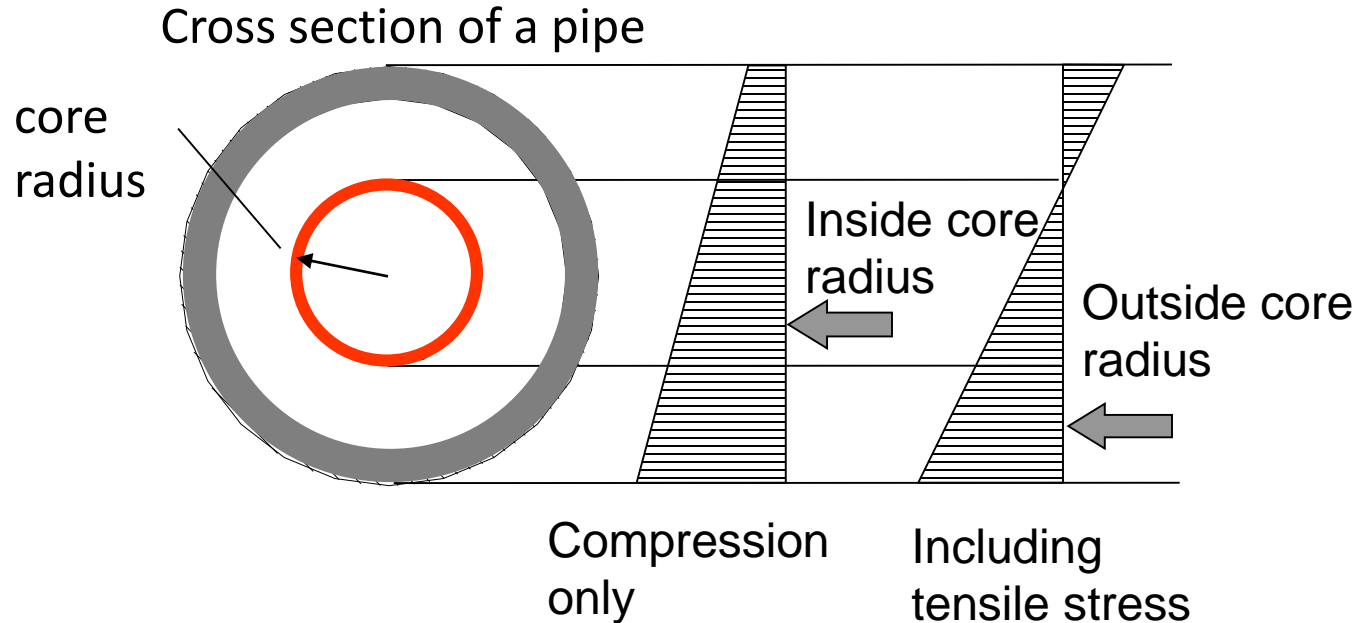
The possibility of generation of **bending moment by the eccentricity of axial force** during construction of sharp curvature was examined.

Generally, when axial force acts to the section with eccentricity, tensile stress may be generated.

$$\sigma = -\frac{M}{I}y - \frac{eP}{I} + \frac{P}{A} = -5.54[N/mm^2] > 5.24 (N/mm^2) \text{ Maximum tensile strength}$$
