**37<sup>TH</sup> INTERNATIONAL  
NO - DIG  
FLORENCE 2019**

**A case study in successful sewer network rehabilitation  
with UV cured CIPP & traditional/non-traditional survey technologies.**

**- Wastewater Network in Ras Al Khaimah, U.A.E. -**

**Börje Persson**

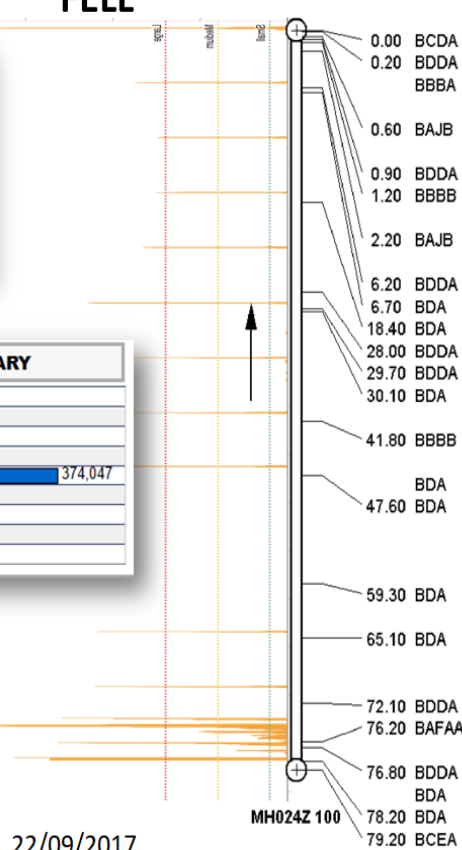
MH024Z 100A

DEFECTS	
Small	6
Medium	4
Large	15
All Defects	25

LPS SUMMARY	
Minor	
Moderate	1.83
Severe	2.40
Total LPS	4.33
LPD	374,047
LPD IDM	31,271
Minor %	1.90%
Moderate %	35.14%
Severe %	62.96%

**25 Total  
Leaks**

**2 Displaced Joints**

Psn: 12; Surface damage, increased roughness, mechanical damage; Cl.: 3

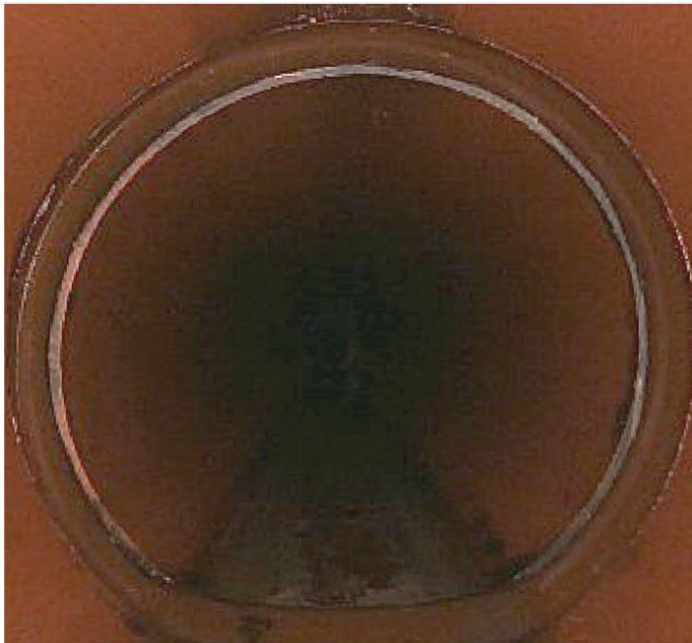
B  
E  
F  
O  
R  
E

Example: MH011Z/53A – MH011Z/53

SN	SECTION NAME	MATERIAL	DIAMETER	LENGTH	RECOMMENDATION
1	MH011Z/53A - MH011Z/53	PVC	200	59.50	CIPP as per deflection, exceeded limits
2	MH009Z/47 - MH011Z/53	PVC	200	43.60	Cutting of intruding sealing @6.80m, 17.10m & 18.20m, 6 Patches @0.80m, 6.80m, 17.10m, 18.20m, 41.60m & 42.70 m as per CCTV OR CIPP due to deflection, depth and exceeding numbers of patches
3	MH008Z/45 - MH011Z/53A	PVC	200	95.80	cutting of intruding seal and patch @ 47.80 and CIPP as per deflection
4	MH011Z/53 - MH011Z/54	PVC	250	113.70	CIPP as per deflection, exceeded limits and Fell
5	MH011Z/54 - MH024Z/100	PVC	250	113.60	CIPP as per exceeded limits and Fell
6	MH024Z/100 - MH024Z/100A	PVC	250	79.20	1 patch @2.18 m (infiltration) & CIPP as per deflection, Fell and considering the depth of the line
7	MH024Z/100A - MH024Z/99	PVC	250	79.00	CIPP as per Fell and considering the depth of the line
8	MH024Z/99 - MH024Z/98	PVC	250	80.70	cutting intruding seal, Patches @0.50m, 1.0m, 39.30m & 50.90m as per CCTV OR CIPP as per FELL

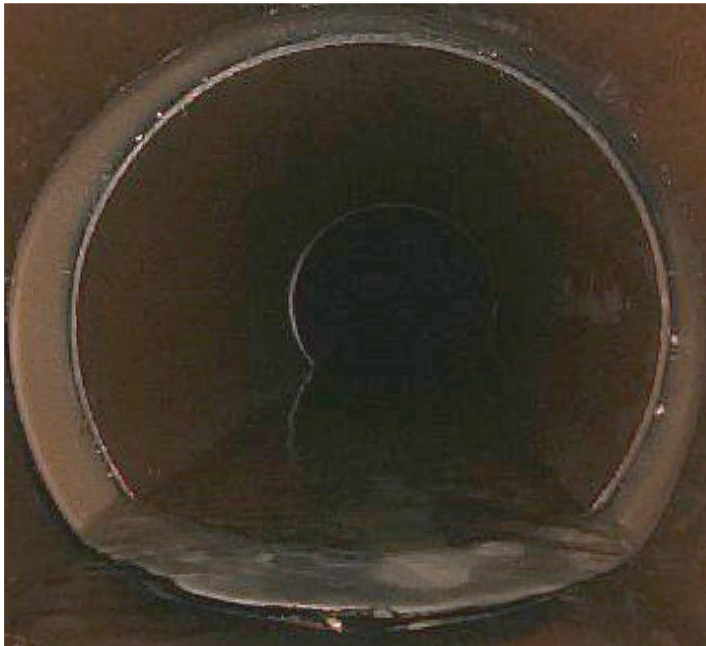
B  
E  
F  
O  
R  
E

Example: MH024Z/99 – MH024Z/98
