**37TH INTERNATIONAL
No-DIG
FLORENCE 2019**

**A NOVEL MONITORING PROCEDURE FOR ASSESS THE CORRECT ROAD PAVEMENT RESTORATION
AFTER THE ONE-DAY-DIG MINI-TRENCHING INSTALLATION**

Gianluca Cerni, Barbara Bernardini, Diana Salciarini, Federica Ronchi, Evelina Volpe, Alessandro Corradini

University of Perugia, Department of Civil and Environmental Engineering, Perugia, ITALY

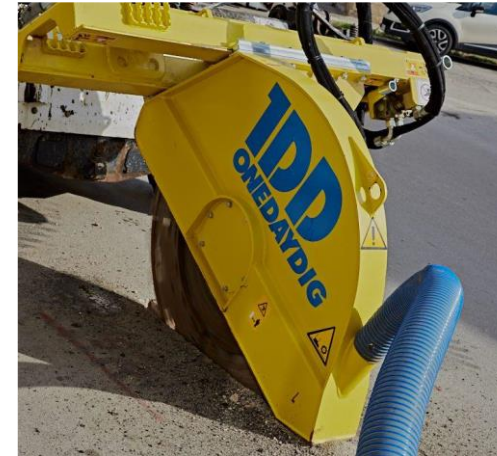
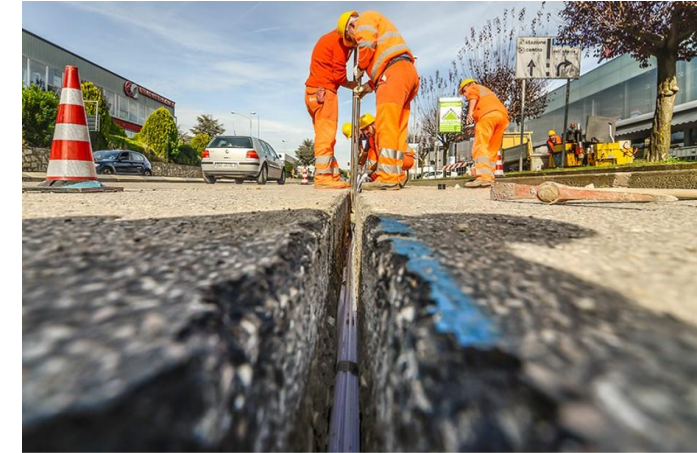
1 Day Dig
Low impact trenching technique
for FTTx
fiber network to the end-users
(ITU-T Recommendation, 2016)

- Quick digging procedures
- Reduced dimension machinery
- No residual material
- Fast hardening
- Quick pavement restoration

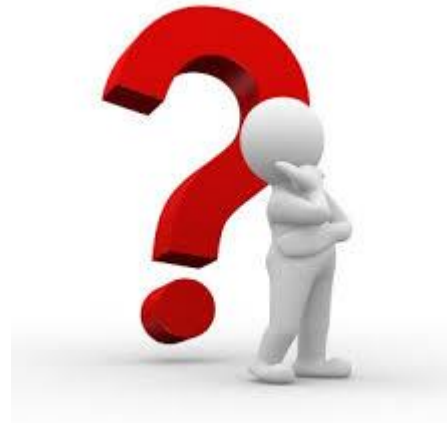
Materials used as backfill :

- **Suitable**
(quick setting, fluid consistency, stable, properly bond with the existing structure, etc.)
- **Properly installed**

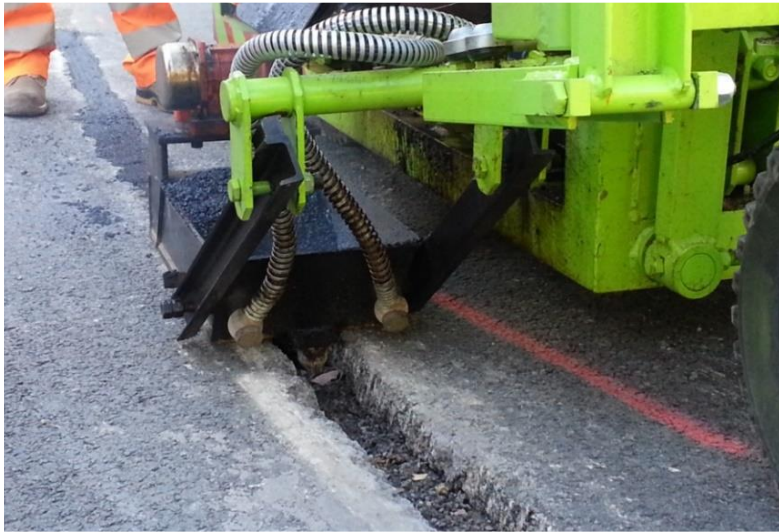
Experimental testing campaign:

- Cta samples → high permanent deformation
- Poor adhesion at the interface
- Different sites → Heterogeneity in mechanical (fatigue) performance

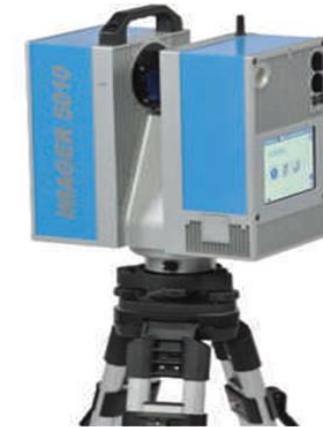
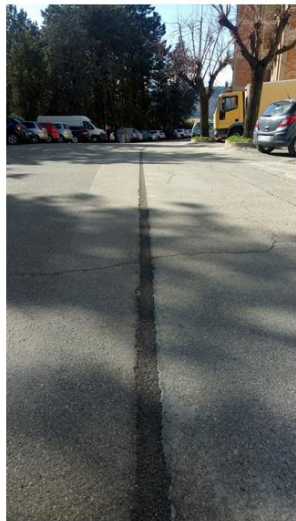
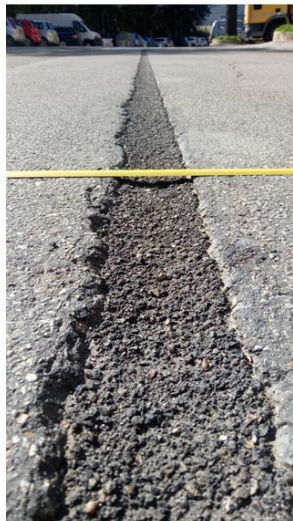
- The first phase focused on the **detection of the road network** (Perugia) interested by 1DD mini-trenching using a 3D laser scanner
- The second phase interested the **elaboration of the point clouds** collected during the detection phase through the open source software CloudCompare.

- A new procedure was developed to **assess the vertical deviations** of the mini-trench surface from a reference plan representative of the road pavement.
- In order to confirm the reliability of the method, **post-processing controls** were executed

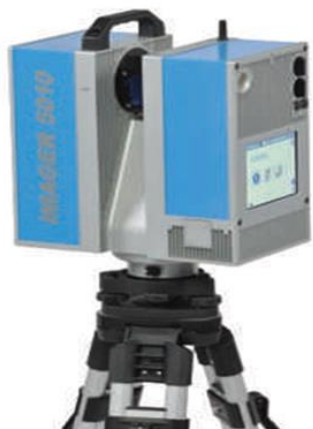
Z+F IMAGER 5010: **phase-shift** laser scanner:

- ✓ compact and easy handling apparatus
- ✓ high measurement speed (maximum rate: more than one million pixels/sec)
- ✓ high angular and distance accuracy
- ✓ range up to 187 meters
- ✓ extended field of view 320°x360°

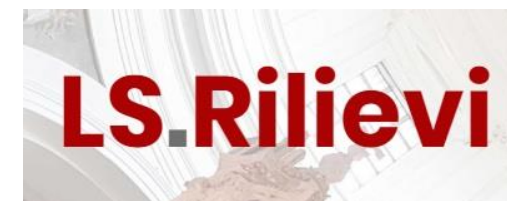
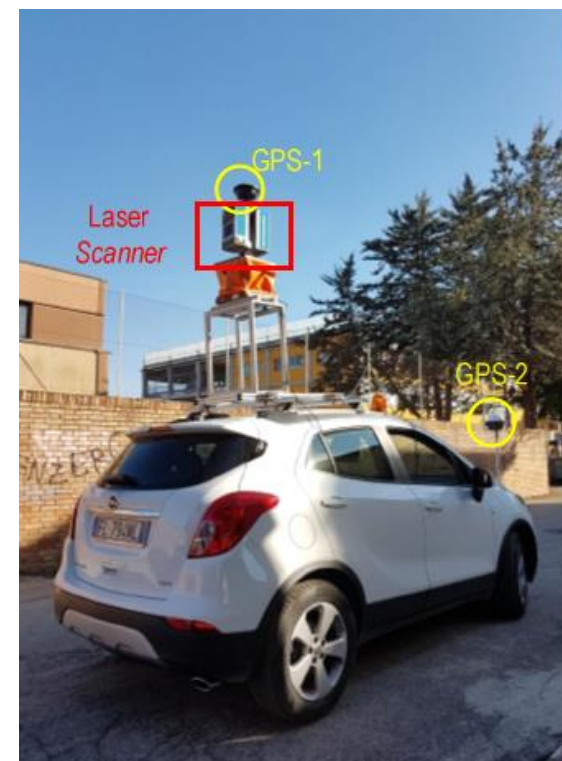
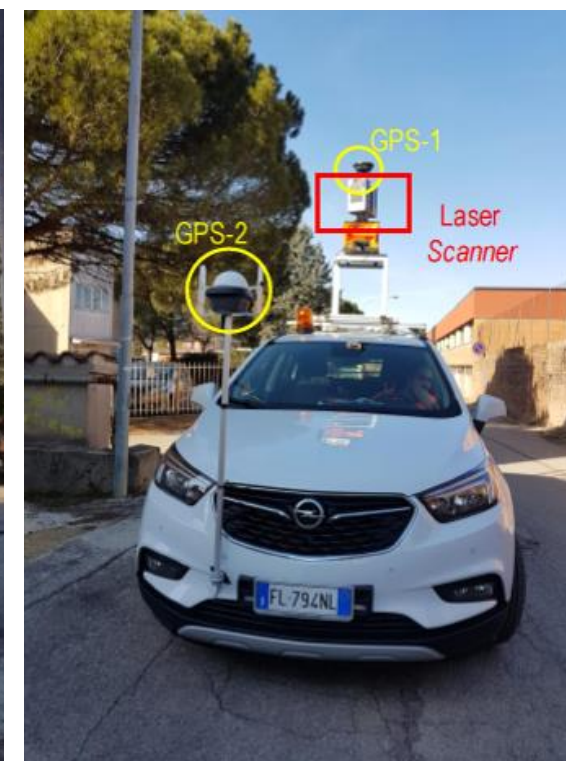
The laser scanner was installed on the roof of a car through a multi-axis leveling platform (LEVEL-PLANE EVO 16, Scan&Go) and it was integrated by two GPSs, which allowed georeferencing each scanning

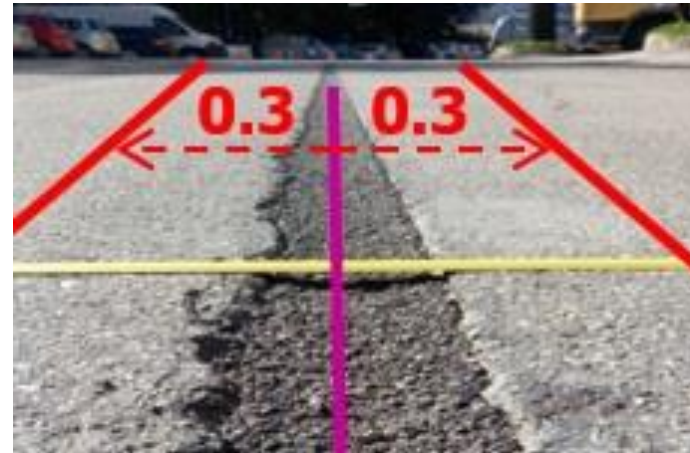
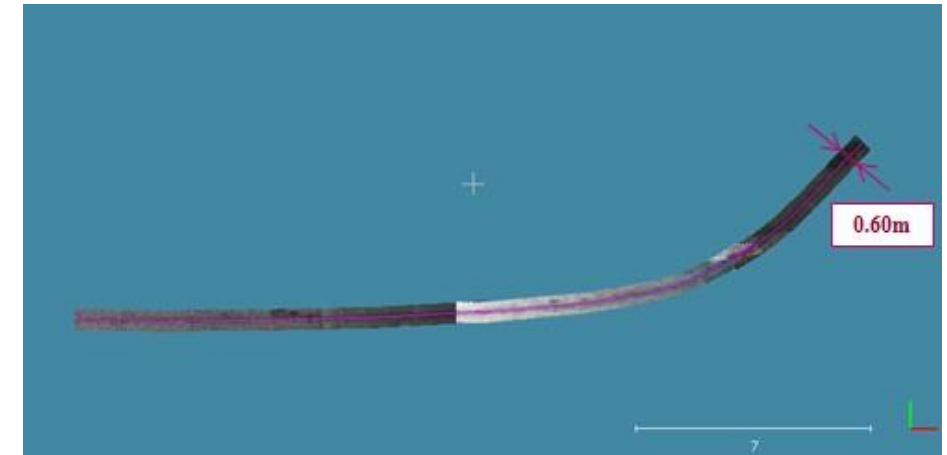
On each scanning → polylines were drawn following the axis of the mini-trench and the whole path was covered.

Among those polylines, **strips of 0.60 m wide**, which contain both the mini-trench and a small portion of the existing pavement, were cut out.

The strip width was chosen based on the compromise of having a strip large enough to define a representative surface of the existing road pavement, and, at the same time, small enough to avoid the presence of irregularities.

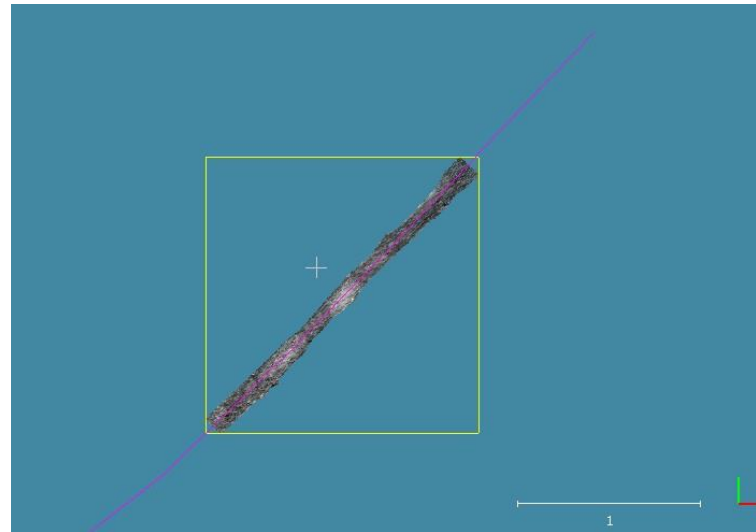
On each segment, the mini-trench was cut out trying to follow as accurately as possible the actual development (a).

New clouds are generated:

- Points within the mini-trench (b)
- Points of the existing pavement only (c)

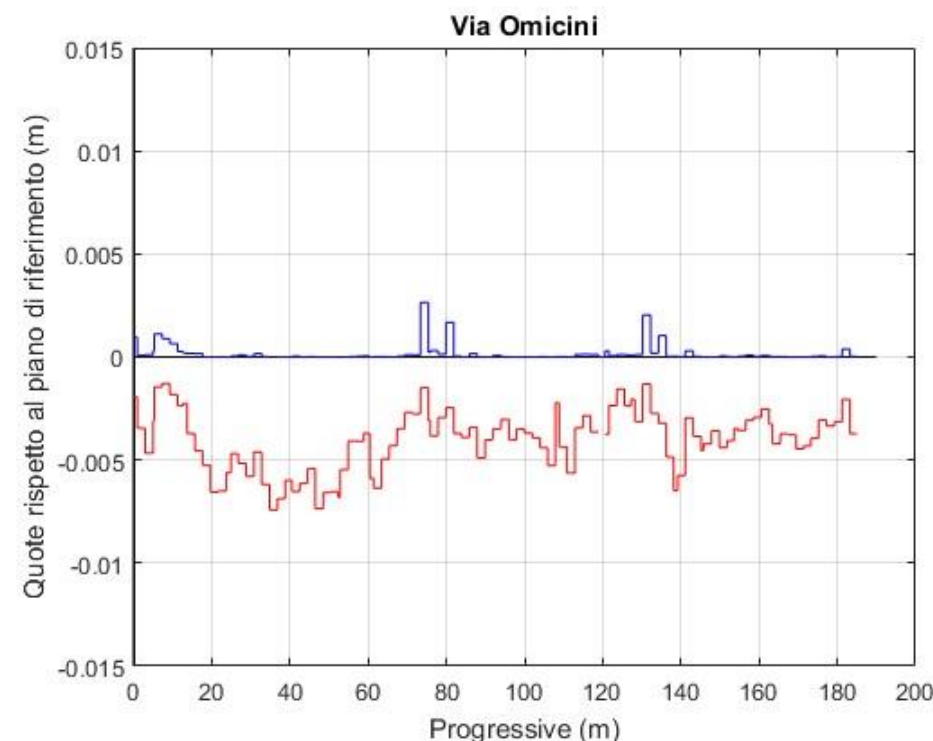
Using a Matlab routine, average deviations suffered by each segment were calculated.

- Arithmetic means of negative and positive deviations
- Weighted means in relation to the number of points of negative and positive deviations

The weighted means, displayed in a graph as a function of the progressive lengths, provided an immediate vision of the status of the analyzed mini-trench

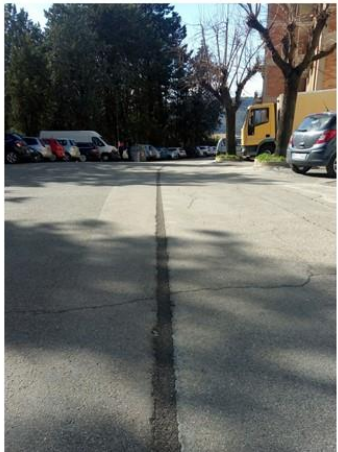
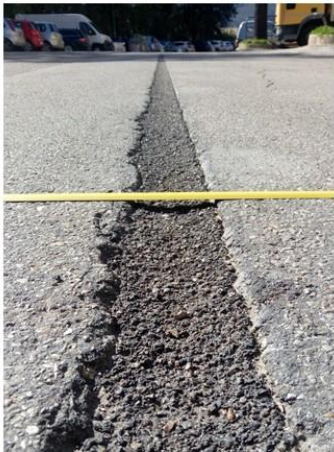
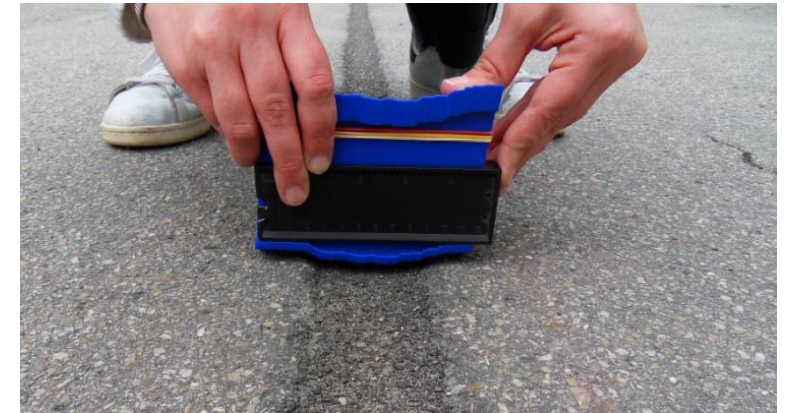
The reliability of the method was evaluated

- Visual inspection
- «Comb profilograph»

The final data check proved an excellent fit of the results obtained through the elaboration in CloudCompare to the actual situation.

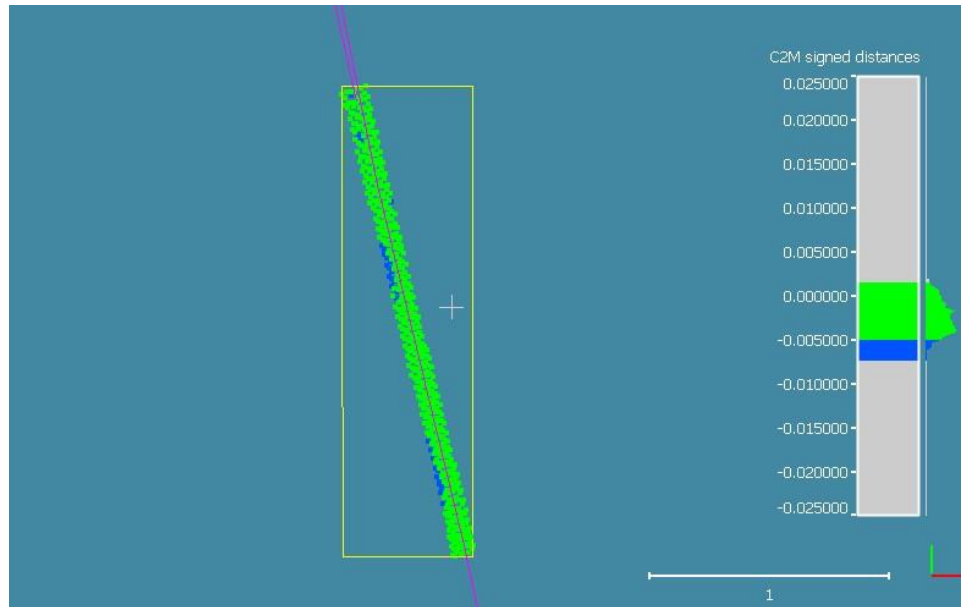
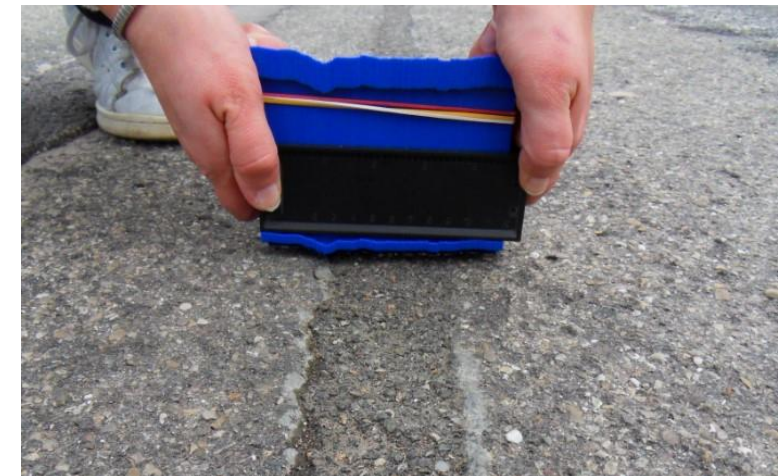
The reliability of the method
was evaluated

- Visual inspection
- «Comb profilograph»

The final data check proved an excellent fit of the
results obtained through the elaboration in
CloudCompare to the actual situation.
