## Spray Applied Lining Systems Address Unique Infrastructure Problems

Karl Bissinger, Chairman of the Board, Vortex Europe AG

- Lakewood, Cleveland, Ohio
- Manhole 40m deep
- Culvert 110m long
- Constructed 1912 – 1915
- Brick construction

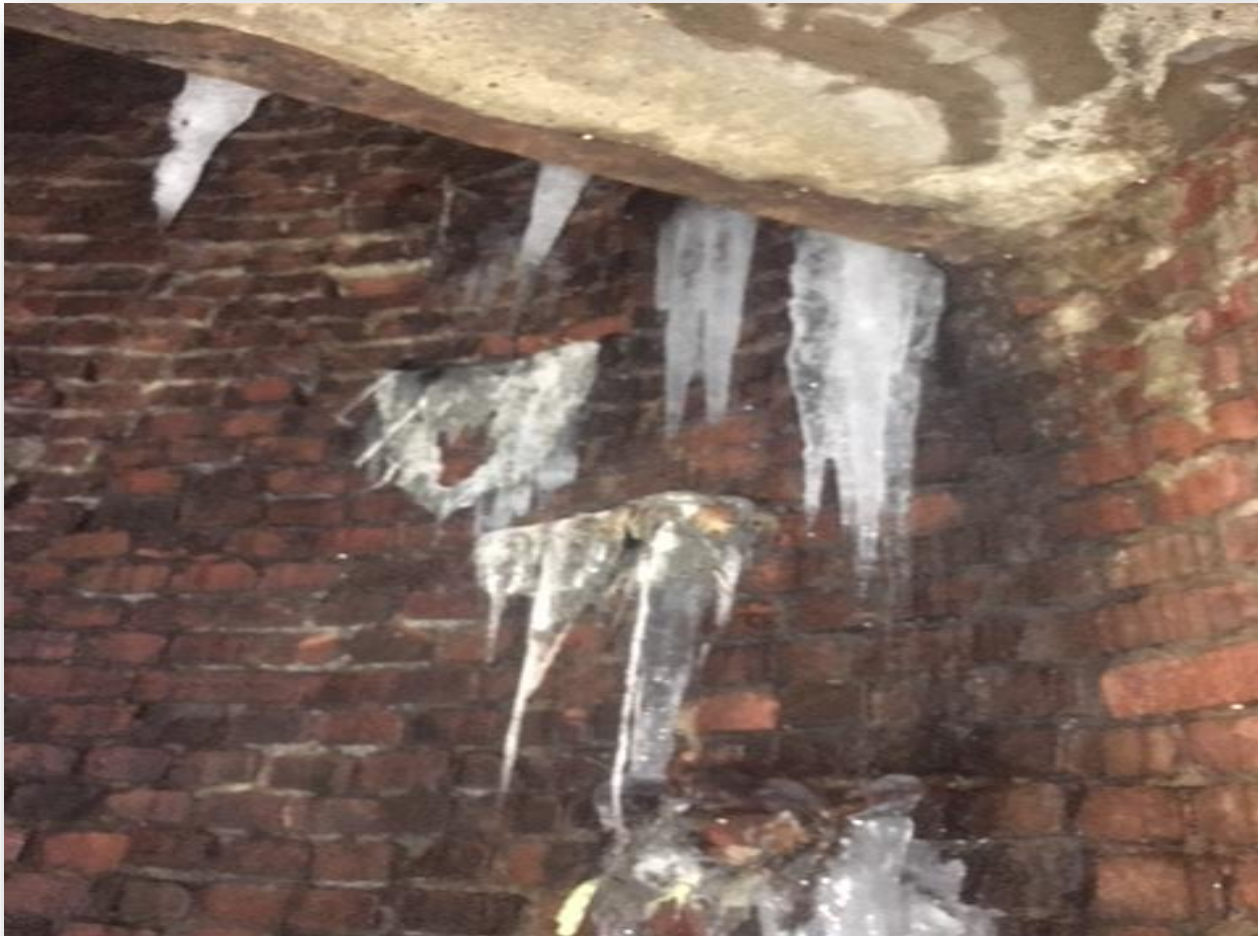
Interior of Manhole at the Base

- Brick construction
- Depth 40m
- DN 1200 – 2400
- Diameter increasing to bottom

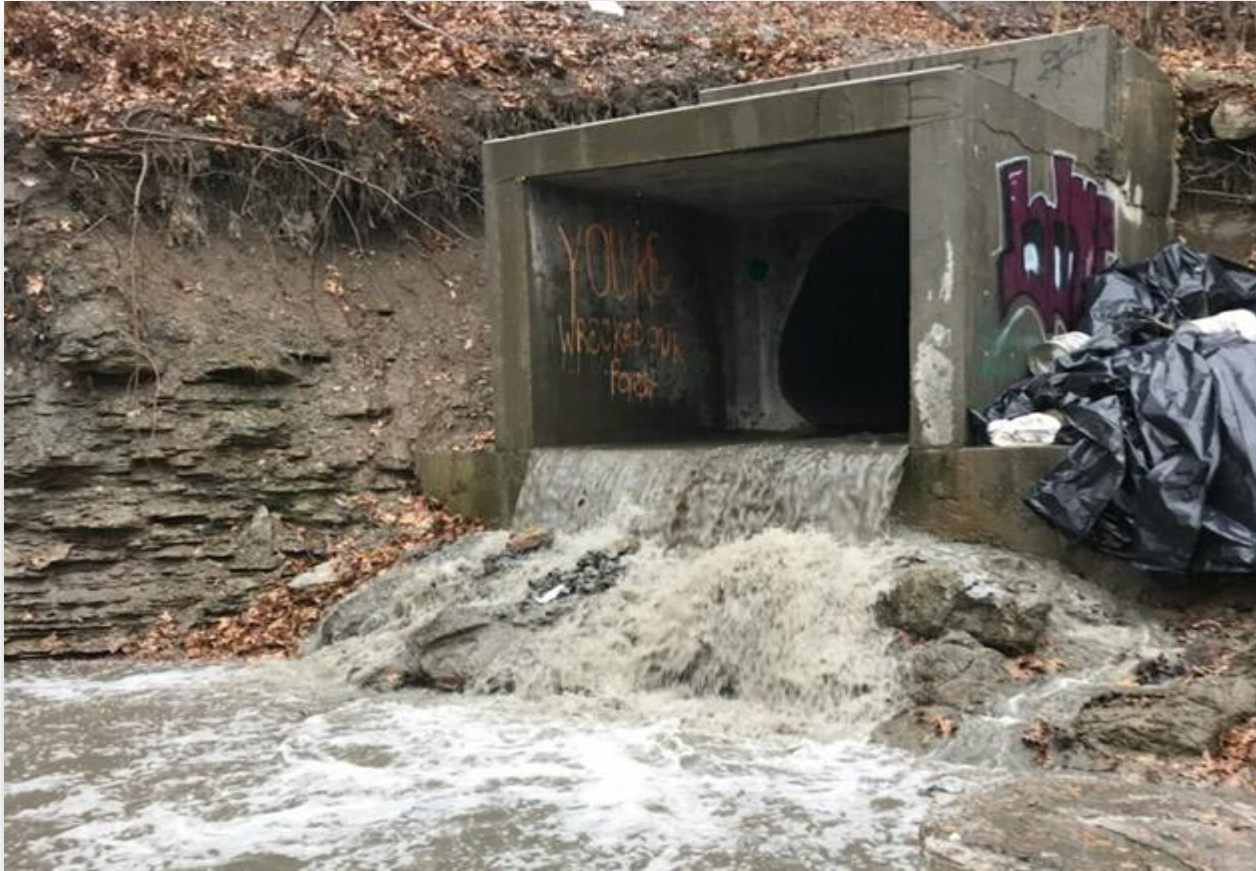
- At bottom of steep river embankment
- Extremely difficult to access

Outfall - Rain event

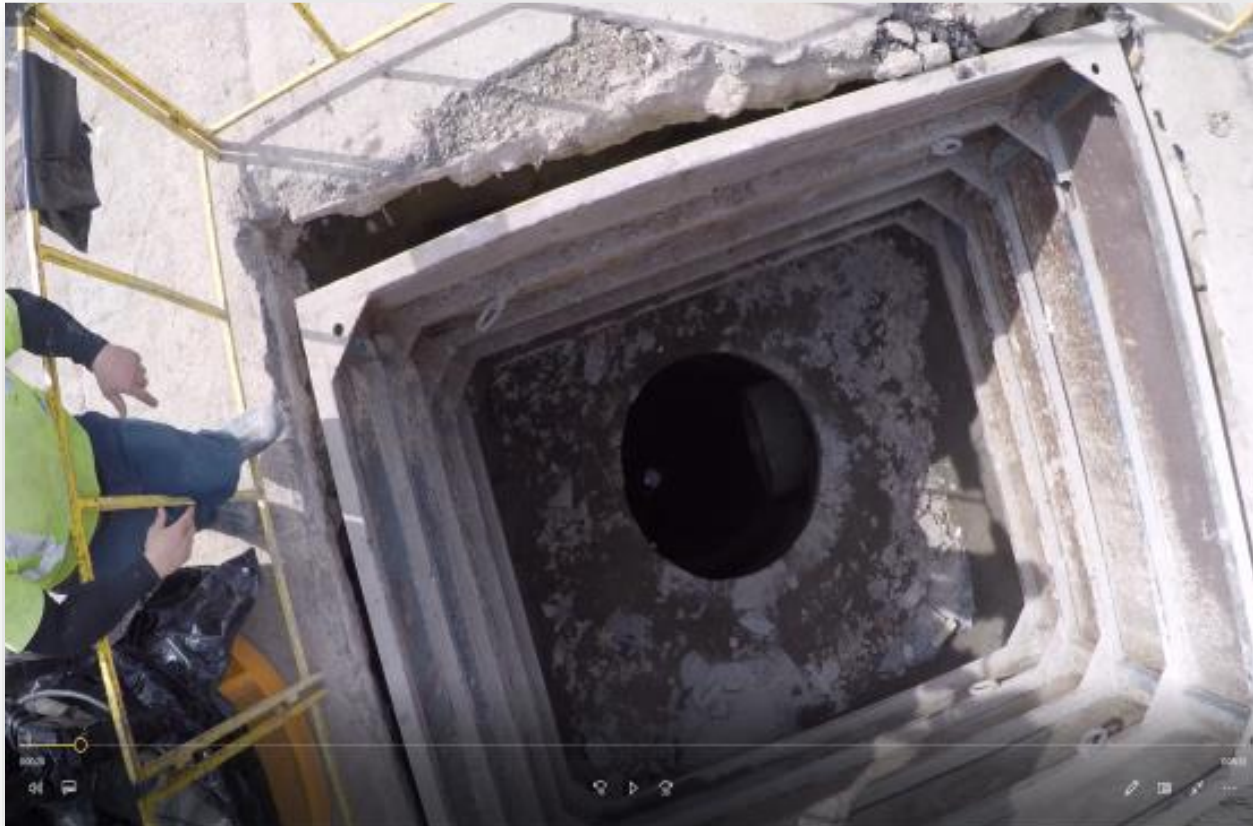
Manhole Access Structure

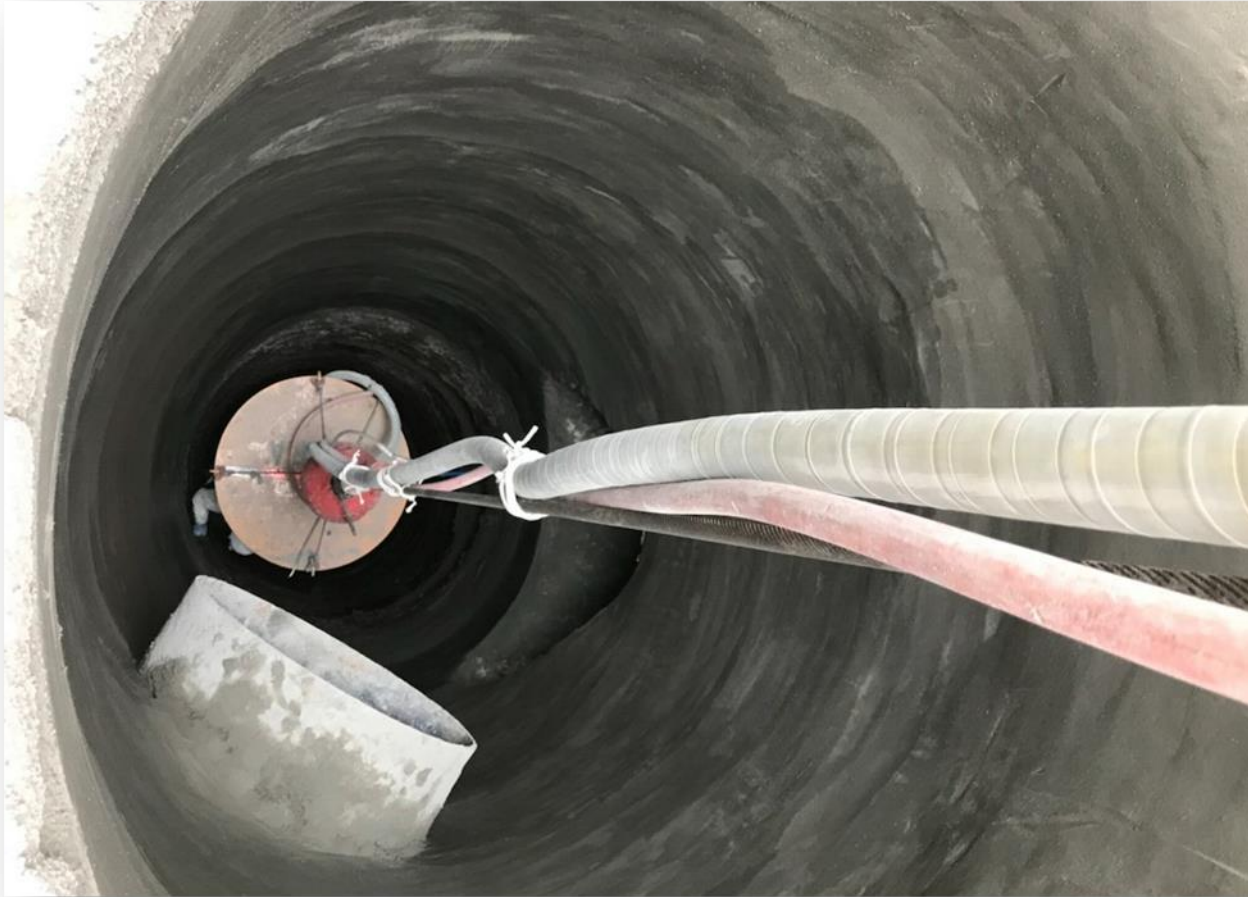
Manhole Original Condition

- Basket attached to a winch and crane to hold the crew
- Lowered into the manhole to spray apply and hand trowel the geopolymer mortar
- Section completed - crane operator lowers basket to next stage
- This step was repeated throughout the process

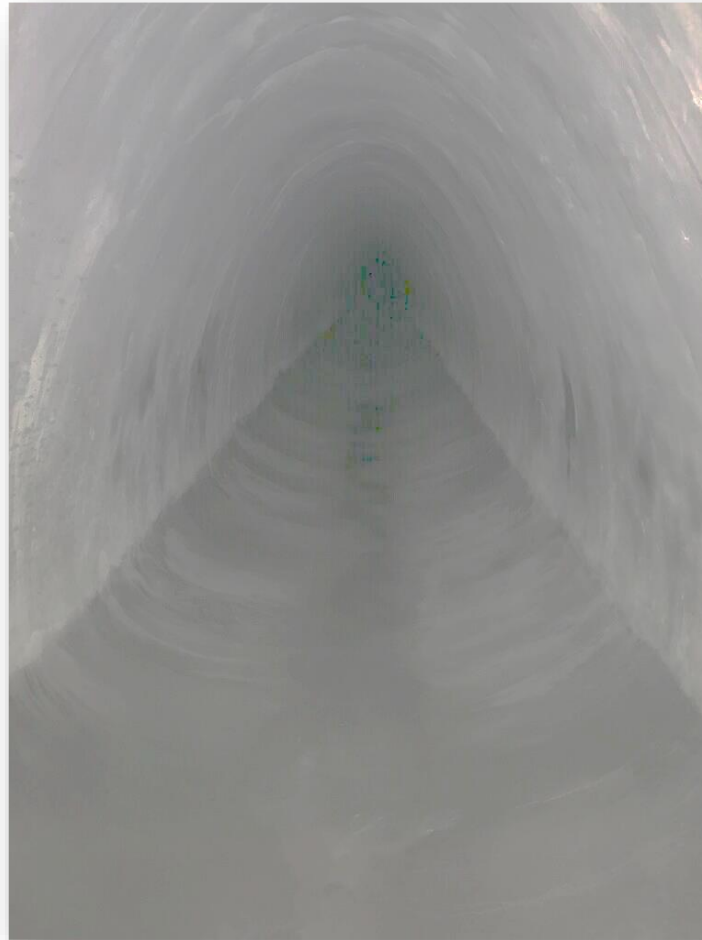
Pipe Structural Lining Completed

- Spray apply
- Patented spray head
