SUCCESSFUL INSTALLATION OF CFRP AND GFRP ON PIPE BRIDGES IN SCOTLAND, UK

PROJECT BACKGROUND - ROUNDKNOWE

The site is located within Calderbraes Golf Club, located just off Roundknowe Road, 2km northwest of Uddingston, South Lanarkshire.

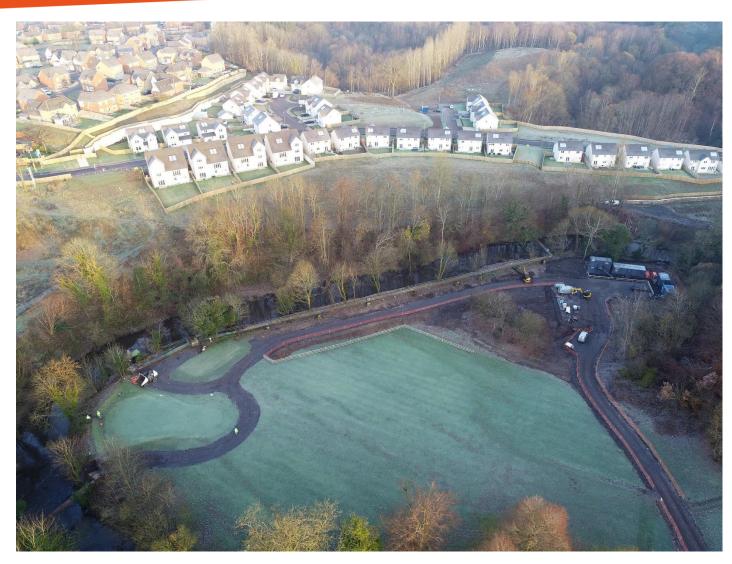
- 900mm OD Steel Pipe
- 235m overall length
- 4 Nr. Manholes
- **11 Nr**. Piers
- **2Nr**. River crossings
- Signs of corrosion
- Alongside a golf course

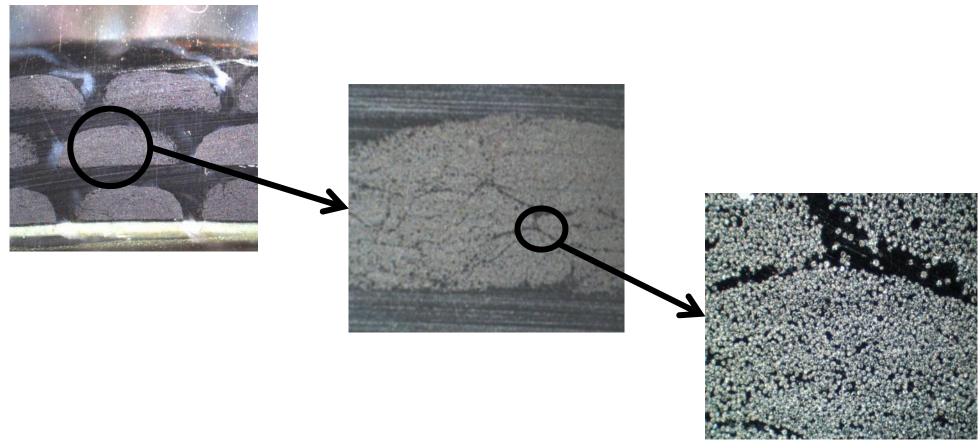
CFRP: Close Up

- Reinforced fiber (carbon or glass)
- Epoxy Resin

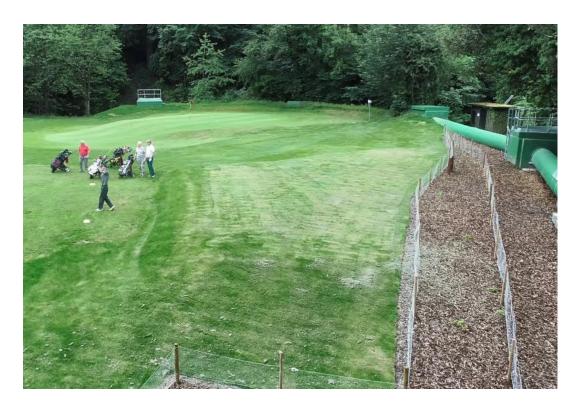
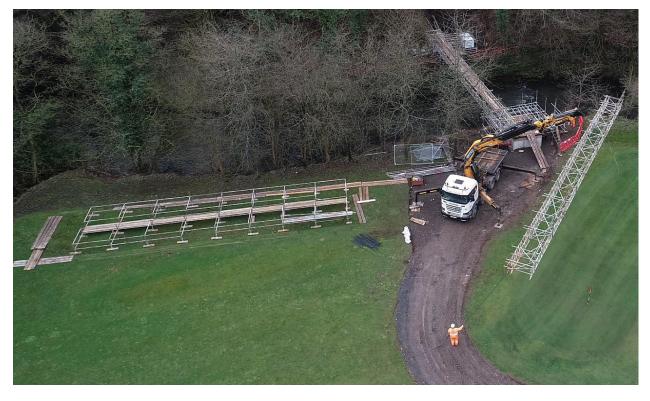
- Requirement to maintain golfers access to the 7th green throughout the installation
- Due to remote location of the pipeline, safe access needed to be created whilst minimizing the environmental impact

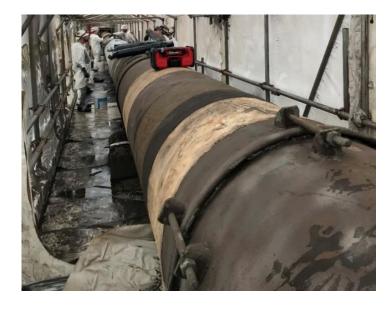
Step 1: Surface Preparation

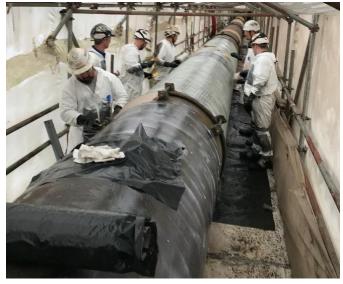
Step 2: Installation of GFRP/CFRP System

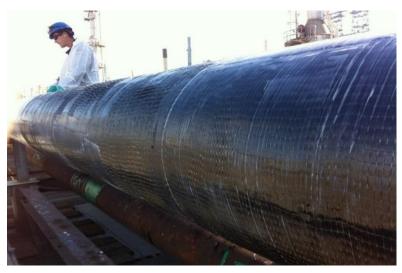
Step 3: Finish System applied

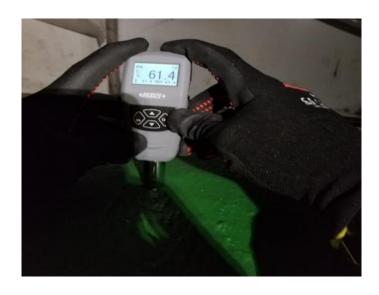
Shore D Hardness Testing

Measures Cure of FRP System

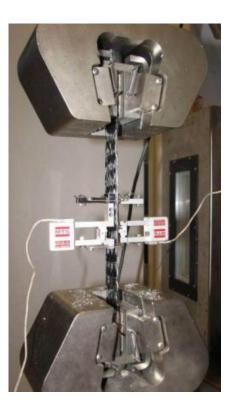
Witness Panels

- One layer of the GFRP and CFRP System
- Preparation of panels spread throughout construction
- Testing per ASTM D3039
- Confirms design assumptions
