**37<sup>TH</sup> INTERNATIONAL  
NO - DIG  
FLORENCE 2019**

## **EXPERIMENTAL CHARACTERIZATION OF MINI-TRENCHES ON ROAD PAVEMENTS**

Alessandro Corradini, Gianluca Cerni, Federica Ronchi, Diana Salciarini

University of Perugia, Department of Civil and Environmental Engineering, Perugia, ITALY

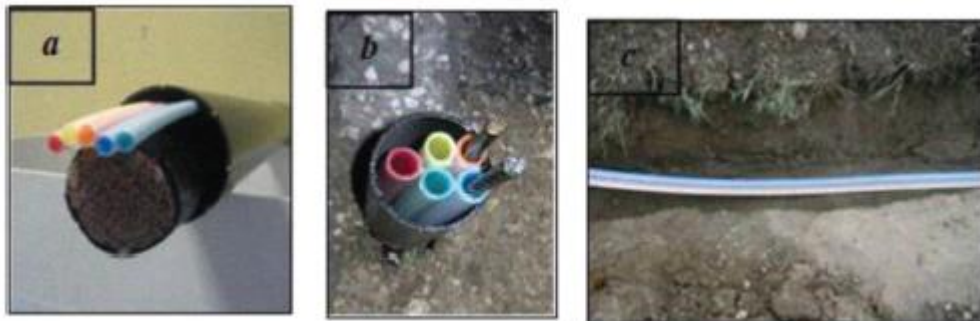
Miniaturization of  
primary elements:  
**FENDER**

Same potentiality  
of fiber

Smaller diameter

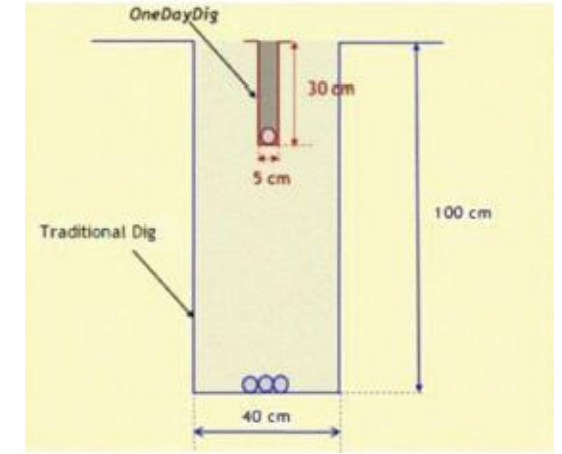
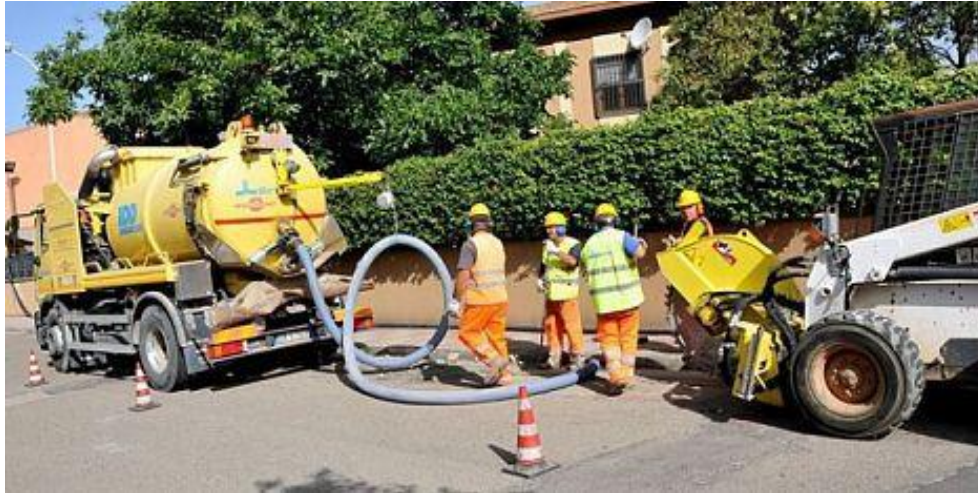
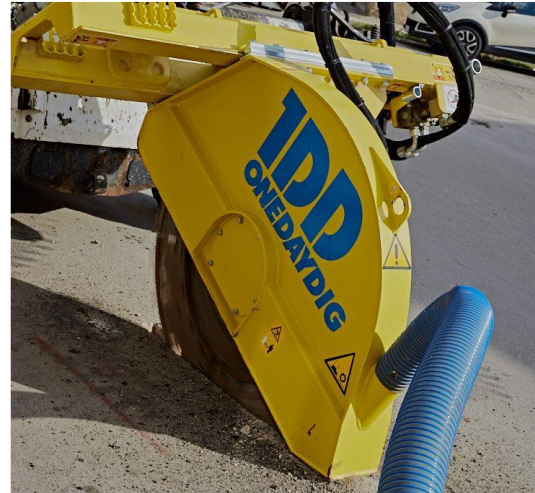
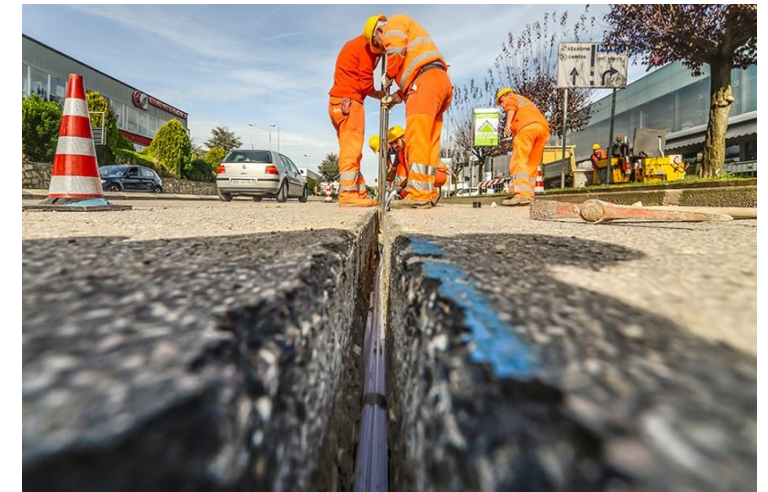
**Low impact trenching technique** for FTTx  
fiber network to the end-users  
(ITU-T Recommendation, 2016)

Quick digging - Reduced dimension machinery - No residual material - Fast hardening – Quick pavement restoration

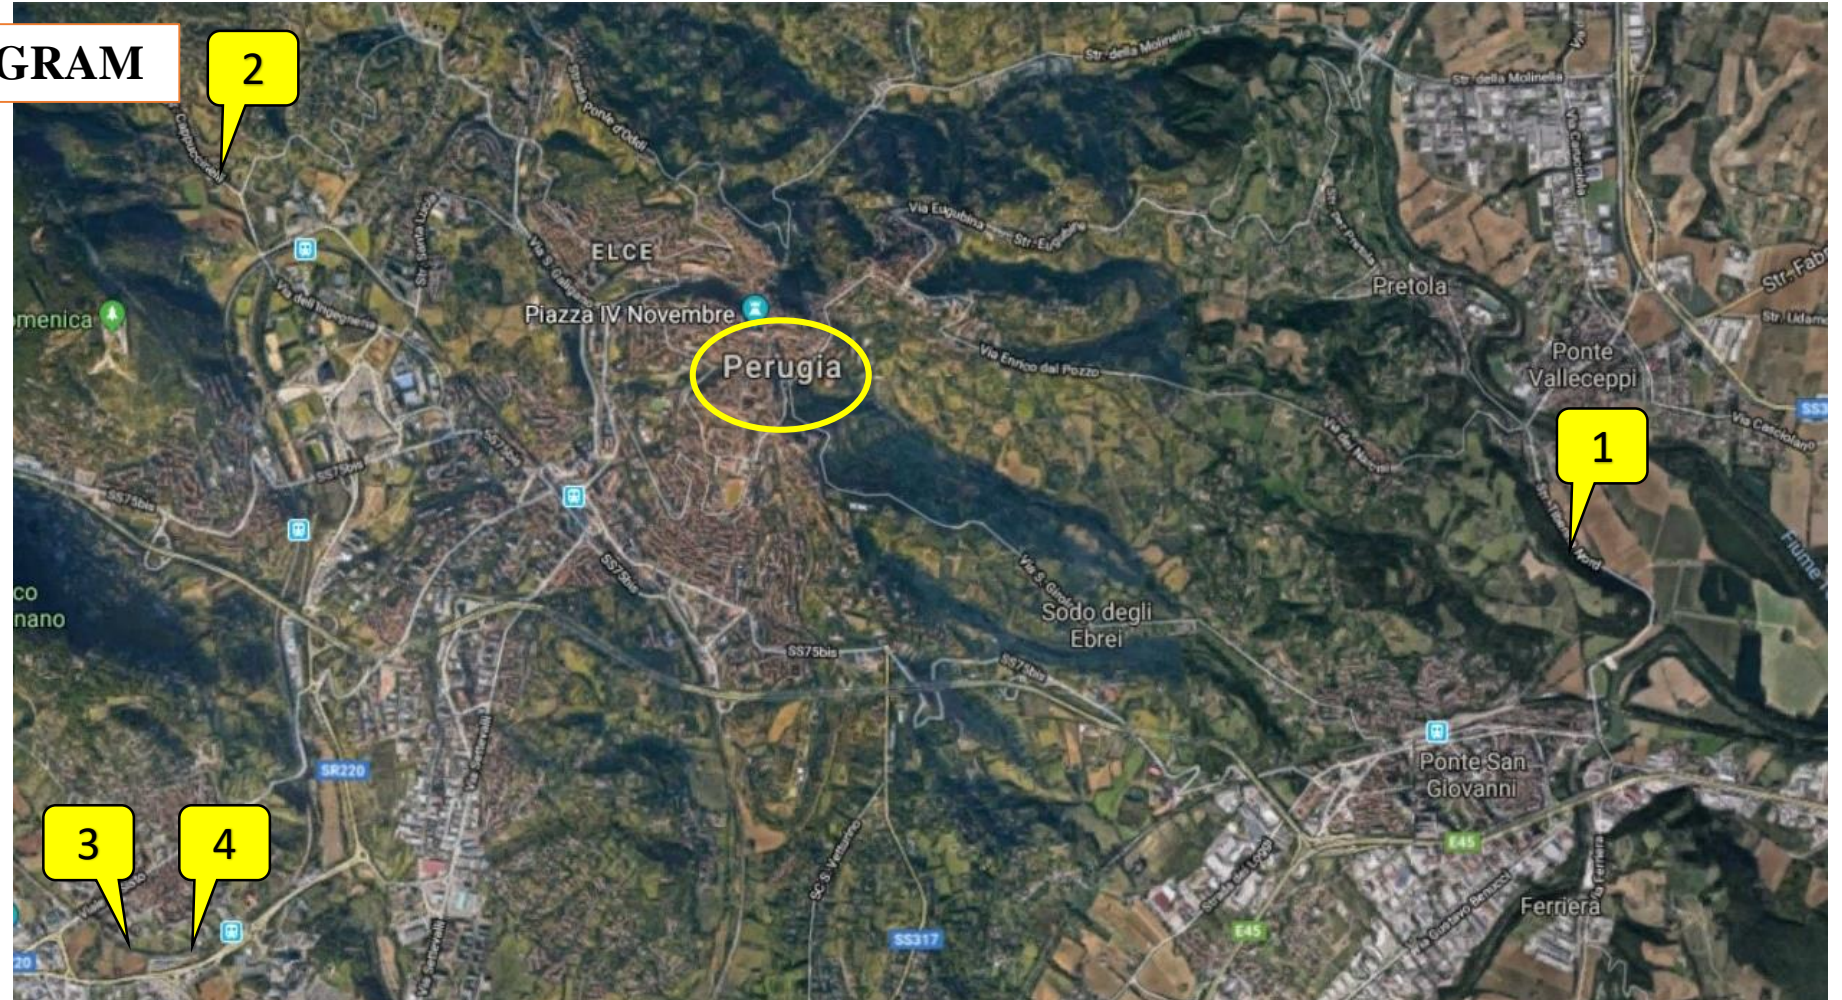
1. Strada Tiberina Nord  
Ponte San Giovanni
2. Strada dei Cappuccinelli  
Loc. Santa Lucia
3. Via Pergolesi  
Loc. San Sisto
4. Via Albinoni  
Loc. San Sisto

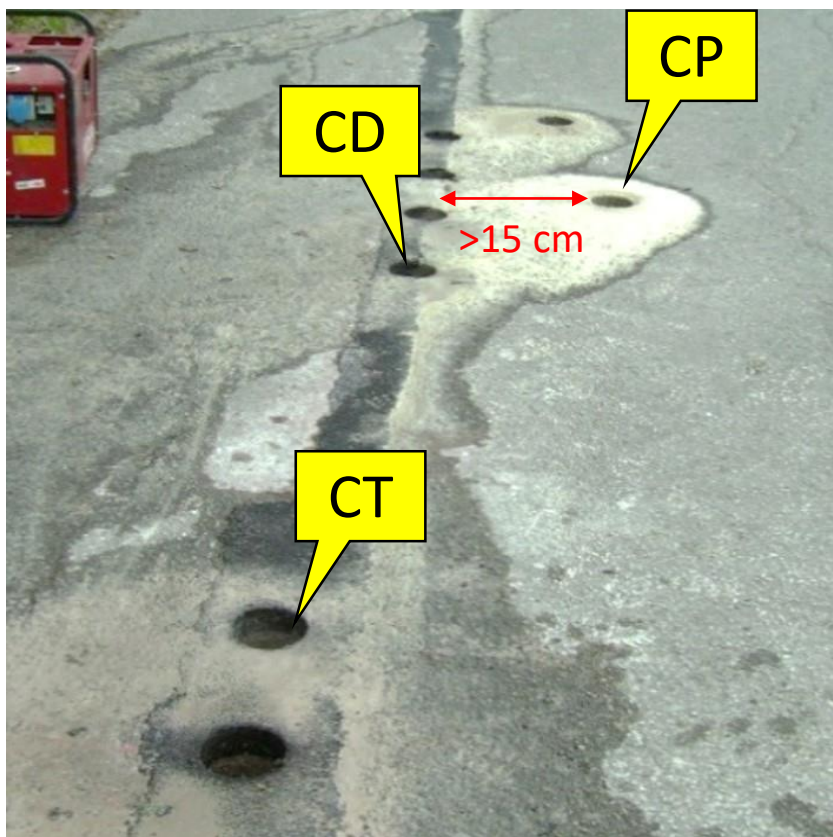
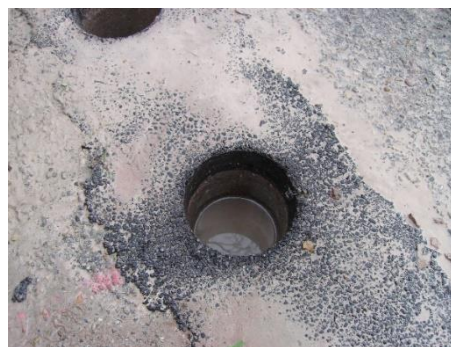
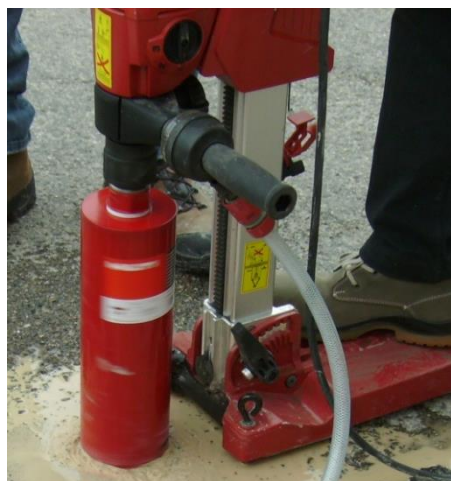
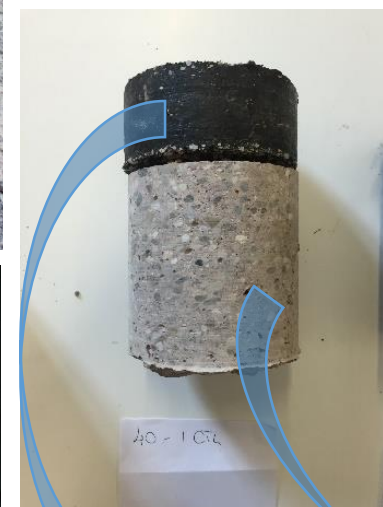
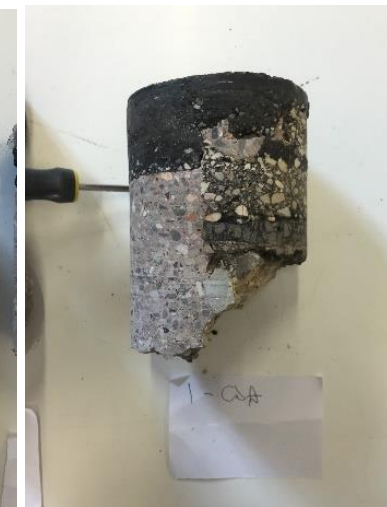
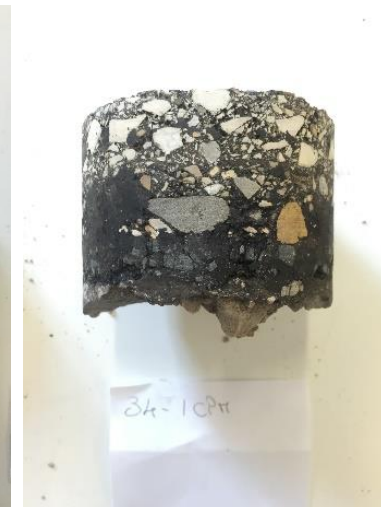
- 75 Cylindrical samples were cored

CTa

CTg

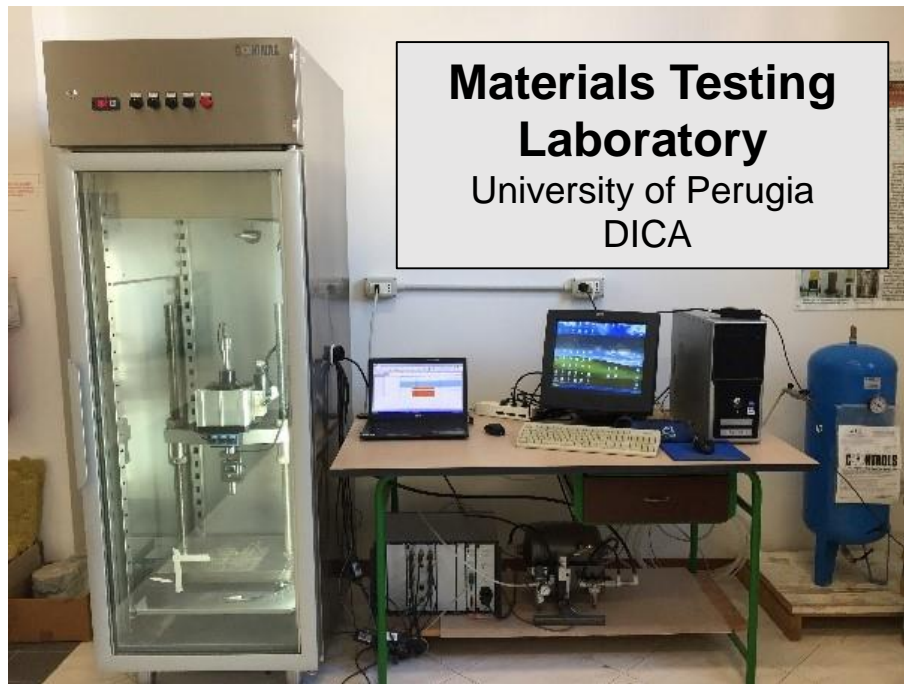
Dynamic servo-pneumatic machine – UTM14 P

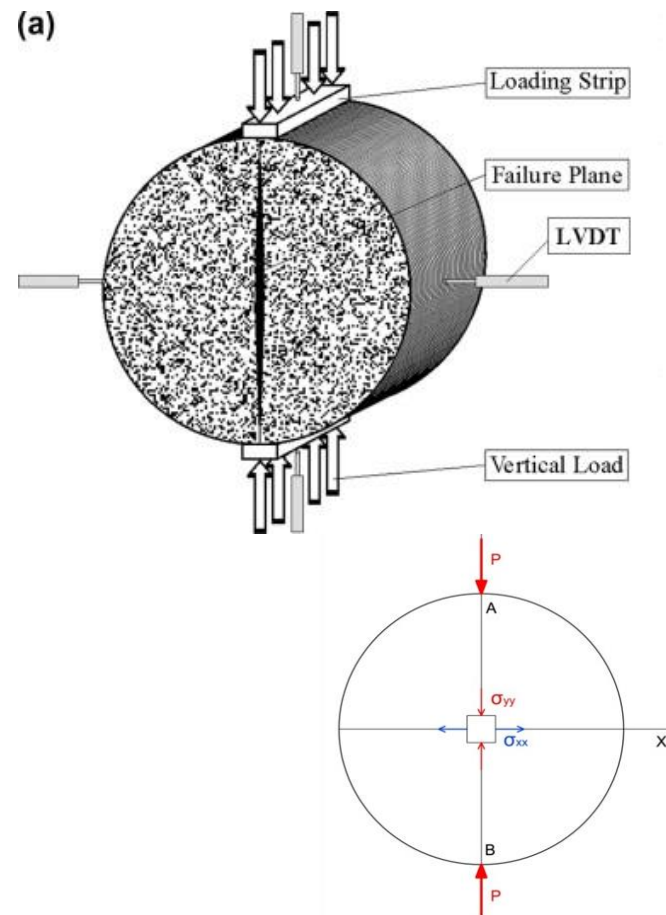
## INDIRECT TENSILE TEST

- The loading frame consists of two loading strips
- Repeated compressive (vertical) loads with a haversine load signal are applied.
- This loading results in repeated tensile stress pulses perpendicular to the direction of the applied load

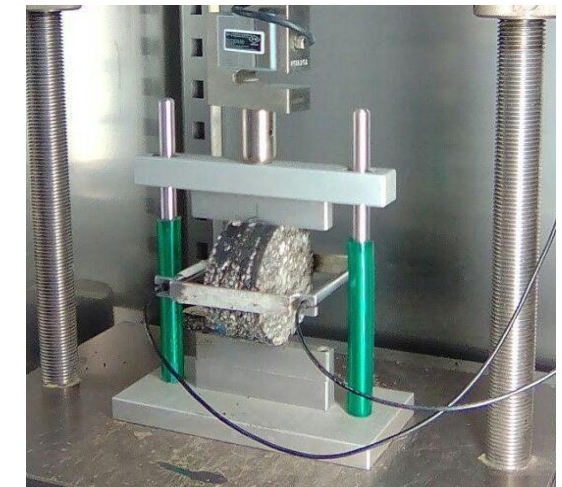
- **Fatigue test**

- **Primary Phase:** it consists in an adaptation phase, characterized by a rapid growth of permanent deformation.
- **Secondary Phase:** This phase is a quasi-stationary period, where the accumulation rate of permanent deformation is approximately linear. Phase I and Phase II constitute the fatigue initiation phase up to the point where micro-cracks begin to coalesce.
- **Tertiary Phase:** this is the failure phase, Macro-cracks begin to develop and global failure is experienced by the material.

- Marked scattering → **Expected!**
- Average  $N_f$  values for S1, S2, S3 and S4 are 174938, 64641, 51901 and 629918 respectively.
- Vertical permanent displacement, evaluated at the final failure approaching, ranges from 1 to 1.5 mm at the most

$N_f$  values → Total number of load applications before obvious cracking appeared on the vertical axis of the specimen

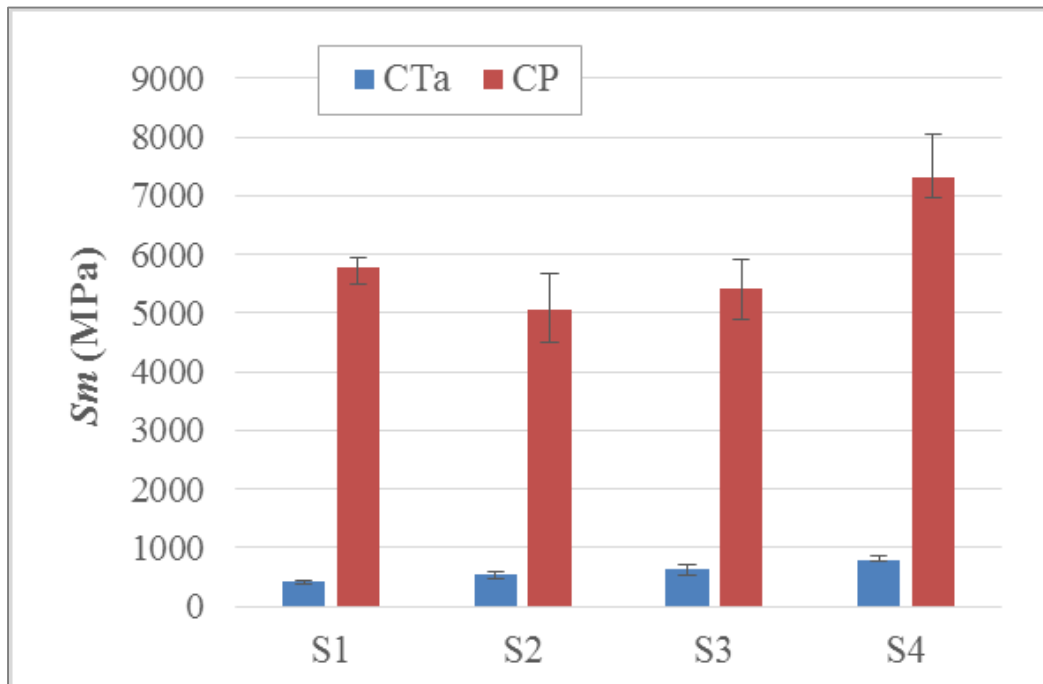
- CP samples showed modulus values at least 8 times greater than CTa
- The dispersion of the data, shown by vertical black lines denoting maximum and minimum stiffness values, is significantly fewer than the performance gap

According to flexible pavements design criteria, the asphalt concrete of CP samples can be assumed as the stiffer material of the existing pavements. Otherwise, the asphalt concrete used at the top of the backfilling should work as a sealant, without neglecting safety and driving comfort.

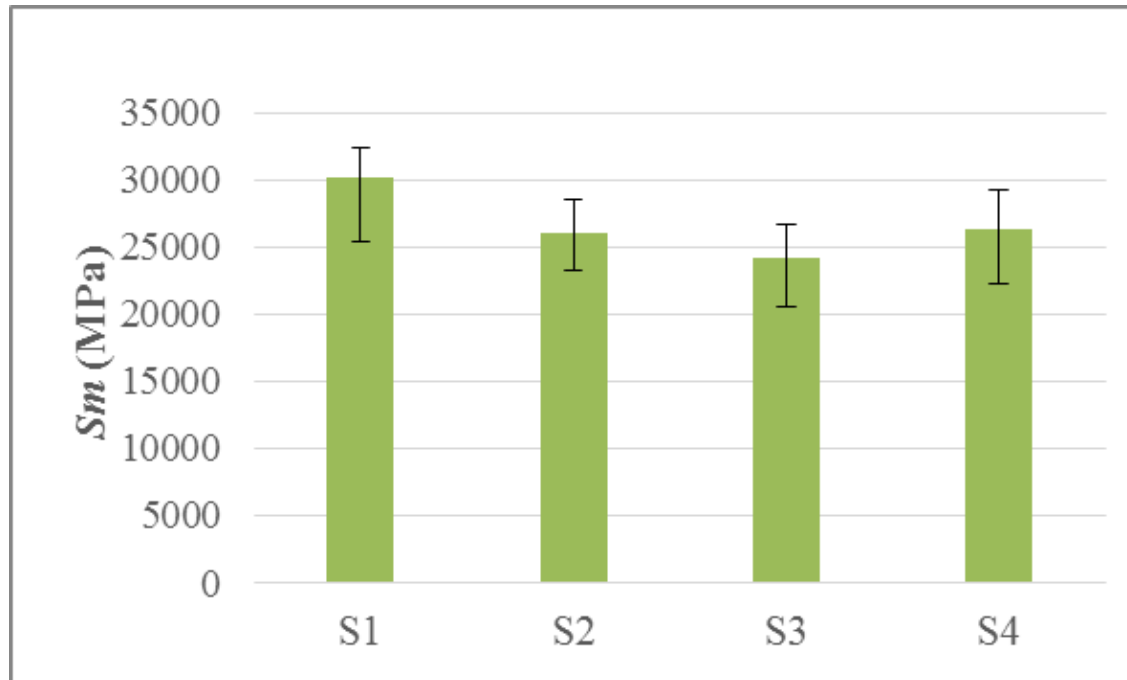
- The cement grout, which is at least 25 cm deep, is required to guarantee adequate mechanical performance within the mini-trench.
- The stiffness values obtained were higher than those of the asphalt concrete mixtures, both CTa and CP.

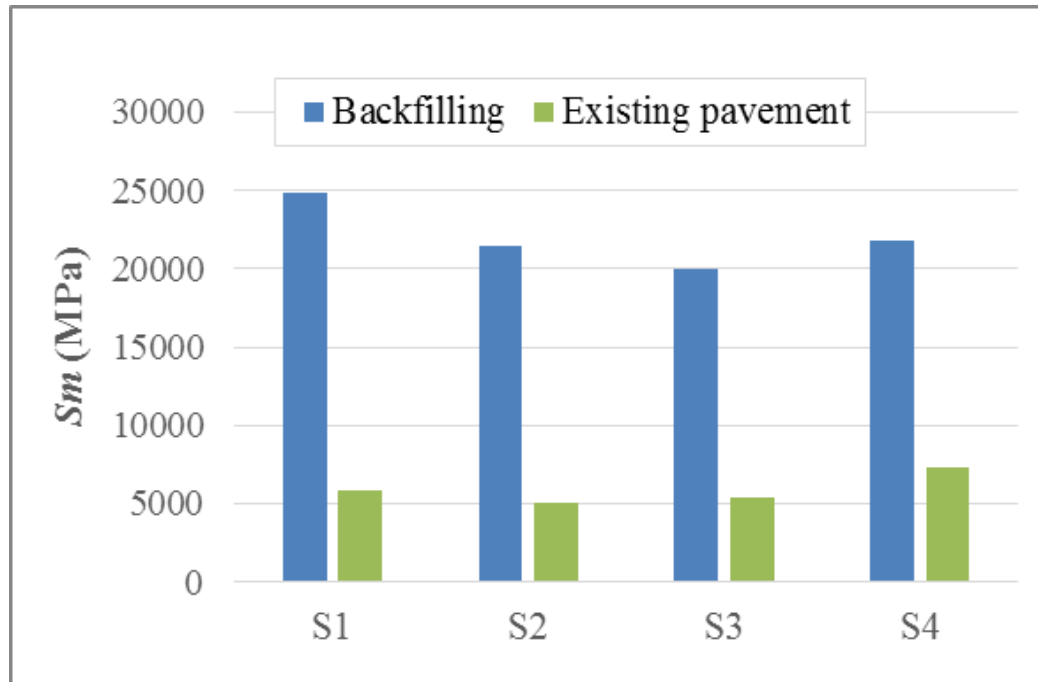
- In order to **evaluate the performance of the entire mini-trenching** and to compare such properties with those of the existing pavements, the stiffness of the CTa and CTg samples were weighted based on material depths (5 cm and 25 respectively)
- hyp. → The stiffness of the existing pavement is assumed to be constant going downwards.
- The overall stiffness of the mini-trench backfilling resulted to be significantly greater than that of the existing pavements.

- A clear difference in terms of stiffness modulus values between CTa and CP specimens, with greater values for the existing pavements.
- The asphalt concrete used at the top of the backfilling should work as a sealant, without neglecting safety and driving comfort.
- The cement grout is required to stand and distribute vehicle loads.
- The overall stiffness of the mini-trench backfilling can be assumed to be significantly greater than that of the existing pavement.

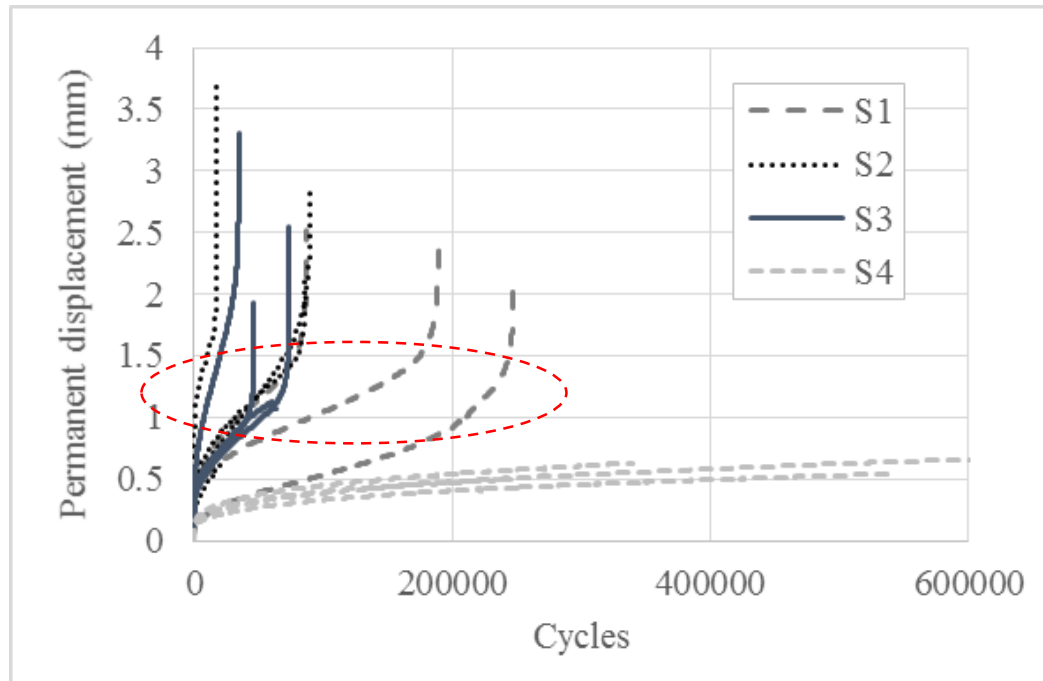
Stress level: 400 kPa (applied to both CTa and CP samples)

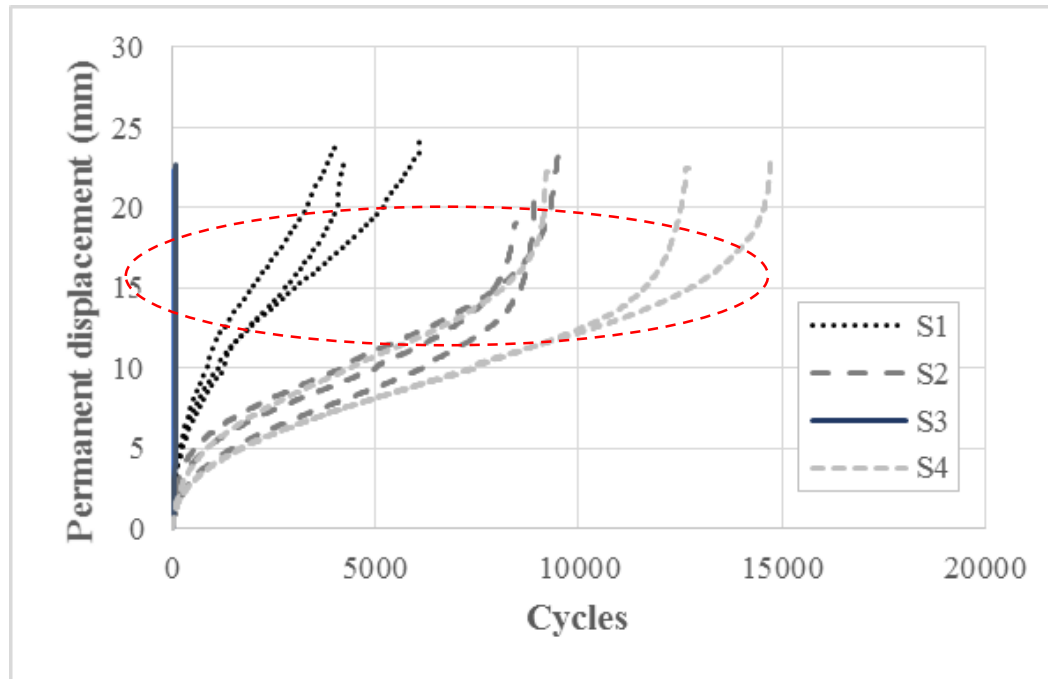
- Scattering → **Not Expected!**
- S3: all the replicates showed few tens cycles to failure  
→ Either environmental condition or machinery malfunctioning during construction might have affected material fatigue performance.
- Average  $N_f$  values for S1, S2, S3 and S4 are 834, 4161, 51 and 5238 respectively.
- Vertical permanent displacement, evaluated at the final failure approaching, ranges from 10 to 18 mm (high values).  
 $N_f$  values → Total number of load applications required to reach 9 mm as vertical permanent displacement

Results suggested that the asphalt concrete employed in the upper part of the trench worked as a sealing cap and therefore it was likely designed so as to keep a good fluidity and to adhere the sides of the cut.

- CT specimens showed scattering results: **either environmental conditions or machinery malfunctioning during construction might have affected material performance.**
- Results on CP and Cta suggested that the asphalt concrete employed in the upper part of the trench (low fatigue lives) **works as a sealing cap** and therefore it was likely designed so as to keep a good fluidity and to adhere the sides of the trench. **Due to the tendency to accumulate permanent deformation, the compaction phase at the end of the construction process could represents a crucial phase to avoid densification under traffic loading over time.**
- Concerning the CTg specimens those resulted much more resistant to fatigue than the asphalt concrete blends.
- The **adhesion at the interface might be increased by improving construction operations** such as cleaning the excavation walls.

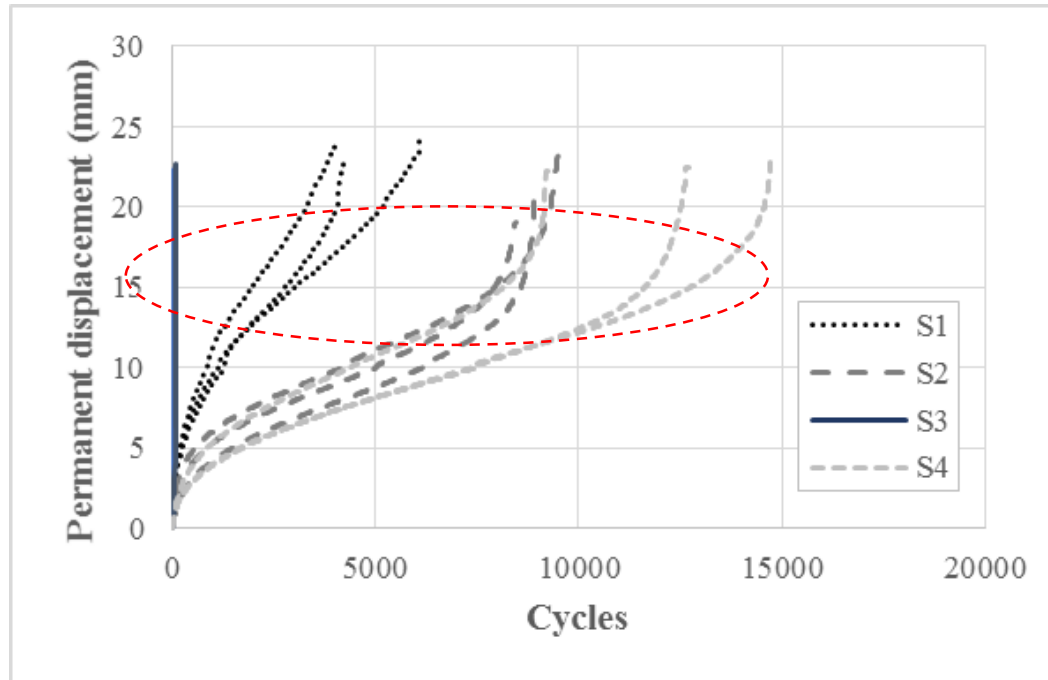
- Otherwise, a great tendency to accumulate permanent deformation was observed.
- The compaction phase at the end of the construction process could represent a crucial phase to avoid densification under traffic loading over time.

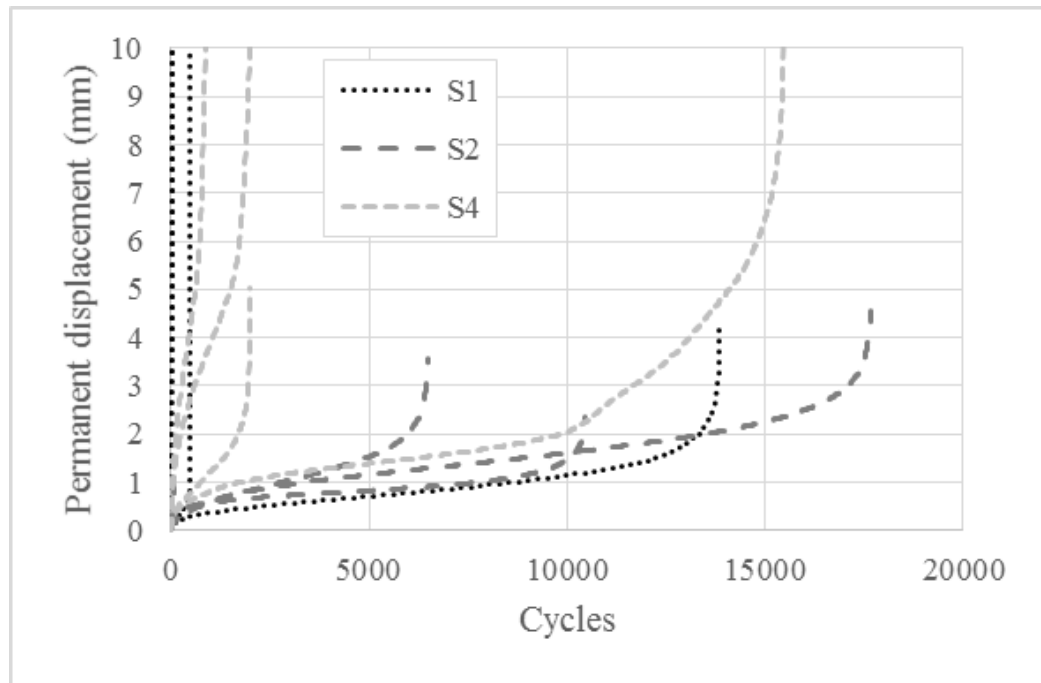
- Drilling activities revealed that in some circumstances (as in S3) the adhesion was totally absent after sampling operations
- Marked scattering
- In S1, S2 and S4 some specimens showed a great adhesion at the interface
- Performance might be increased by improving construction operations such as cleaning the excavation walls in order to obtain a stronger bond between the existing pavement and the new material.

$N_f$  values → Total number of load applications before the specimen splits into two halves along the interface
