37TH INTERNATIONAL
NO - DIG
FLORENCE 2019

Spray Applied Lining Systems Address Unique Infrastructure Problems

Karl Bissinger, Chairman of the Board, Vortex Europe AG

- Lakewood, Cleveland, Ohio
- Manhole 40m deep
- Culvert 110m long
- Constructed 1912 – 1915
- Brick construction

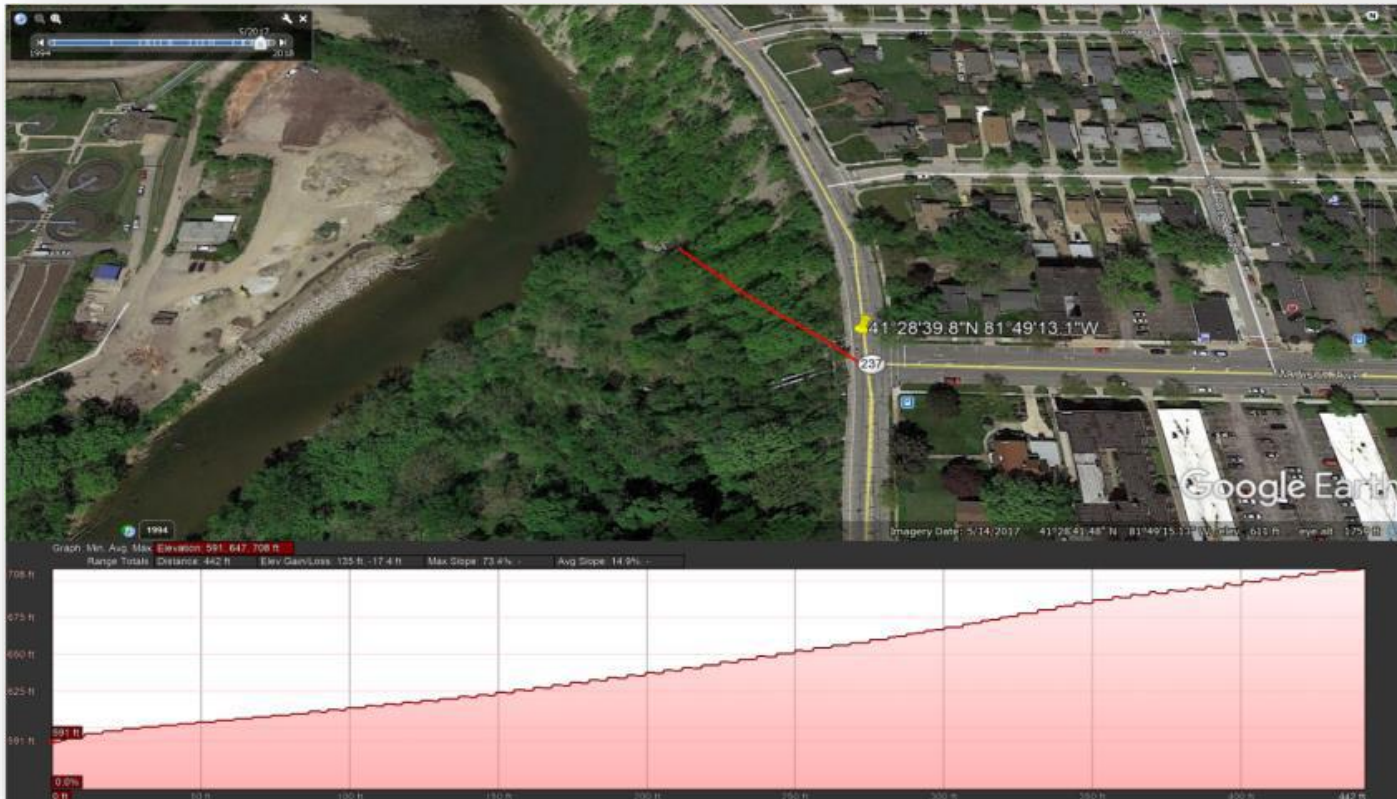
- Traffic maintenance
- Manhole on T-intersection

Site location – centered in traveling lane of a T-intersection

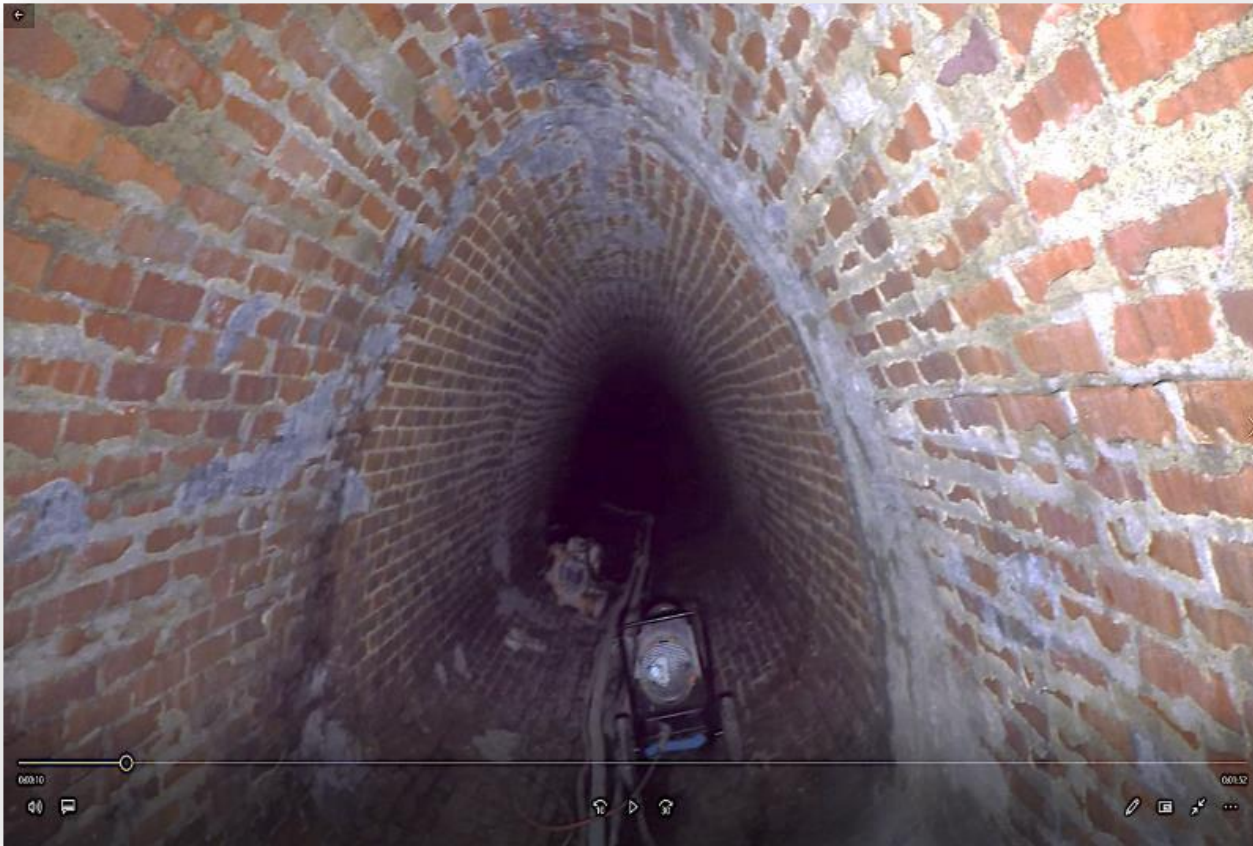
Heater in Pipe

- Rain, snow, high winds ...
- Very low temperatures
- Additional heating system requested

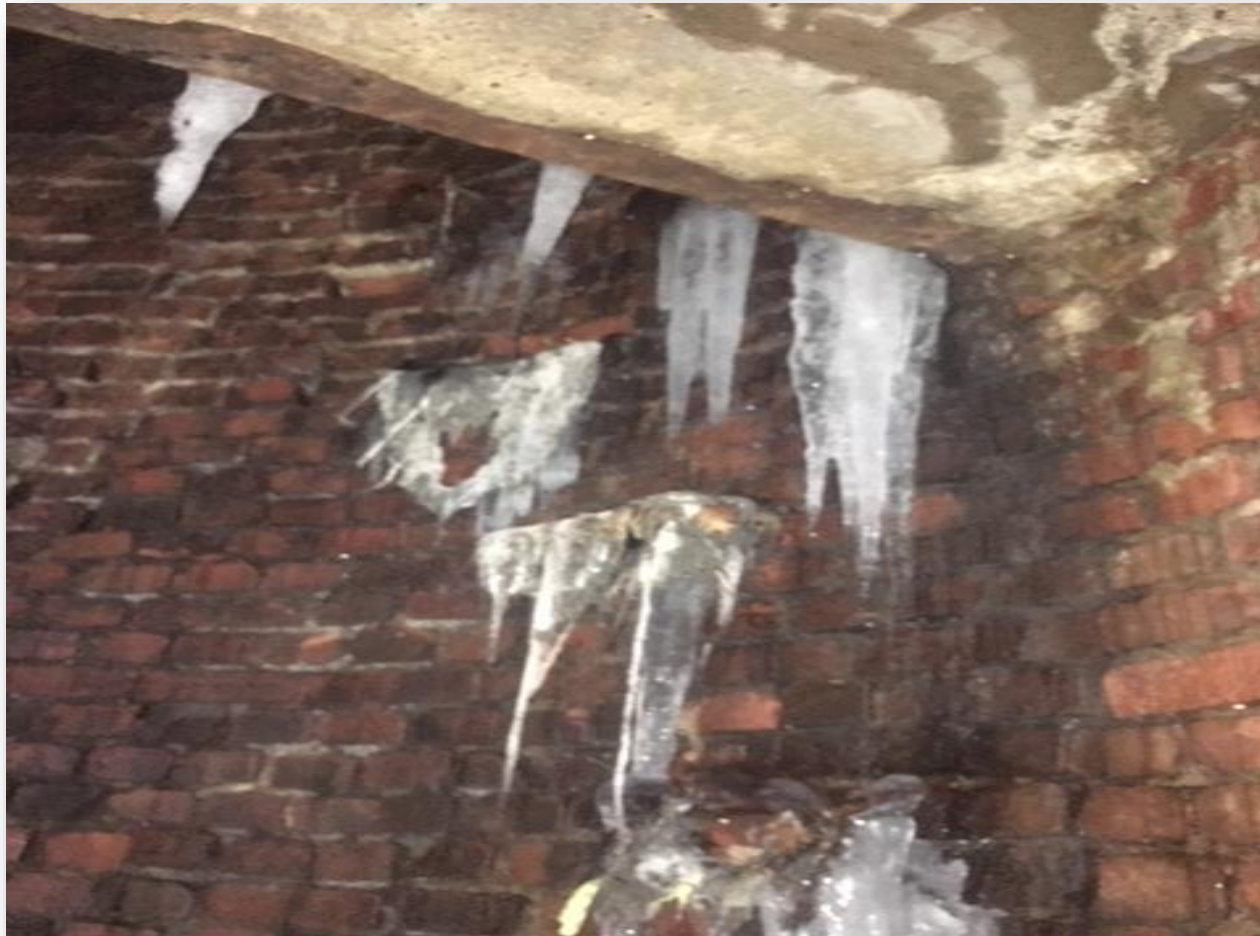
Interior of Manhole at the Base

- Brick construction
- Depth 40m
- DN 1200 – 2400
- Diameter increasing to bottom

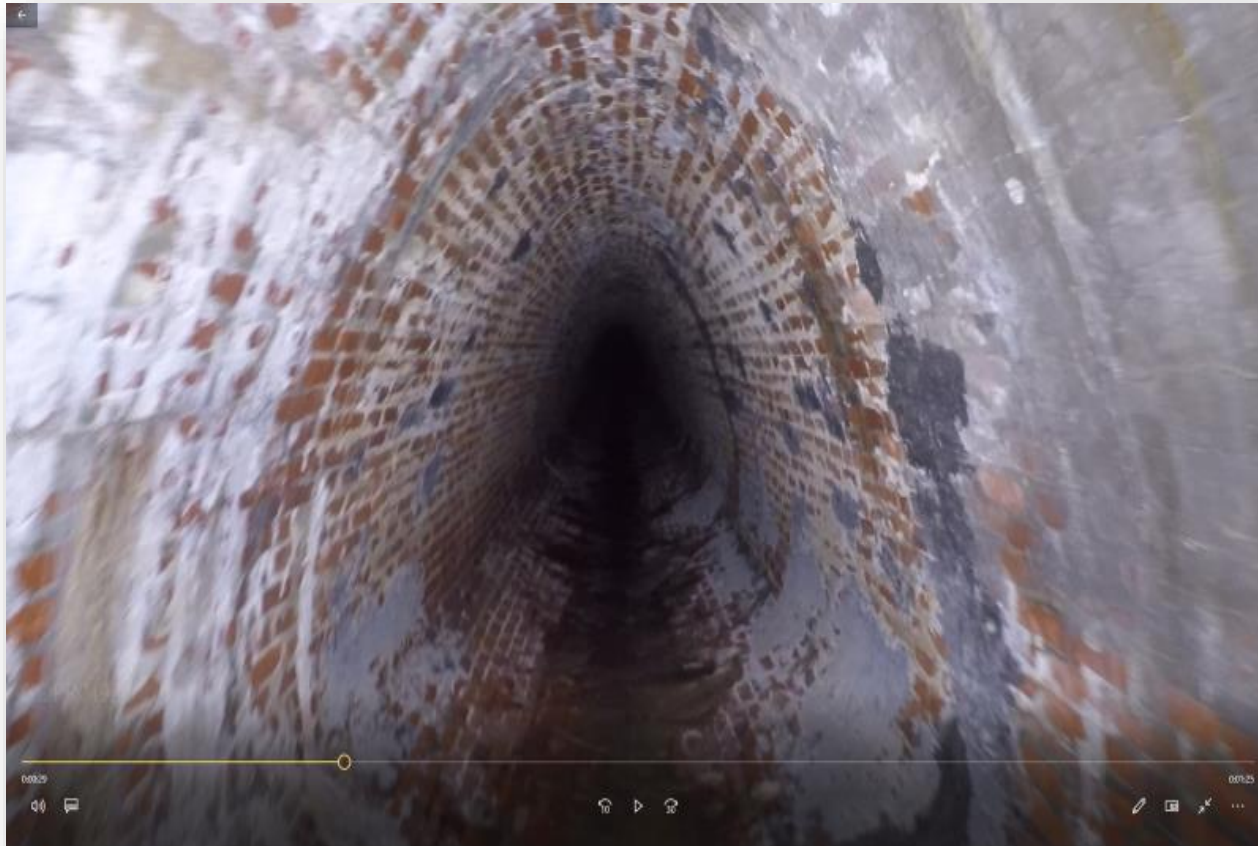
Brick culvert

- Brick construction
- Length 110m
- Height 2.0m
- Width 1.7m
- W egg-shaped

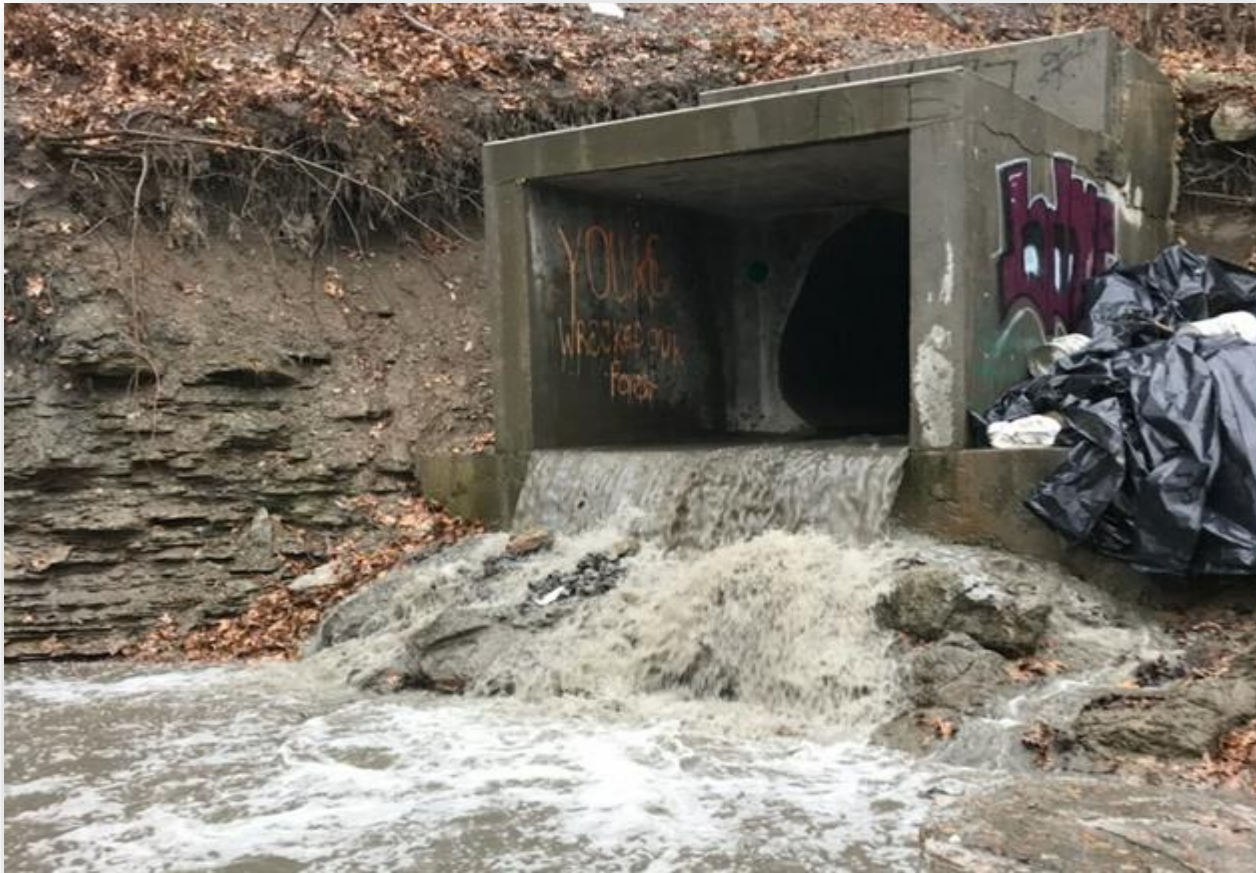
- At bottom of steep river embankment
- Extremely difficult to access

Outfall - Rain event

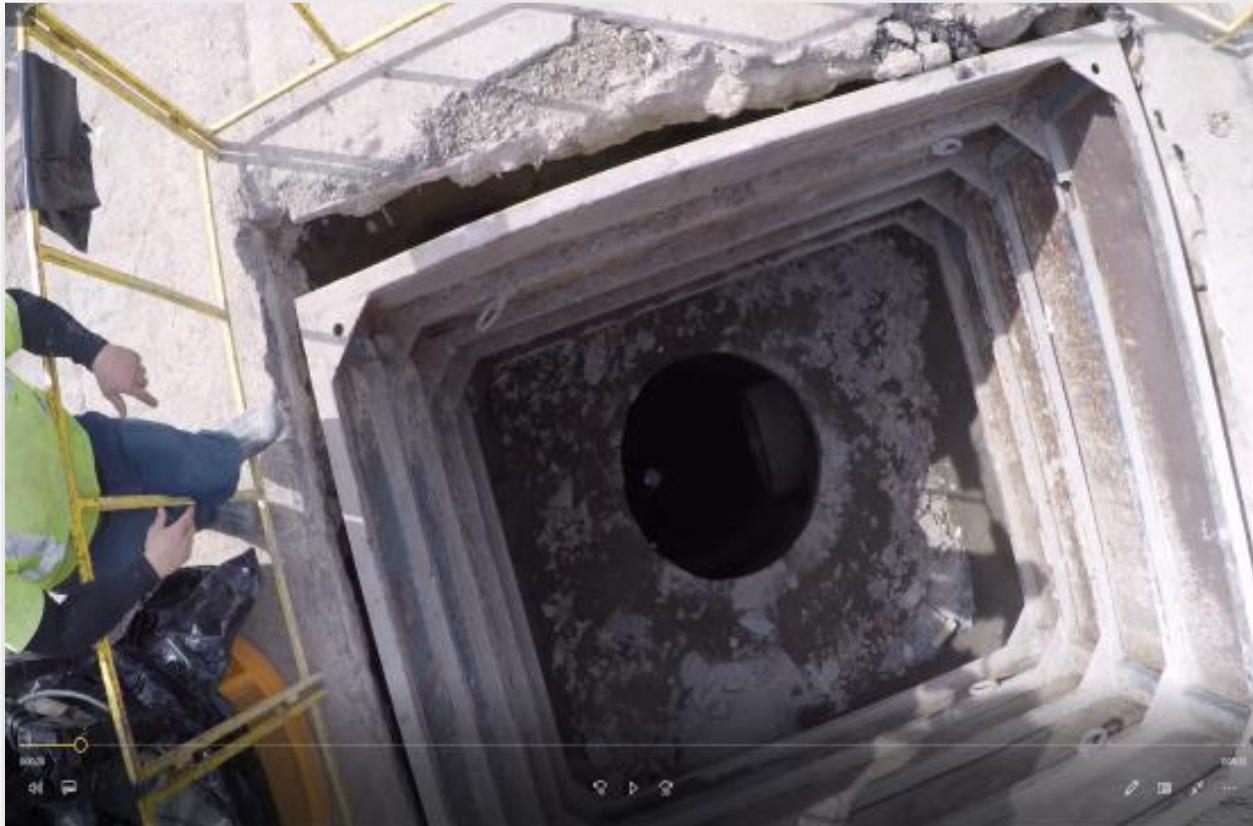
Manhole Access Structure

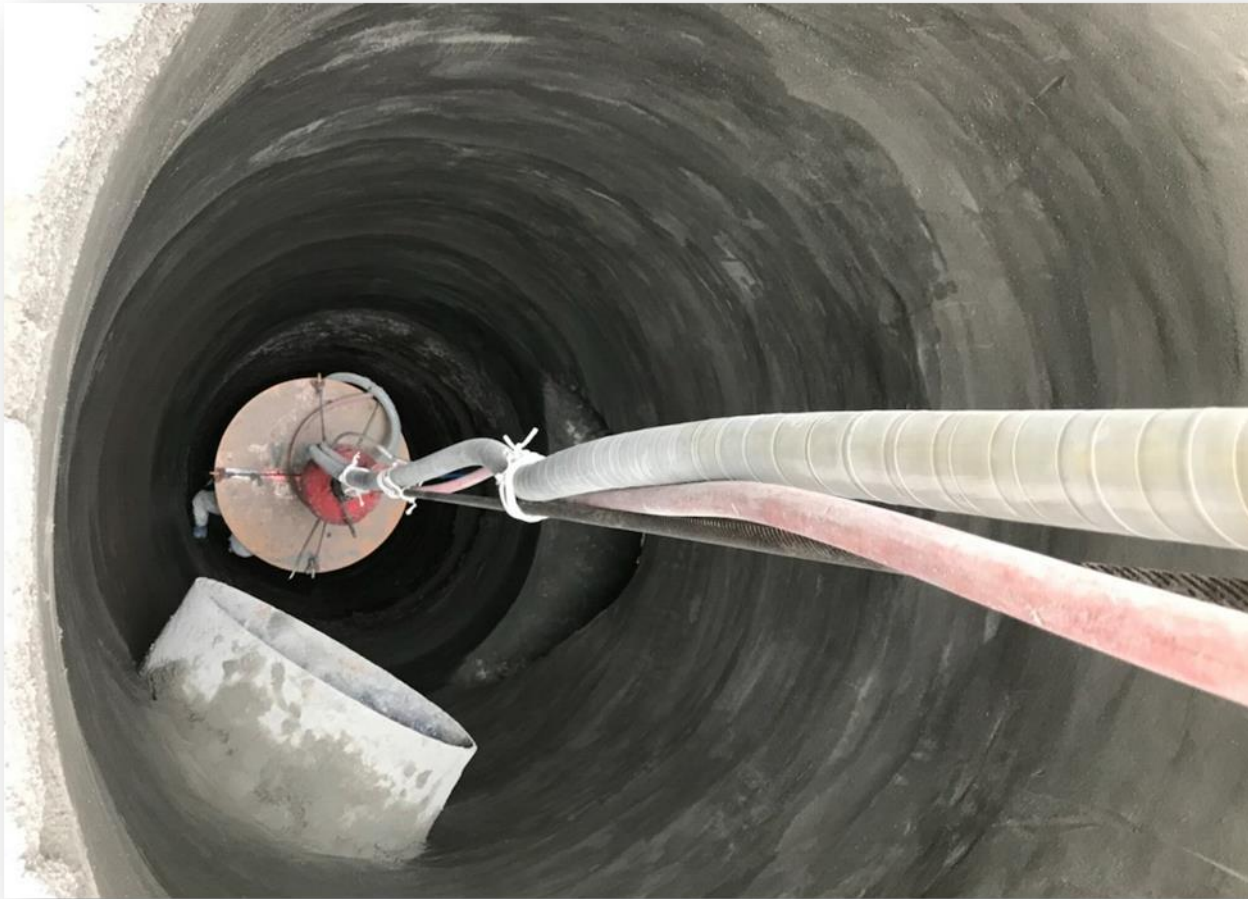
Manhole Original Condition

- Basket attached to a winch and crane to hold the crew
- Lowered into the manhole to spray apply and hand trowel the geopolymer mortar
- Section completed - crane operator lowers basket to next stage
- This step was repeated throughout the process

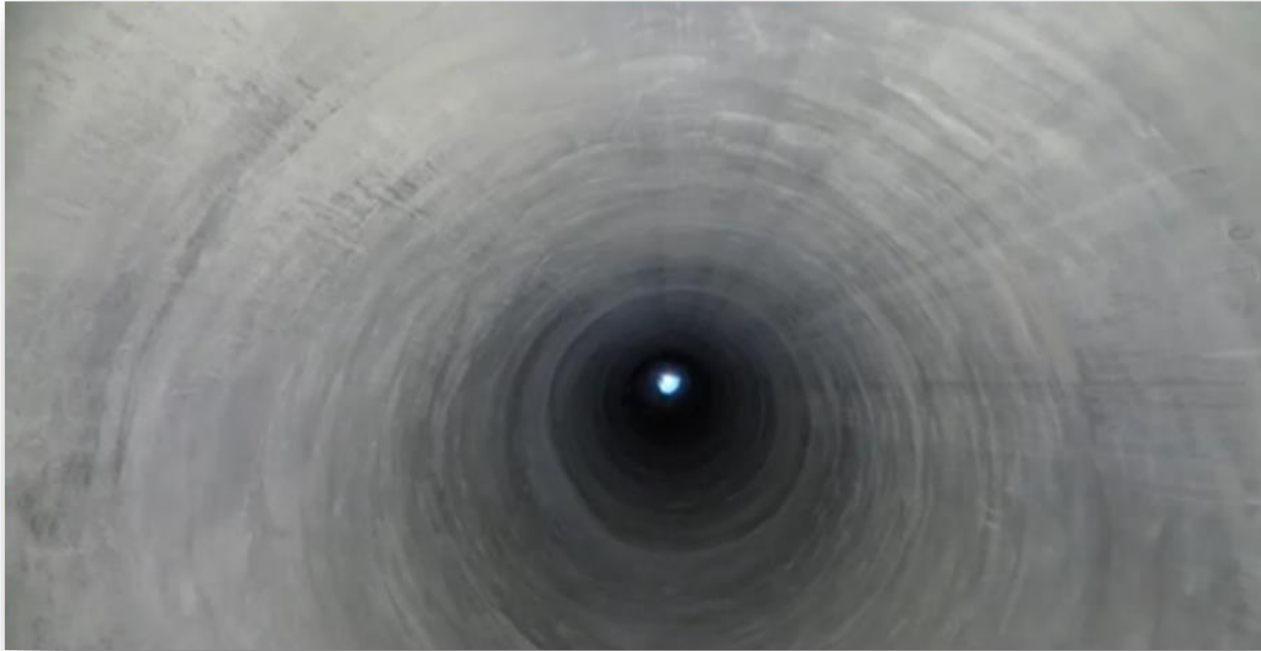
Manhole Structural Lining Completed (View from the bottom up)

- 23 working days
- A month ahead of schedule
- Manhole and culvert completely restored
- Full structural integrity
- Another 50+ years of corrosion-free service

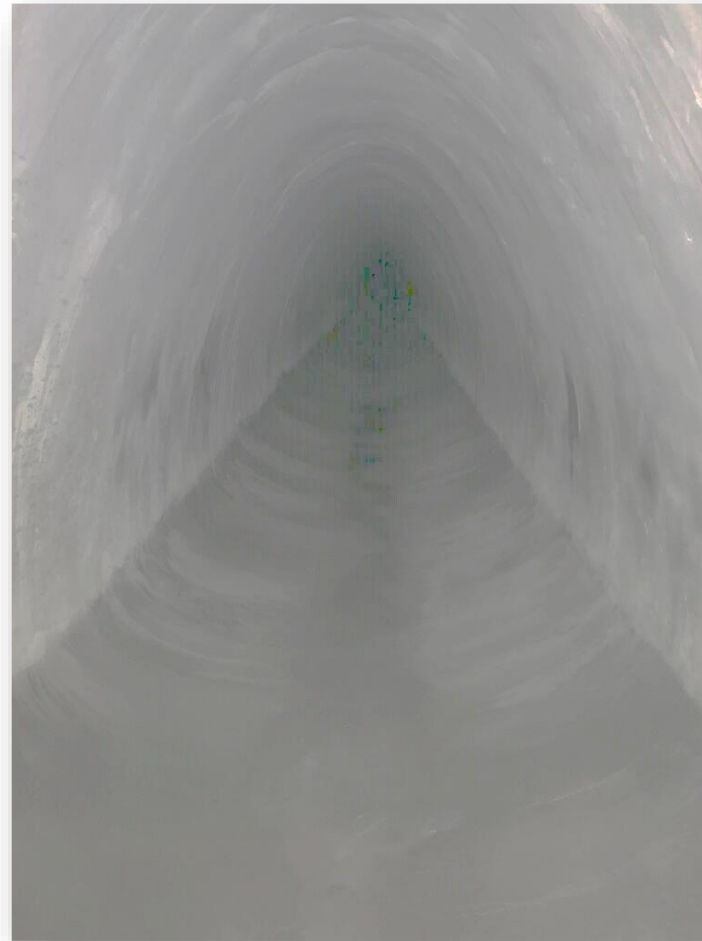
Pipe Structural Lining Completed

- Spray apply
- Patented spray head
