**37TH INTERNATIONAL
NO - DIG
FLORENCE 2019**

**DESIGN&BUILDING CONTRACTS AS A PERFORMING
OPPORTUNITY TO C.I.P.P. SEWERS REHABILITATION –
BRIANZACQUE CASE STUDY**

Simone M. Cellitti
Mauro Pozzi
Fuselli Federica

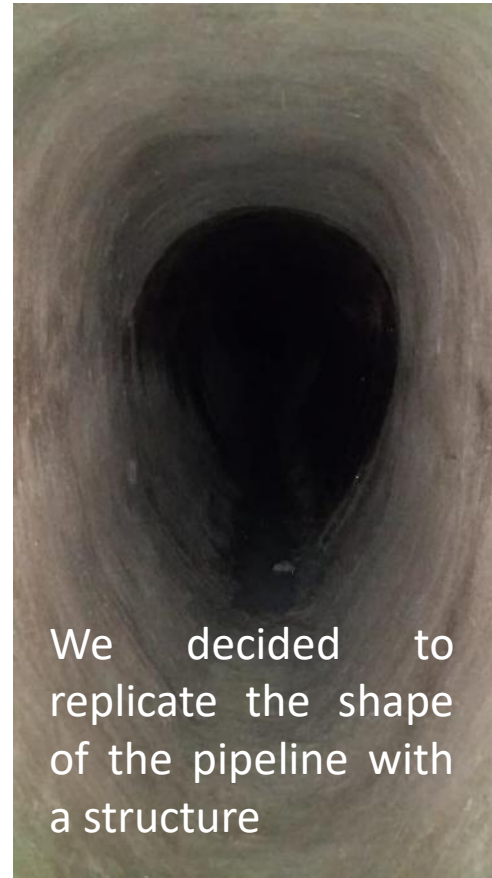
Different Diameters

We decided to replicate the shape of the pipeline with a structure

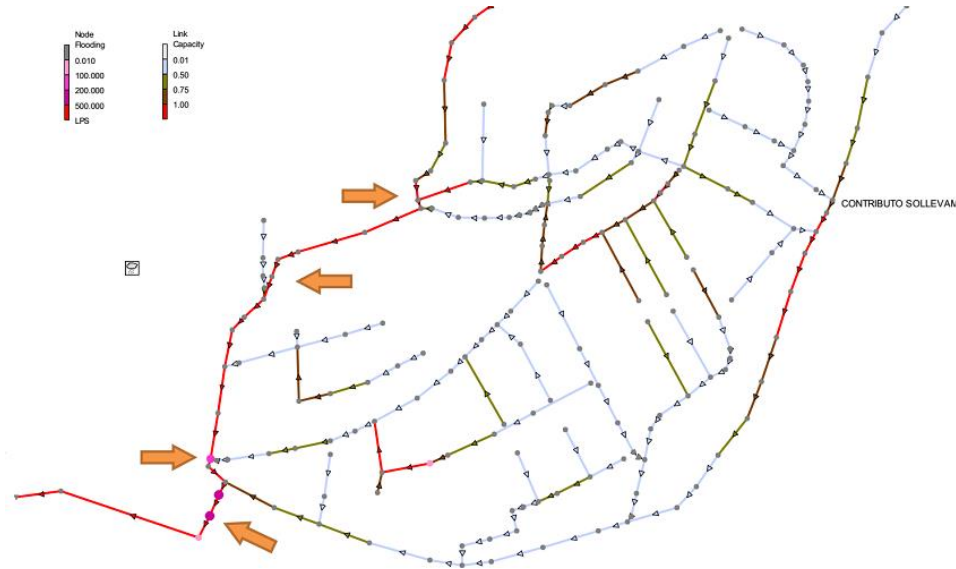
The management of wastewater during all the
Sewer rehabilitation

Mathematical Model → 3 Pumps 110 l/s

Change Flow of the waste water

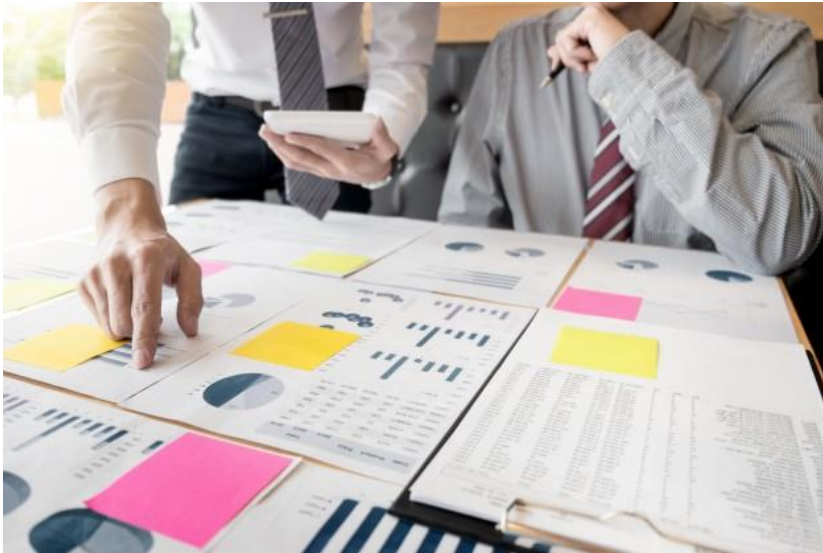
1 check – Datasheets

Technical
datasheets and
certifications
are compared
with the static
project report.

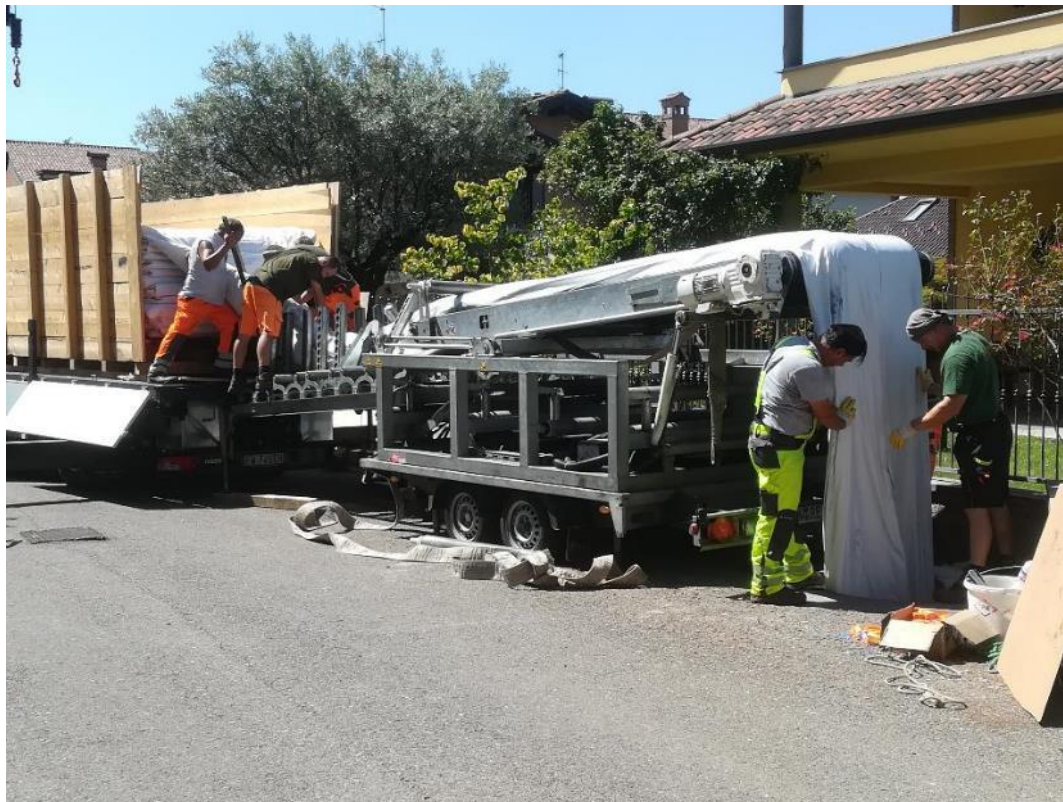
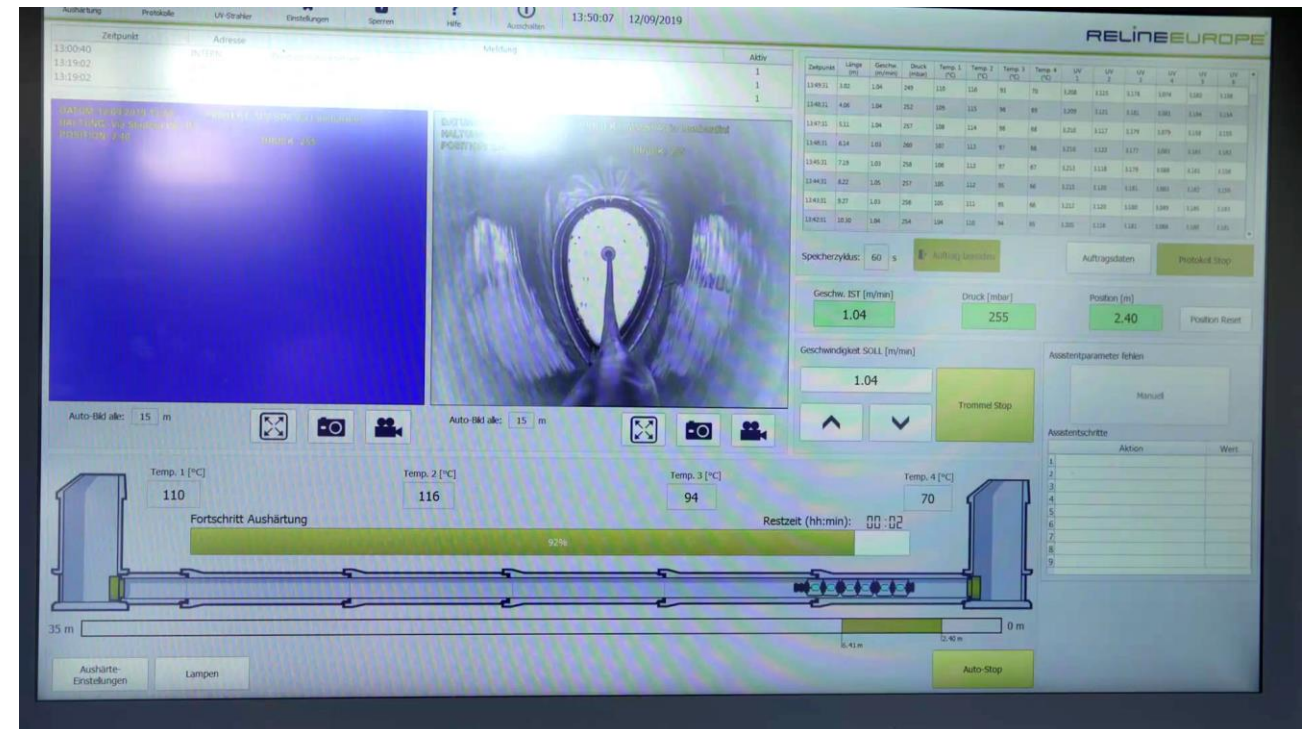
In the building site – **3 Check during the insertion and the catalysis of the liner**
we supervise the processes and procedures - guidelines UNI EN 11296/4

Software for checking the process of catalysis

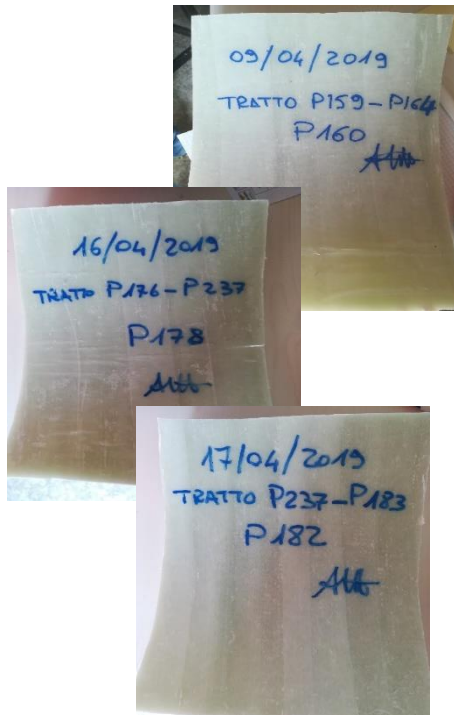
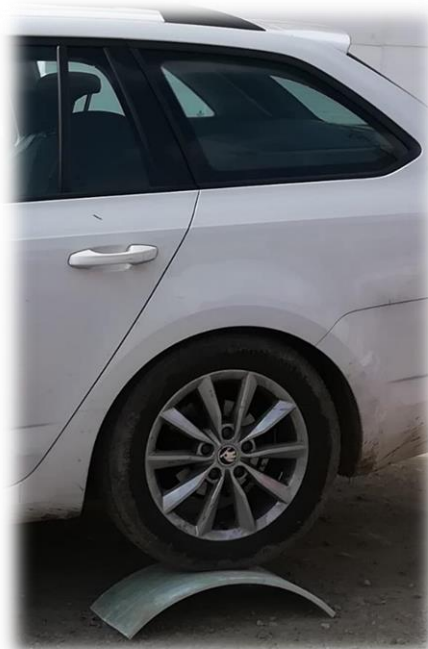
In the building site - **5 Check**

we take a sample for
analysis – UNI EN 11296/4

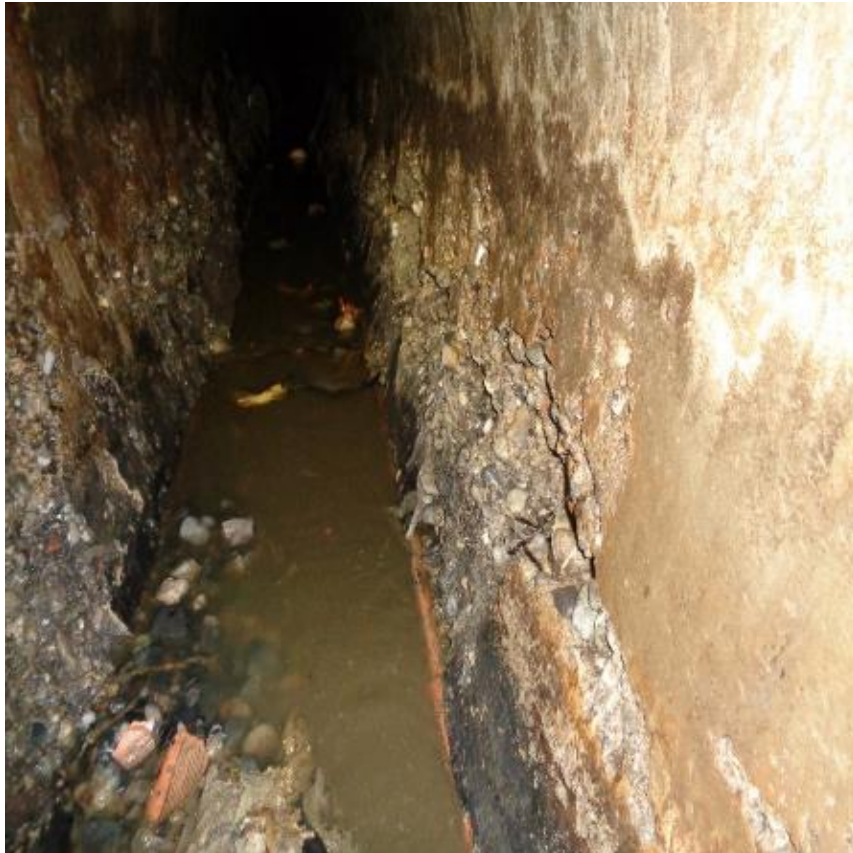
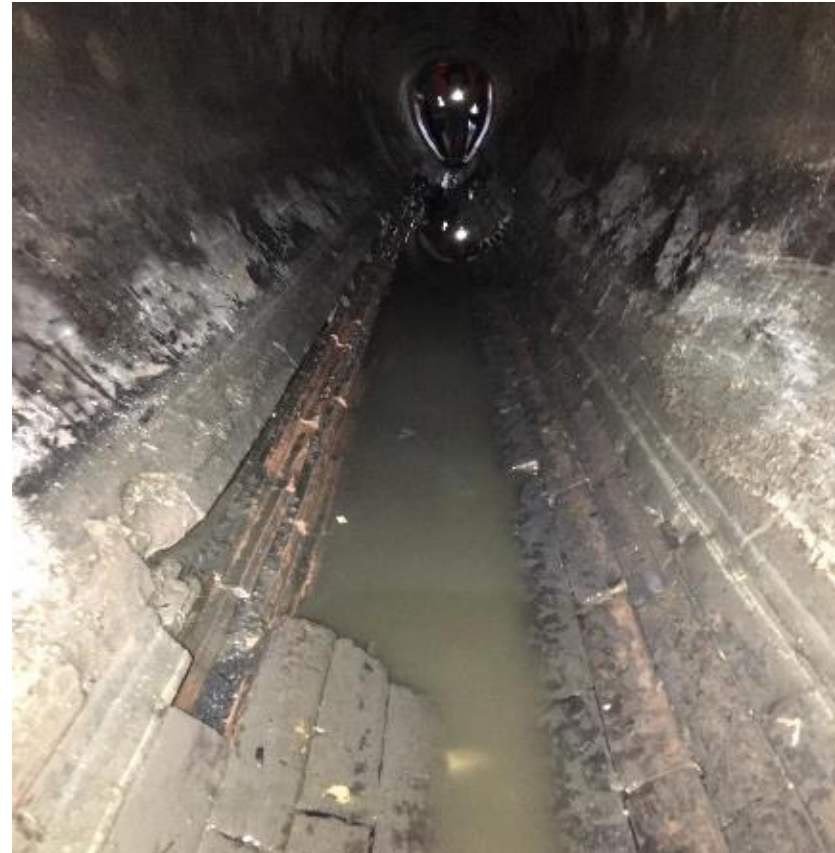
Problems on going: Erosion of the pipeline more than we thought

estimated in the
project

20% of the pipelines

Reconstruction whit
bricks and cement

Costs about 3% of
the contract

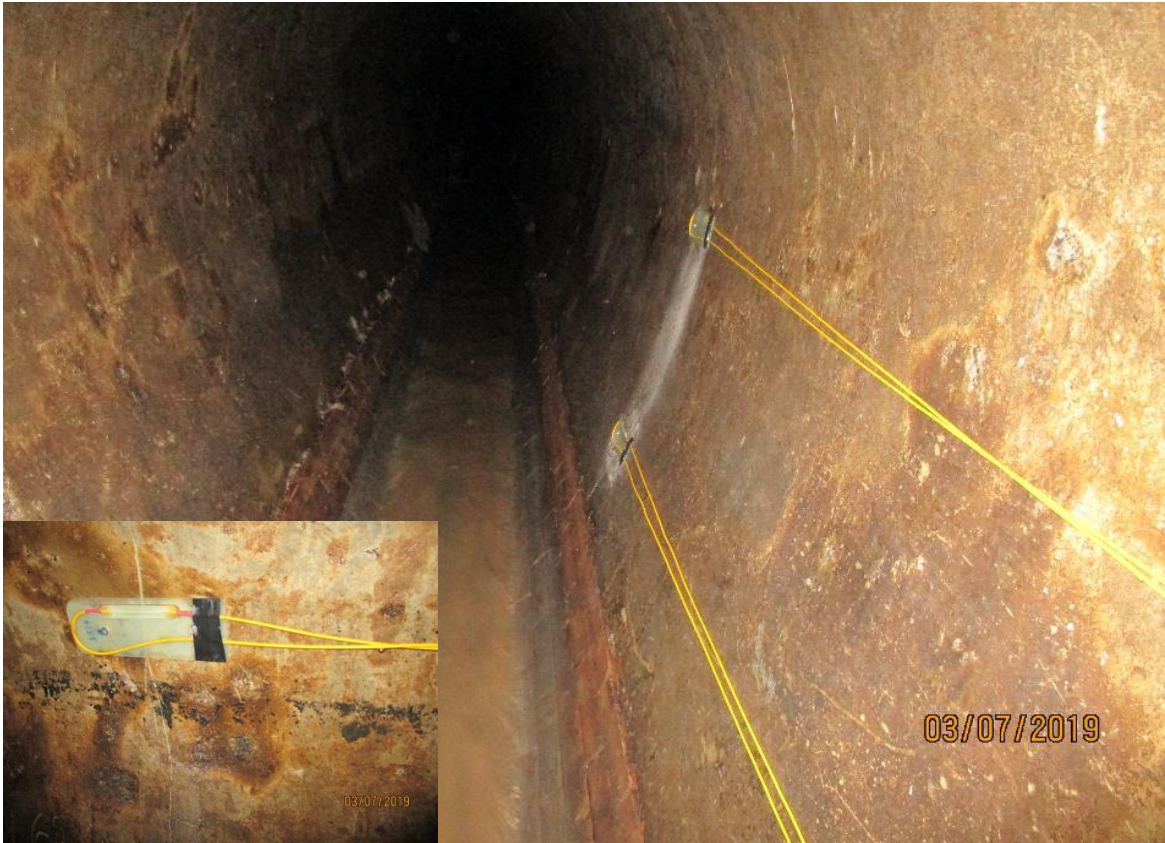
UNIVERSITY Politecnico di Milano and Rotech S.r.l. proposed a test with Optical fiber to measure the flow of the wastewater.

The goal is to correlate the recorded vibrations measured by the optical fiber to the measures of the fluid speed made by a flow meter
