**37<sup>TH</sup> INTERNATIONAL  
No-DIG  
FLORENCE 2019**

Unique Horizontal Drain Installation under a Building  
Using Pilot Tube Guided Auger Bore Methods

Michelle Macauley - Macauley Trenchless  
Steve Torgerson - Trenchless Construction Services

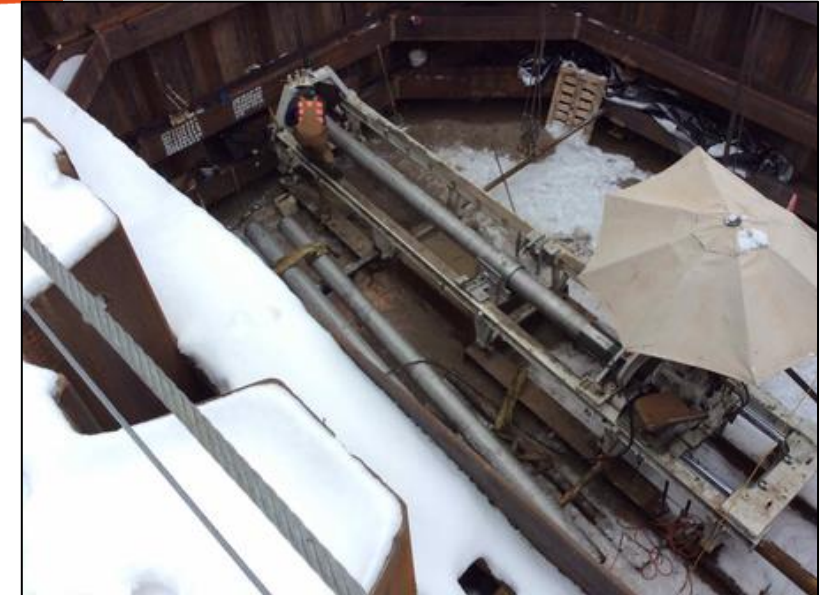
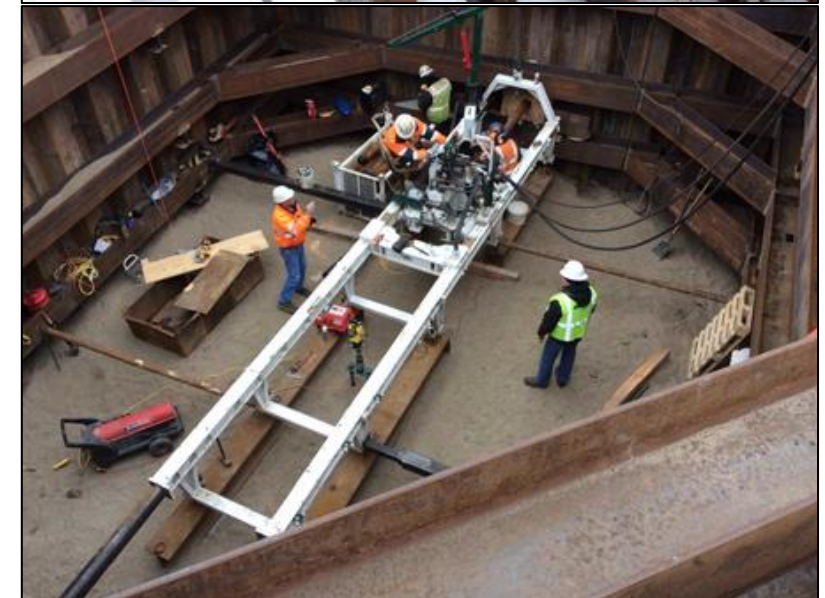
- Started on November 28th
  - Anticipated high quantities of groundwater
  - Planned to use water auger
  - Encountered clay, which plugged auger
  - Jacking forces climbed
  - Water soluble lubricant clumped and caused system to repeatedly plug
  - Switched to regular bentonite-based lubricant since storm drain wasn't a drain --- Jacking forces reduced
- 2 days for pilot tube installation, 2 days for auger/casing, 2 days for 10-inch drain installation

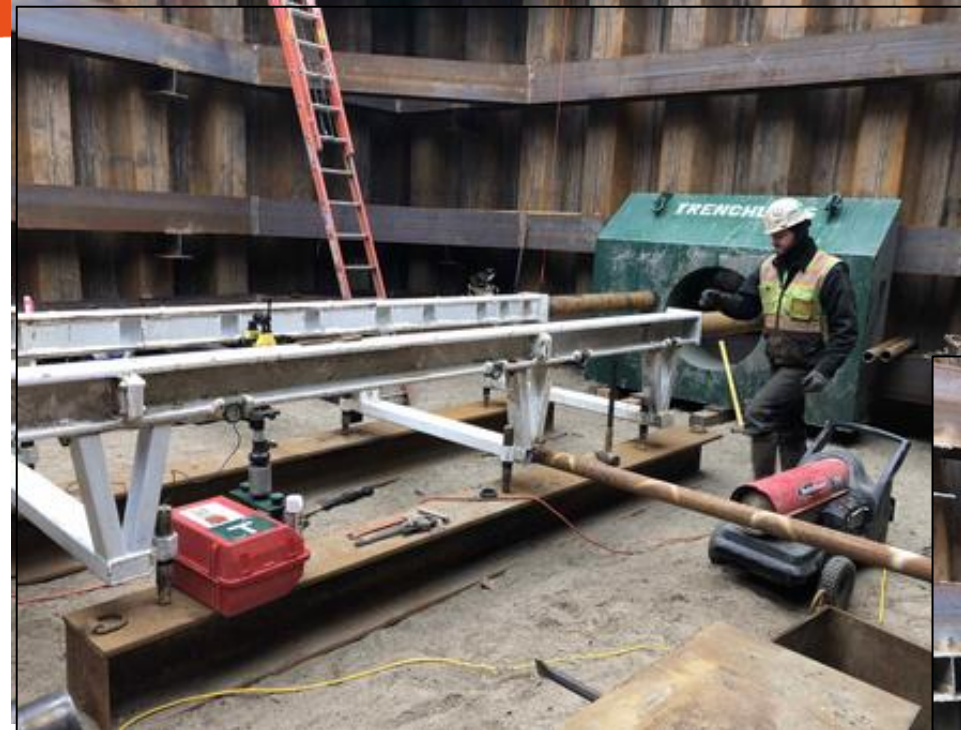
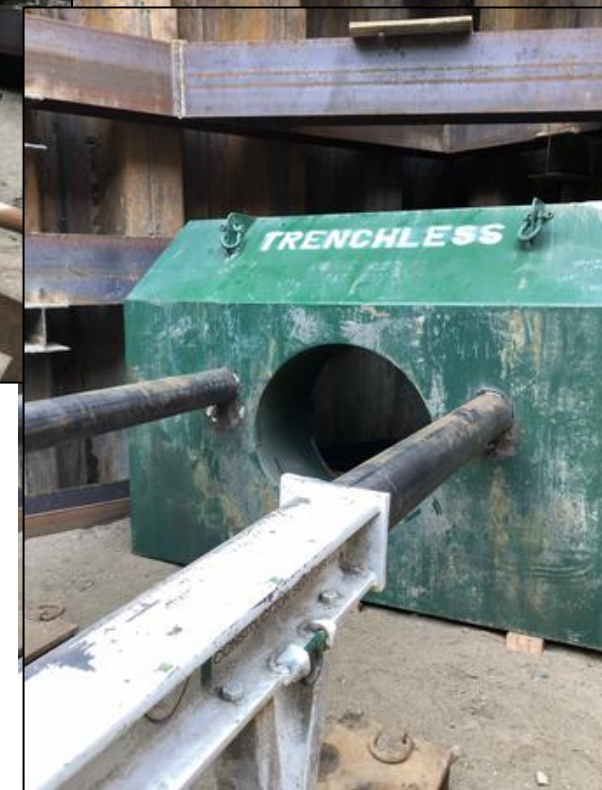
- HD 4
  - Started on December 10th
  - Went very well
  - 3 days for horizontal drain installation
- HD 3
  - Started on December 13th
  - Went very well
  - 2 days for horizontal drain installation

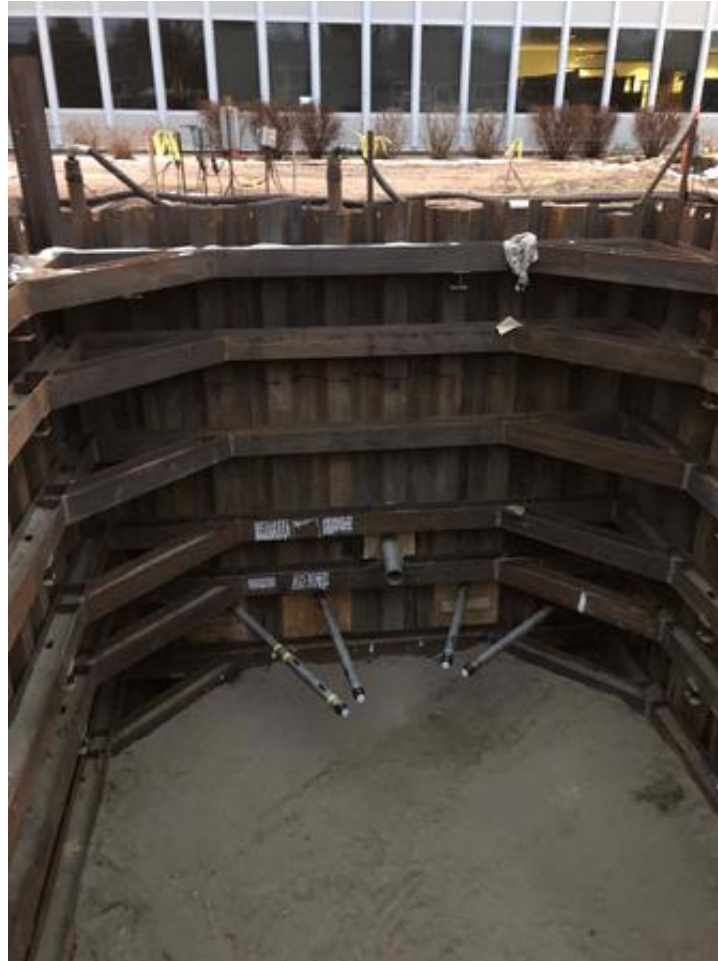
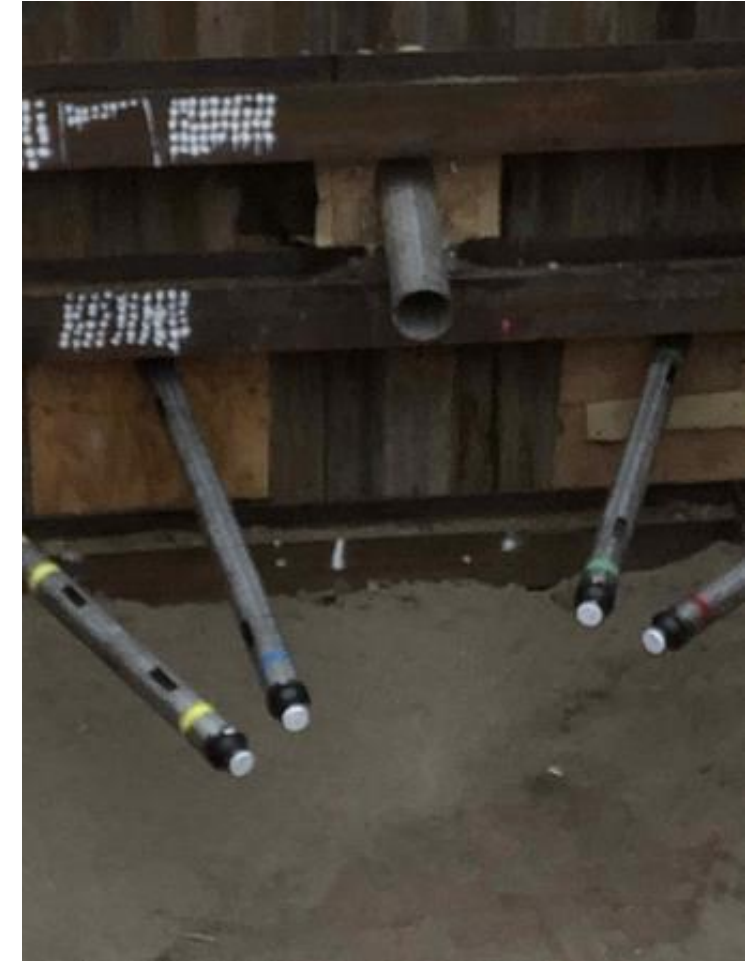
- Started December 20th (two days before government shutdown)
- Last one: went very well
- Finished just in time
- Drove off with 26 minutes to spare before mandatory site closure due to government shutdown
