**37TH INTERNATIONAL
NO - DIG
FLORENCE 2019**

**DESIGN&BUILDING CONTRACTS AS A PERFORMING
OPPORTUNITY TO C.I.P.P. SEWERS REHABILITATION –
BRIANZACQUE CASE STUDY**

Simone M. Cellitti
Mauro Pozzi
Fuselli Federica

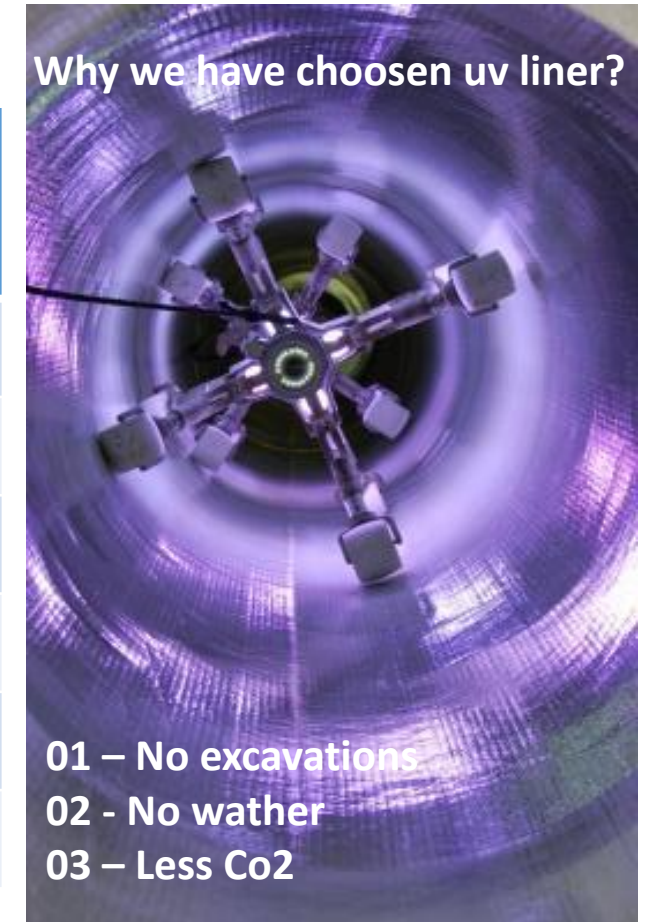
The static calculation in order to determine the thickness of the liner to be inserted into the existing pipeline.

Section (mm)	Position	Damage class	DWA-A 143-2 Software EasyPipe:	UNI 11681 Diametro equivalente formula FALTER	ASTM 1216	DWA-A 143-2 Software: FEM	Liner thickness chosen
800/1200	Road/Green area	Partially deteriorated	Not considered	Not considered	Not considered	Not considered	Not considered
800/1200	Road/Green area	Completely deteriorated	9.5 mm	11.81 mm	10.2 mm	9.5	12.1 mm
800/1200	Railway	Completely deteriorated	9.5 mm	14.10 mm	13.73 mm	12.5 mm	14.2 mm
1000/1500	Road/Green area	Partially deteriorated	Not considered	Not considered	Not considered	Not considered	Not considered
1000/1500	Road/Green area	Completely deteriorated	12.5 mm	13.65 mm	12.89 mm	12.5	14.2 mm
1000/1500	Railway	Completely deteriorated	12.5 mm	16.04 mm	14.95 mm	12.5 mm	16.3 mm

we decided the most precautionary solution

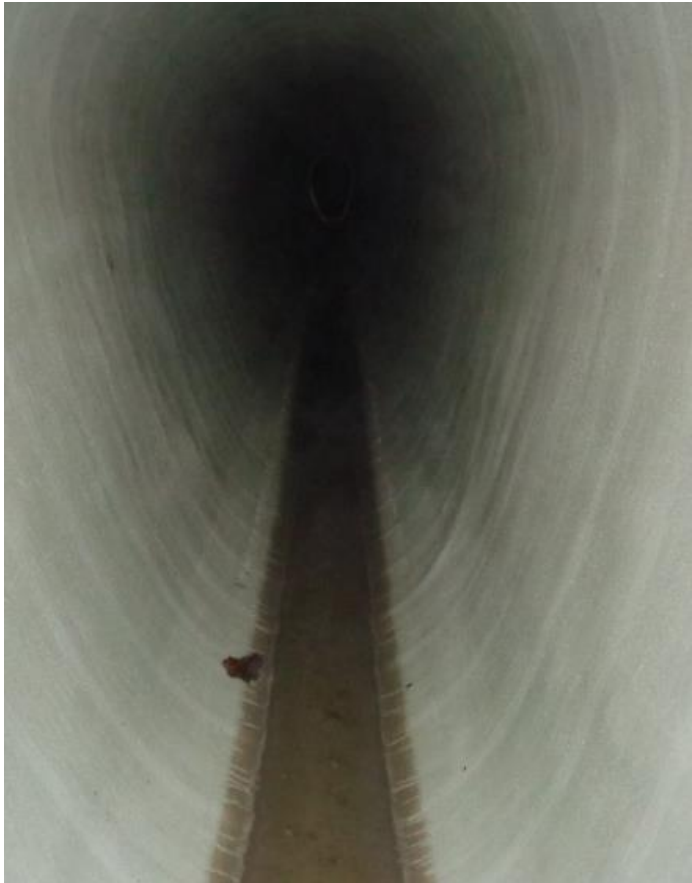
At the end of the insertion process, we analyze the report.

From this report we can understand if there have been executive problems

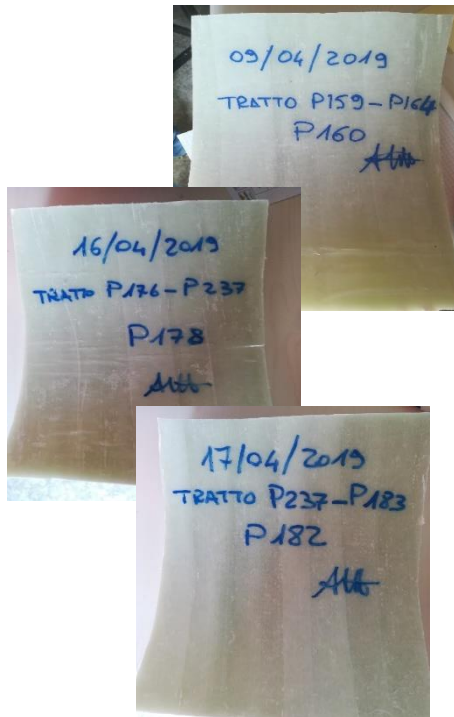
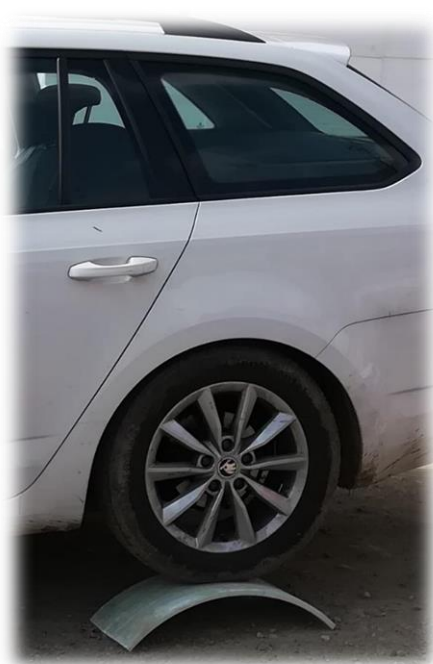
we take a sample for analysis –
UNI EN 11296/4

Procedura	Parametri	Unità di misura	Valore medio	Deviazione standard
#DIN EN ISO 178	Spessore del composito	mm	12,7	0,2
	Spessore complessivo	mm	14,0	0,2
	Modulo di elasticità alla flessione	MPa	20138	1201
	Tensoflessione	MPa	411,6	33,2
