37TH INTERNATIONAL
NO - DIG
FLORENCE 2019

Investigation of Cracks Found in the Circumferential Direction on Jacking Pipes

TEPCO Power Grid Inc.
Yuki KANESHIRO

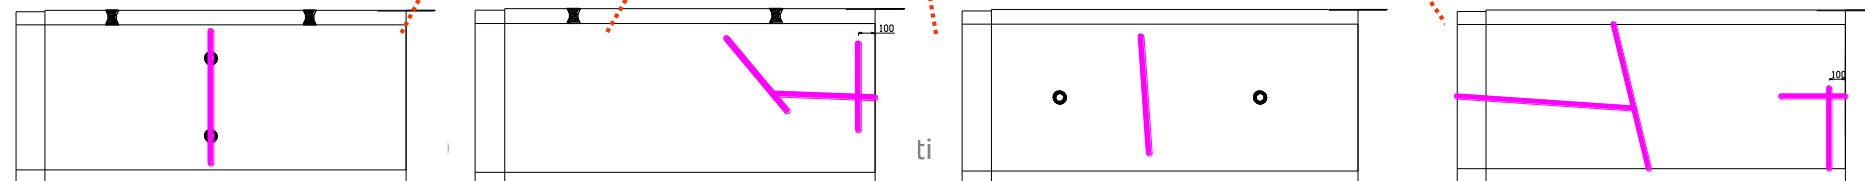
Cracks involved water leakage were found in a total of 8 pipes around curves section when drilling 195.6 m from the departure shaft.

Water leakage

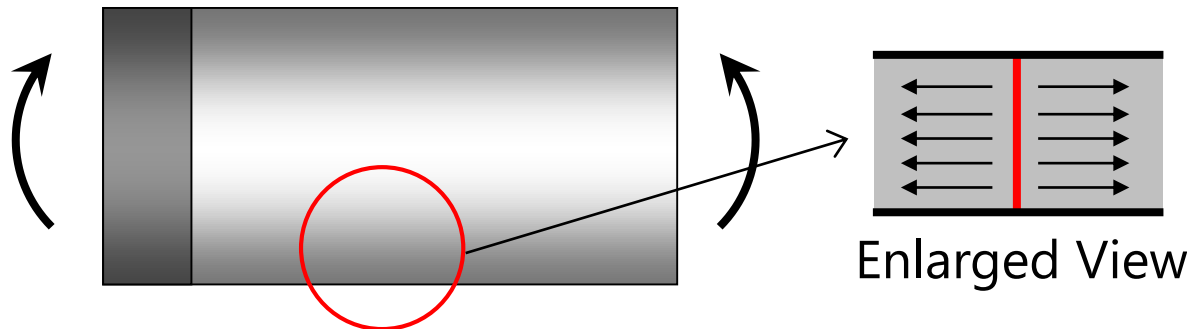
Cracks in the longitudinal direction were assumed to occur by the reason A. Cracks in the circumferential direction were assumed to occur by the different reasons.

From the standpoint of crack appearance, **tensile stress due to bending** was seemed to be the cause of cracks.

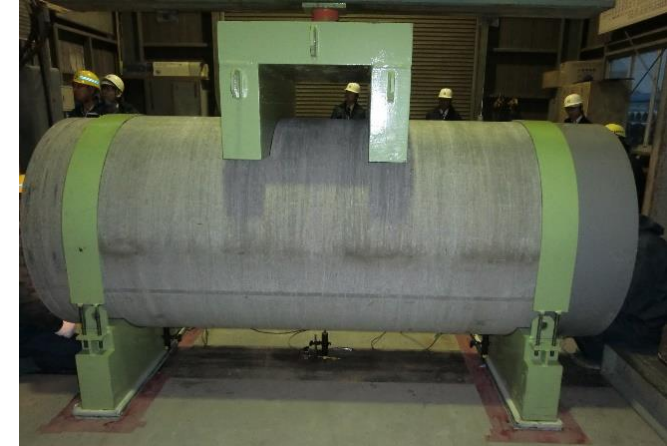
Experiments to obtain cracking load and moment

In order to obtain cracking moment and cracking load of actual pipes, a full-scale-model experiment was conducted using the same pipe as used at the site.

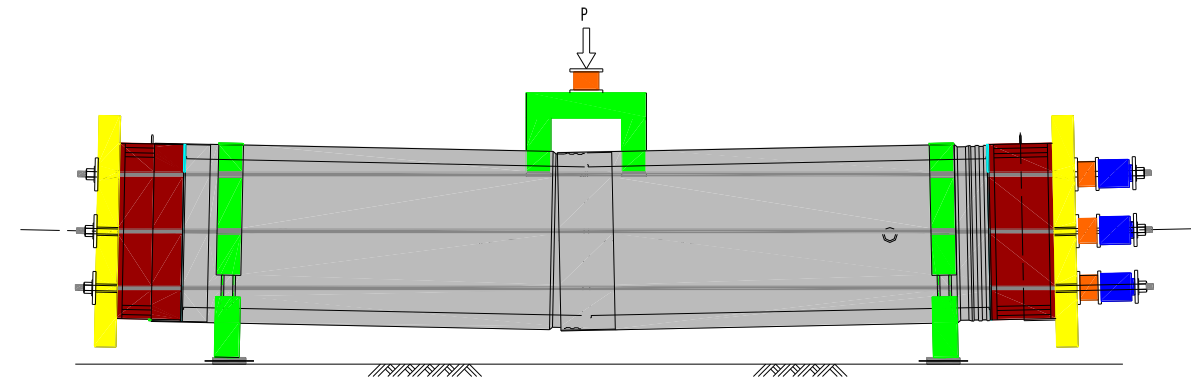
Experiments to obtain rotational spring stiffness

In addition to obtain cracking moment, rotational spring stiffness of the joints was also measured in the experiments so as to utilize in numerical analysis.

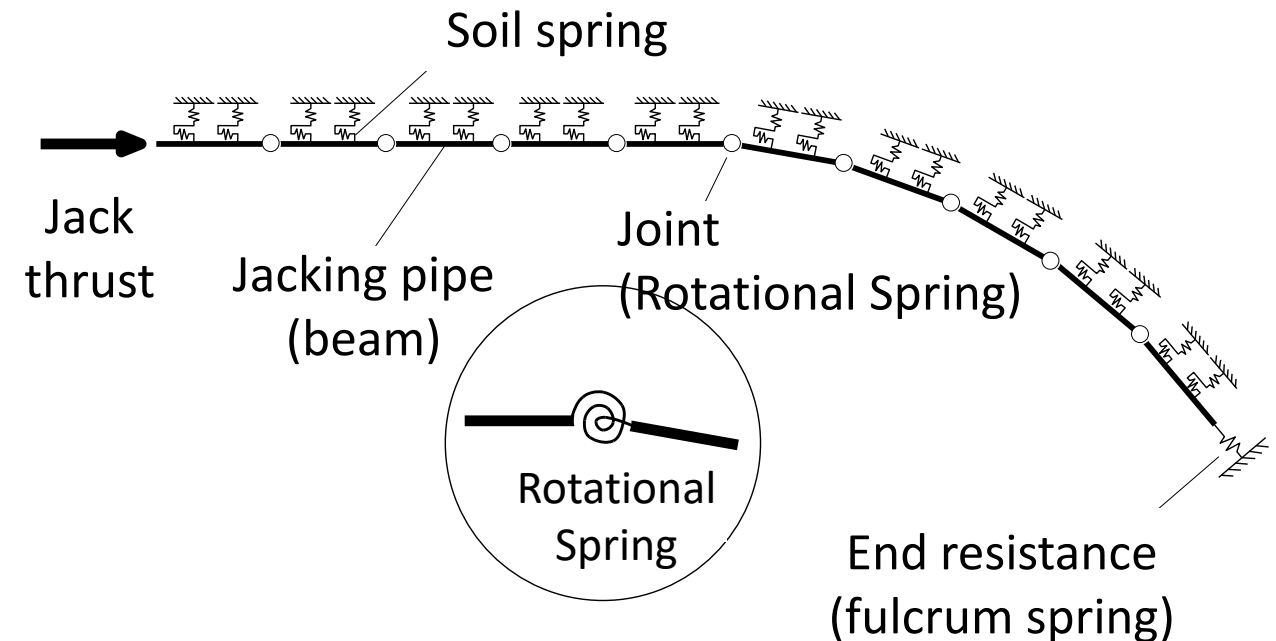
Beam-Spring Model

From the data obtained by the experiments, **numerical analysis using beam-spring model** was conducted in order to presume the actual load that was applying to the pipes.

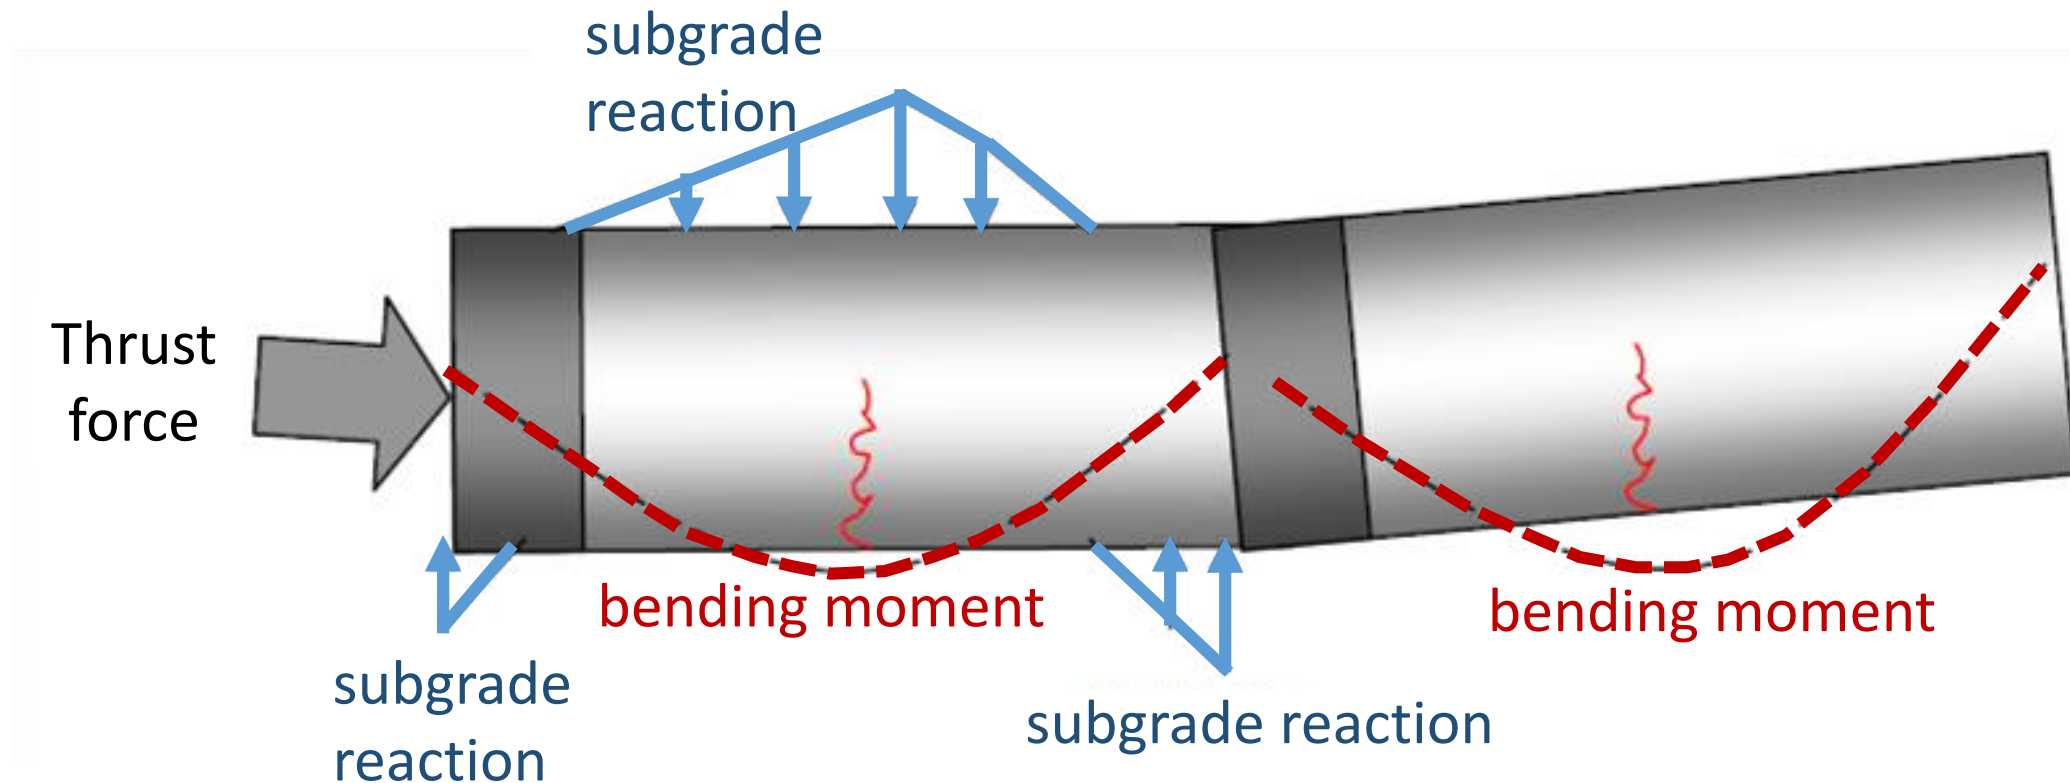
The image how bending moment was generated by subgrade reaction

The maximum bending moment (=275 kN · m, by numerical analysis) was larger than cracking moment (=245.2 kN · m, by full-scale-model experiments), but the actual cracks differ to the axial force.

Given that tensile strength was 5.24 N/mm² by the tests in average, the **calculated tensile stress was lower than tensile strength** as an effect of the compressive load. Since tensile stress was lower than tensile strength, **cracking should not be occurred.**
