**37<sup>TH</sup> INTERNATIONAL  
NO - DIG  
FLORENCE 2019**

**A case study in successful sewer network rehabilitation  
with UV cured CIPP & traditional/non-traditional survey technologies.**

**- Wastewater Network in Ras Al Khaimah, U.A.E. -**

**Börje Persson**

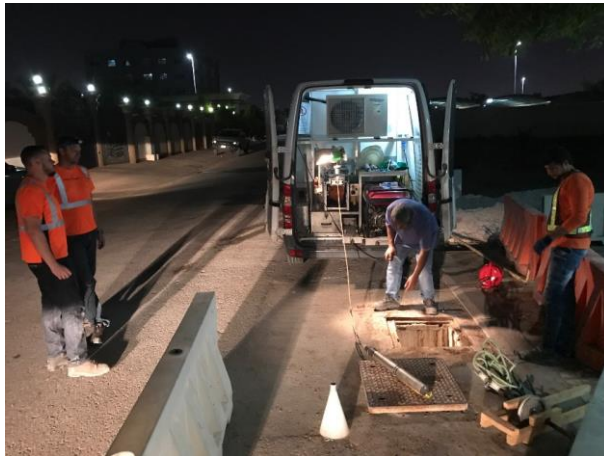
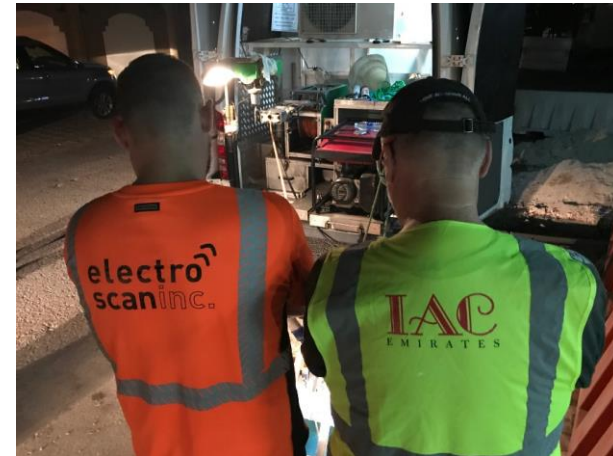
- Seventy-two percent of the network was inspected using a combination of traditional CCTV and Electroscan's FELL<sup>®</sup> system.
