**37TH INTERNATIONAL
NO - DIG
FLORENCE 2019**

FRP 101: Taking The Mystery out of Trenchless Repair of Pressure Pipes with Carbon FRP

***Mo Ehsani, PhD, PE
Professor Emeritus of Civil Eng., U. of Arizona
President/CEO QuakeWrap Inc., Tucson, AZ***

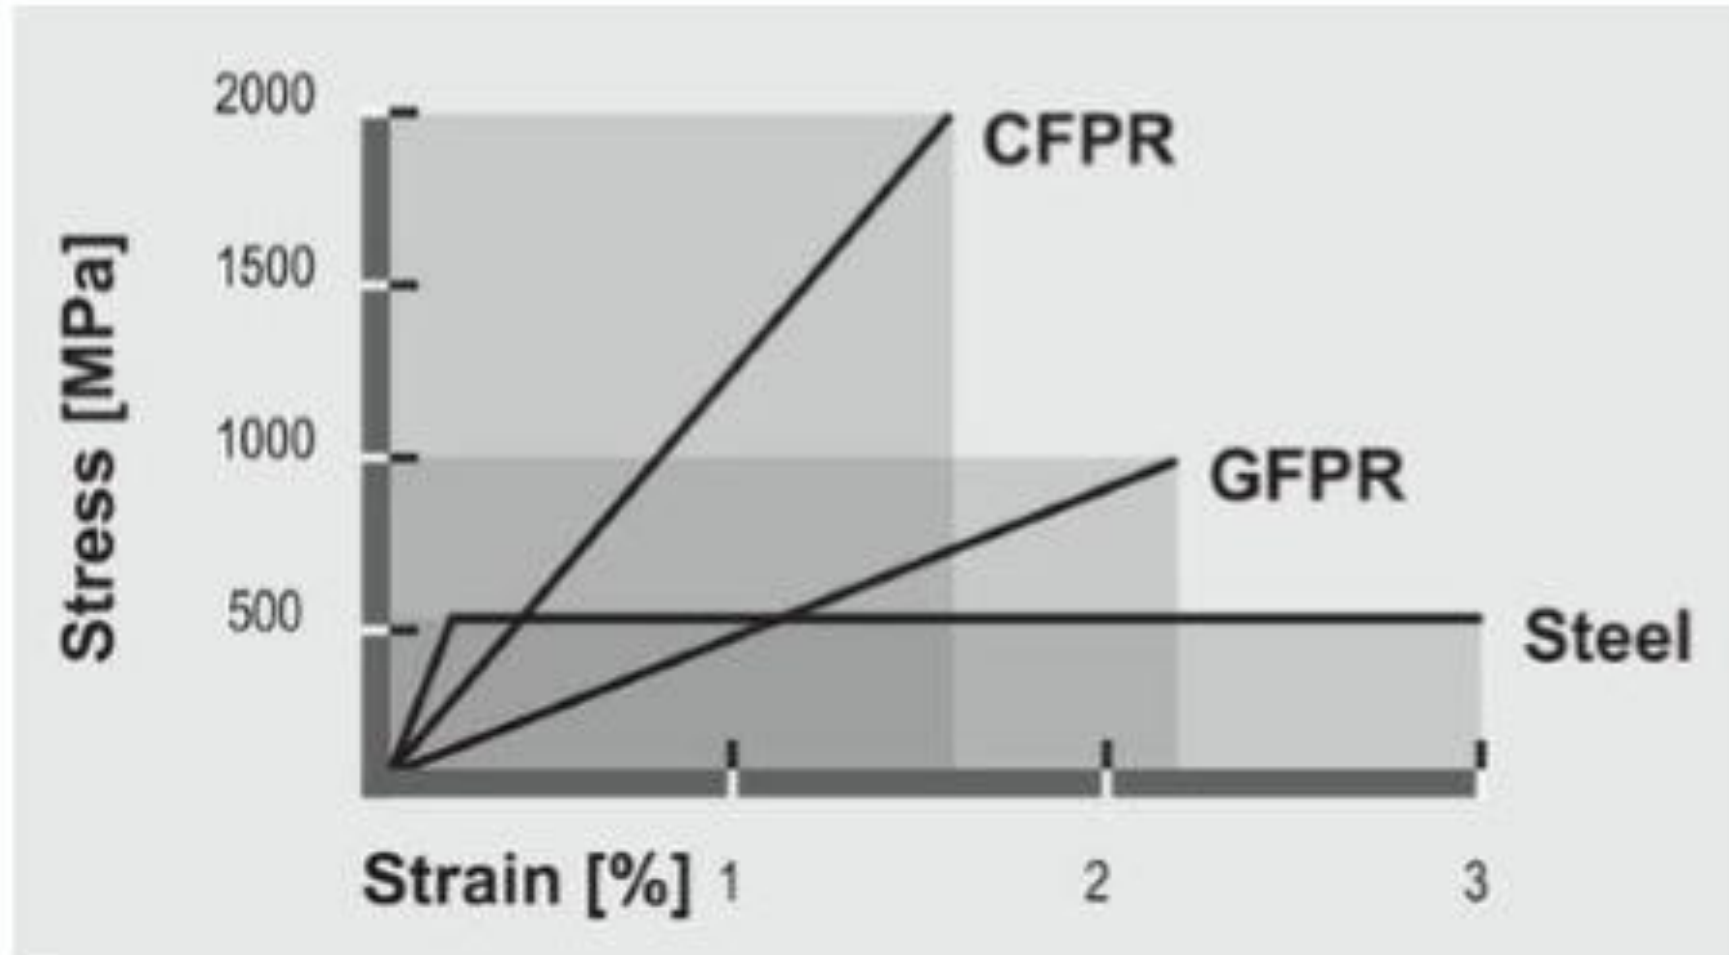
Comparison of FRP and Steel

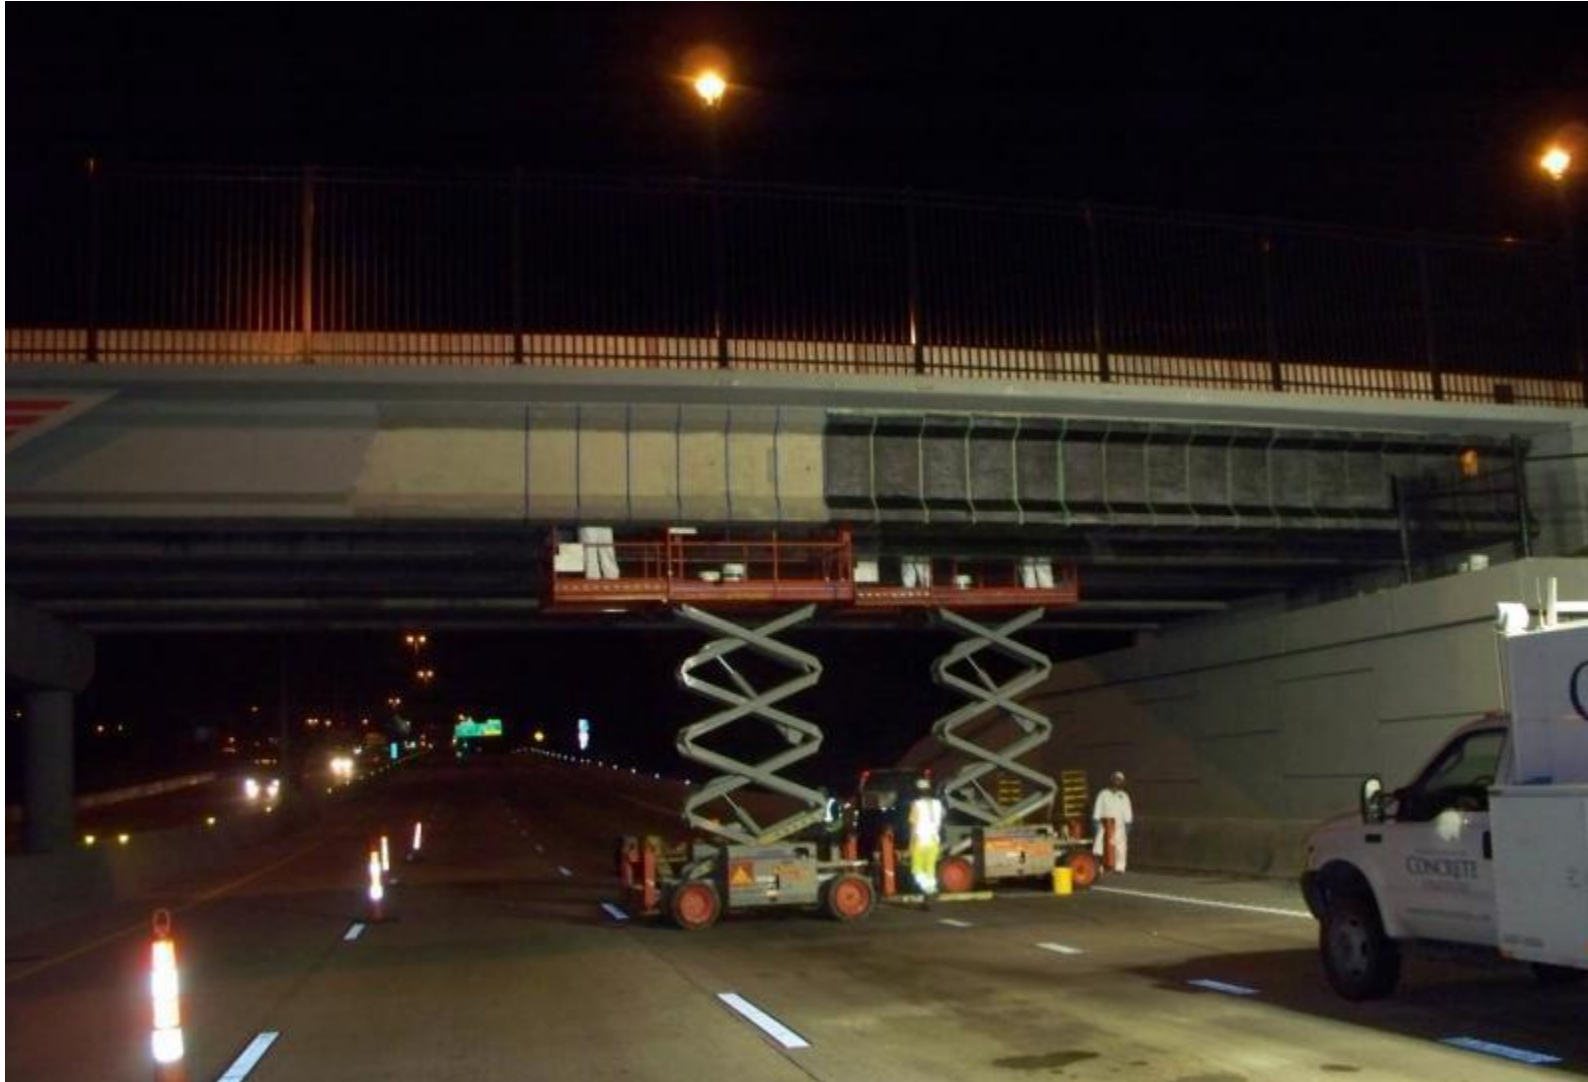
Original Concept Demonstration (1987)

Carbon FRP instead of reinforcing steel

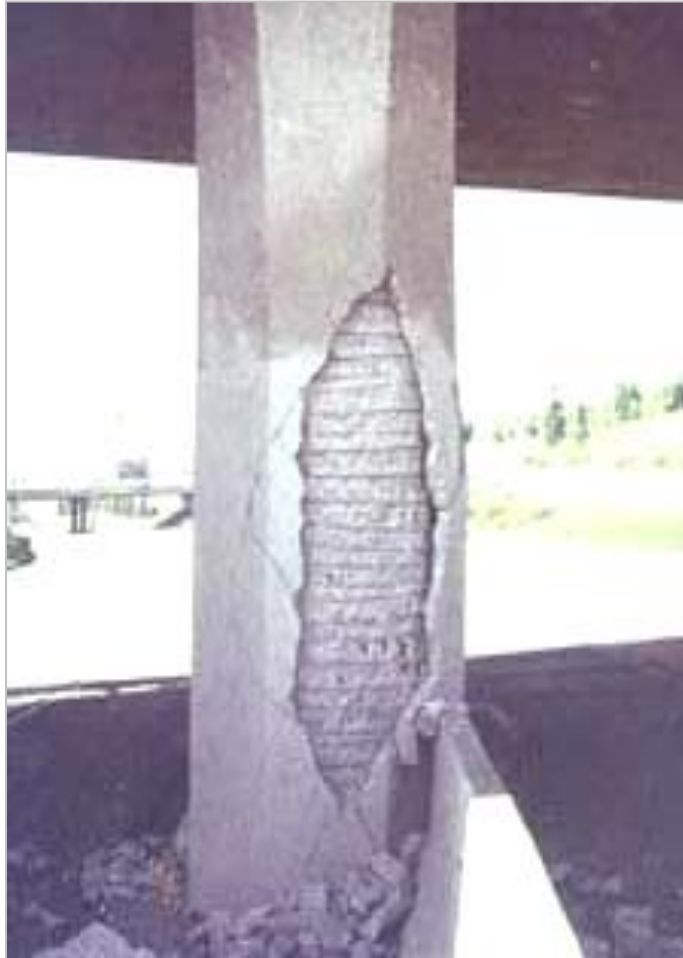
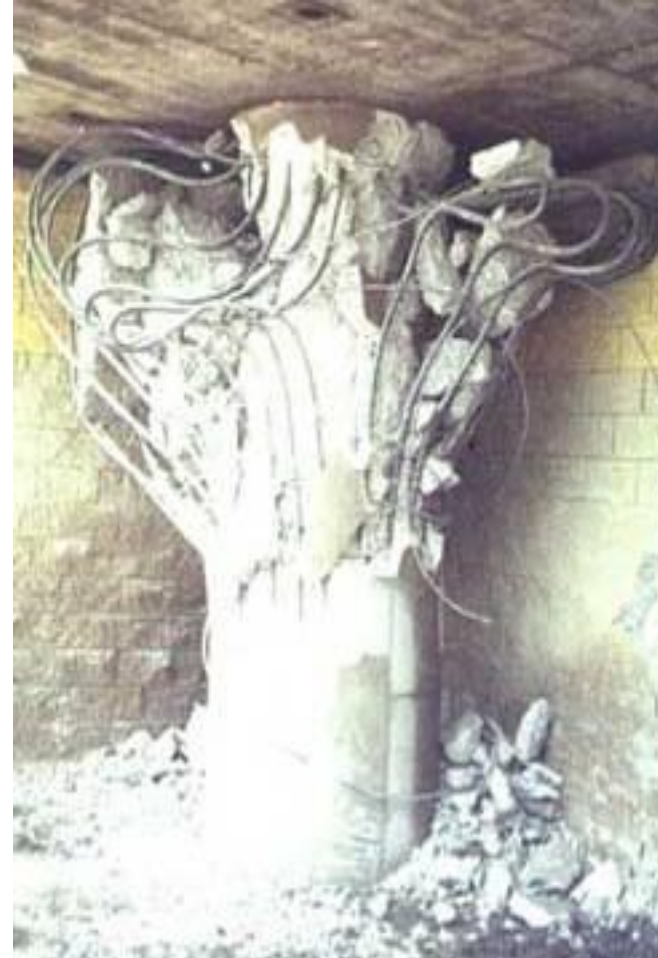
Loma Prieta Earthquake Oct 1989

Failure of R/C Columns

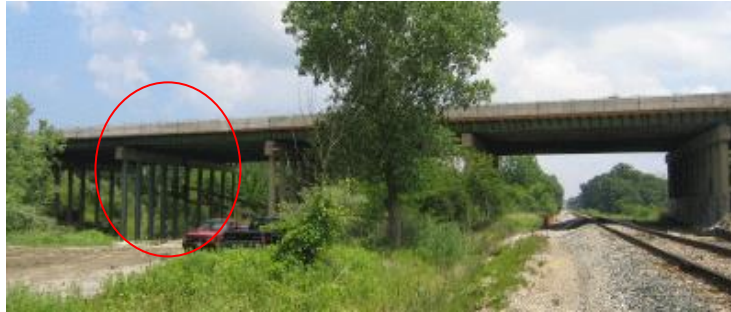
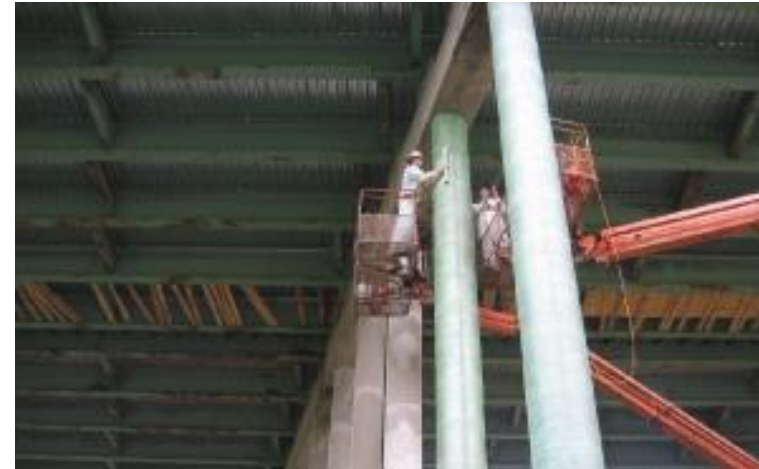
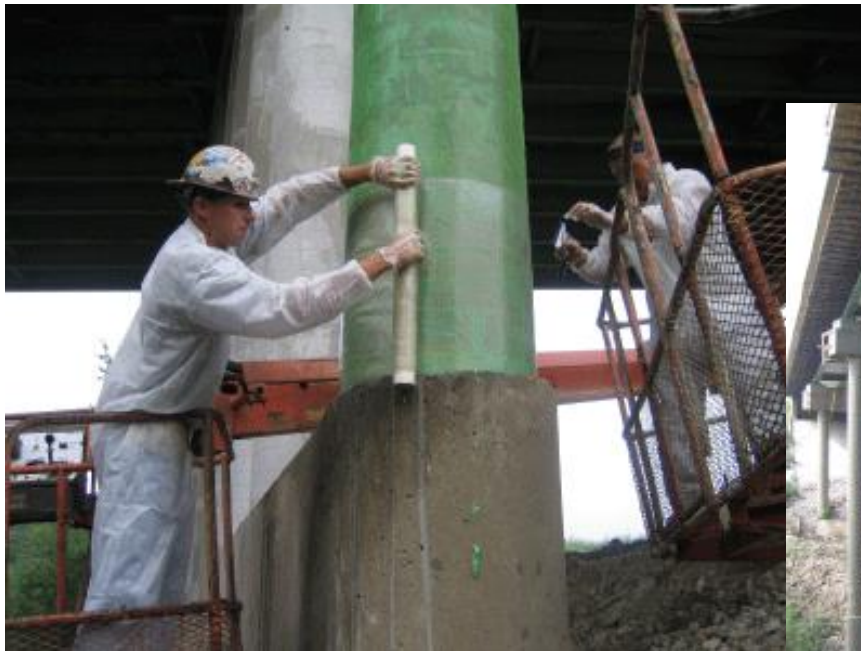
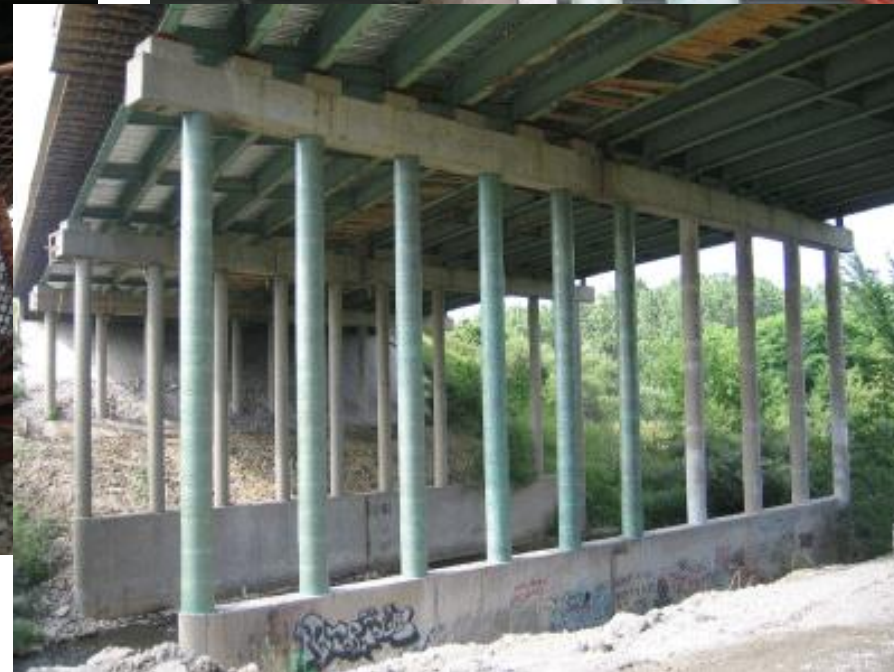
Indiana Bridge

Indiana Project R-27862-A – SR 49

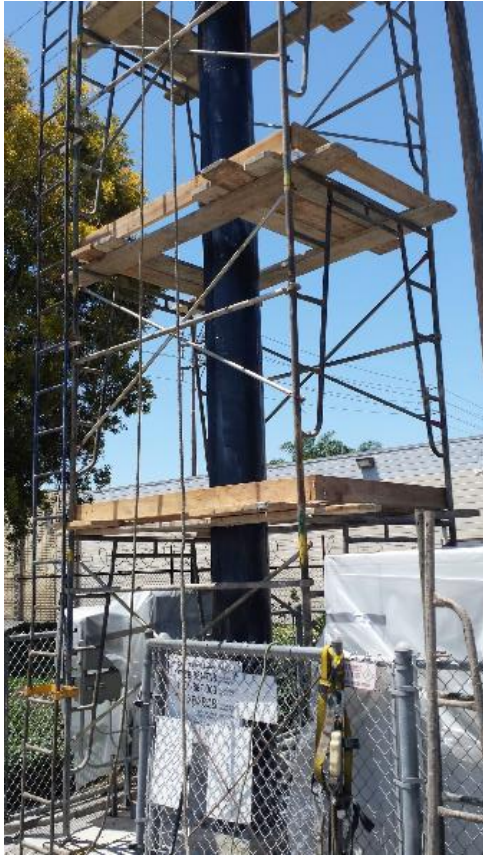
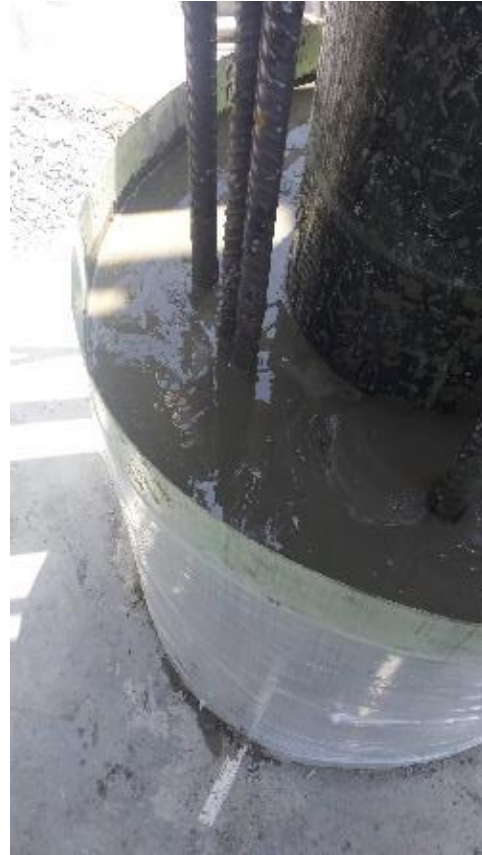
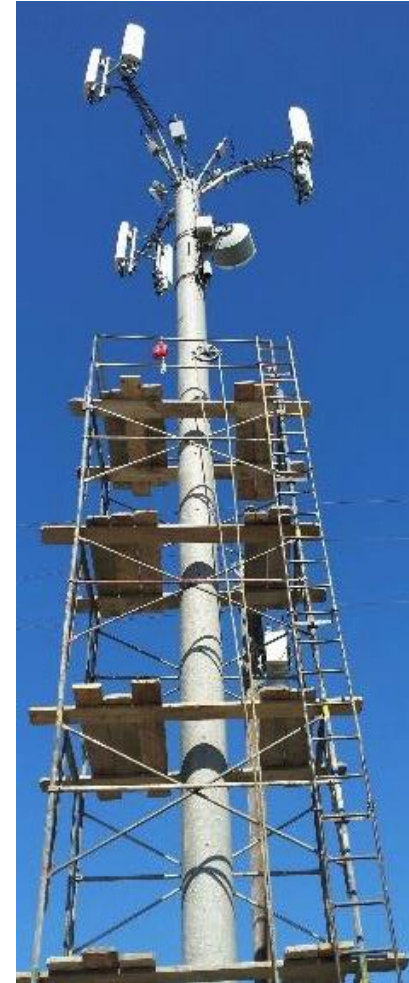
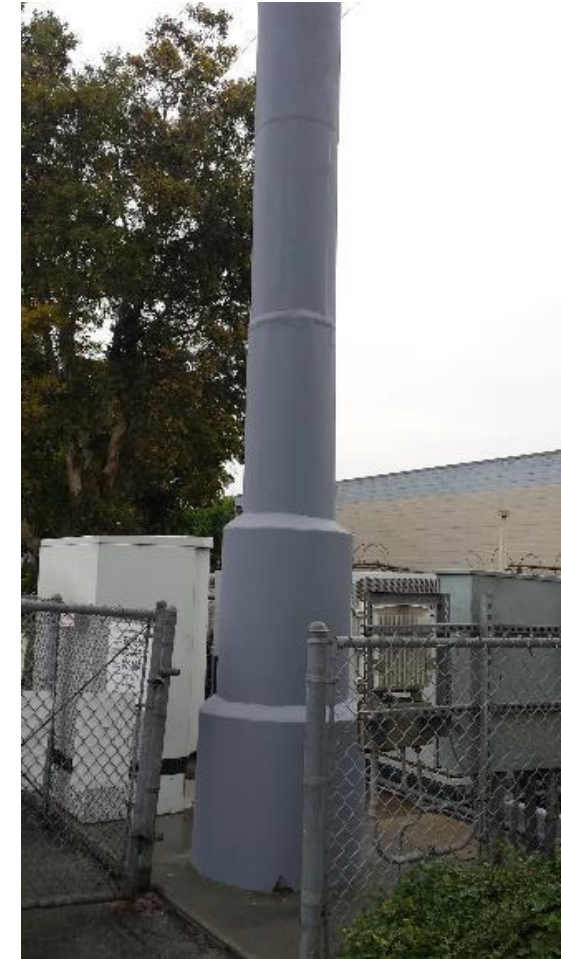
Kazakhstan

Cell Phone Tower Strengthening

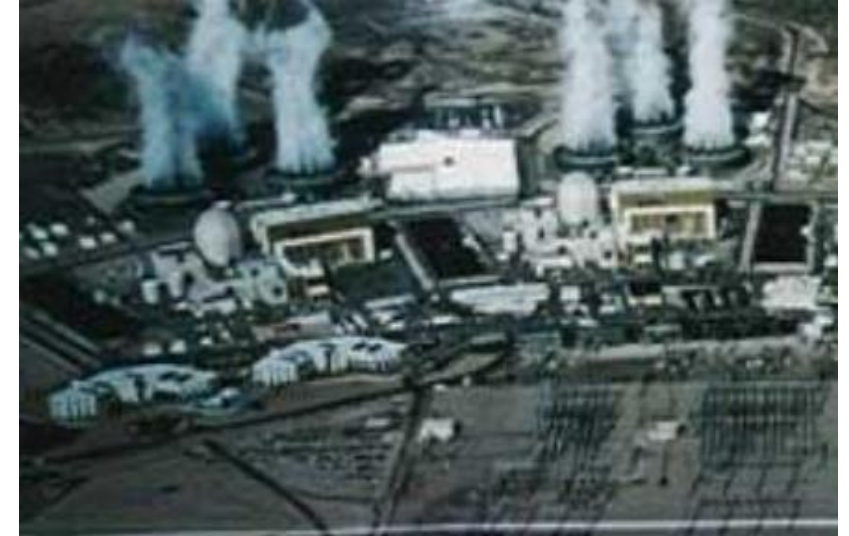
Early Applications in 1998

- Paloverde Nuclear Power Plant, AZ
- Prestressed Concrete Cylinder Pipe (PCCP)
- Corrosion of pre-stressing cables
- High design pressures
- Replacement recommended
- CFRP liner installed
- 108 inch (2700mm) Diameter

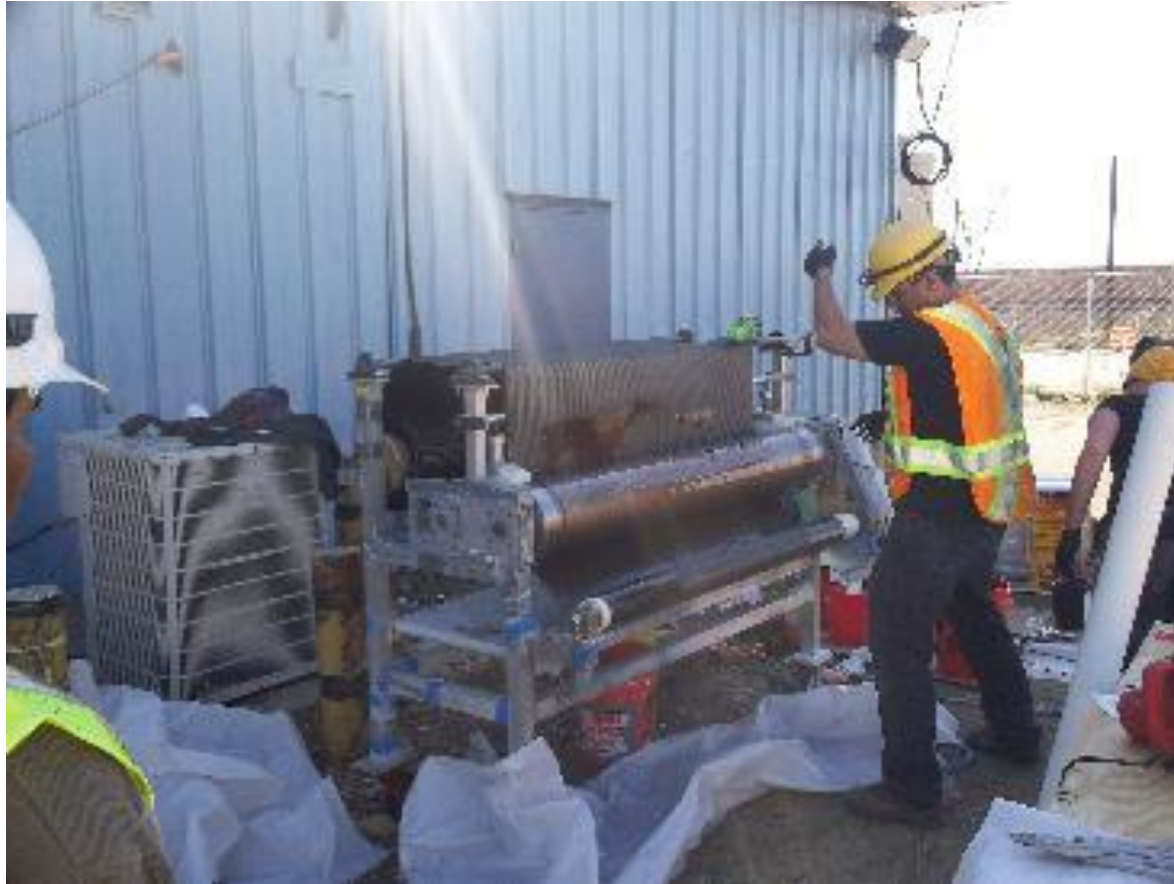
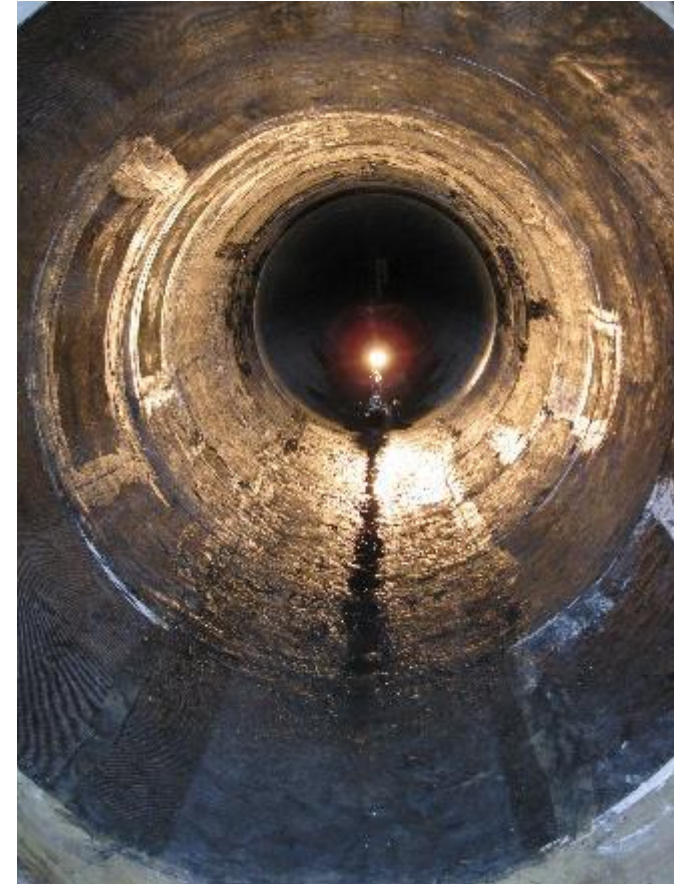
- Carbon fabric saturated with epoxy resin in the field and applied directly to surface of pipe (**Externally** or **Internally**)
- Fabric roll width: 24-48 inch (600-1200mm)
- Fabric thickness: 0.05 inch (1.3 mm)
- For diameters 2 inch (50 mm) and larger
- Applied by packer (small dia.) or by hand
- Used for joint/spot repair or full length
- Creates a pressure vessel inside pipe
- Cures in 24 hours in ambient temperature
- Faster cure is possible by heating
- NSF-61 Approved

Wet Layup Process

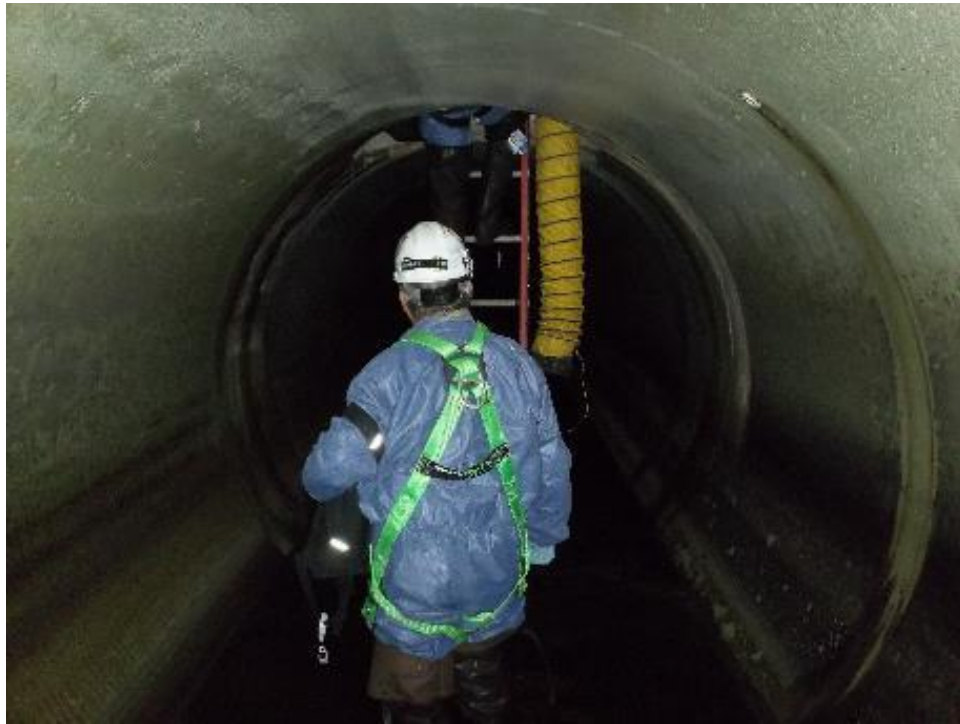
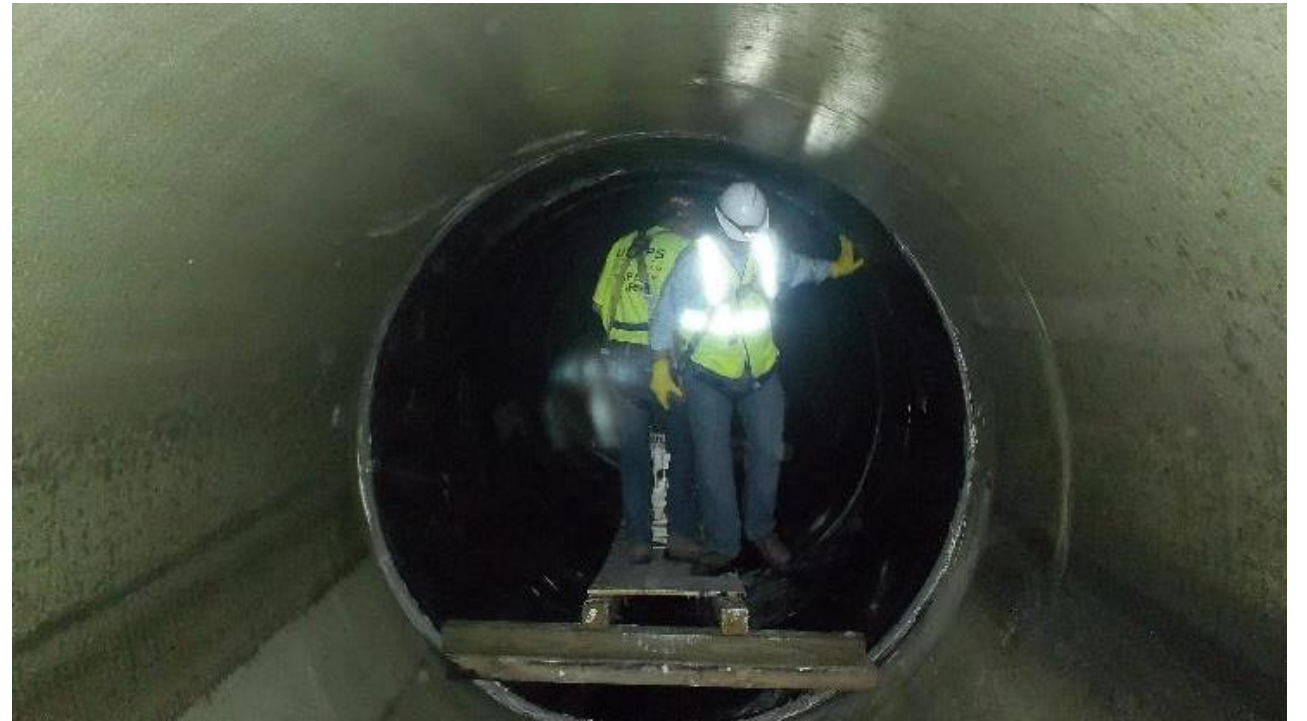
DC Water – 96-inch (2400 mm) Sewer Repair

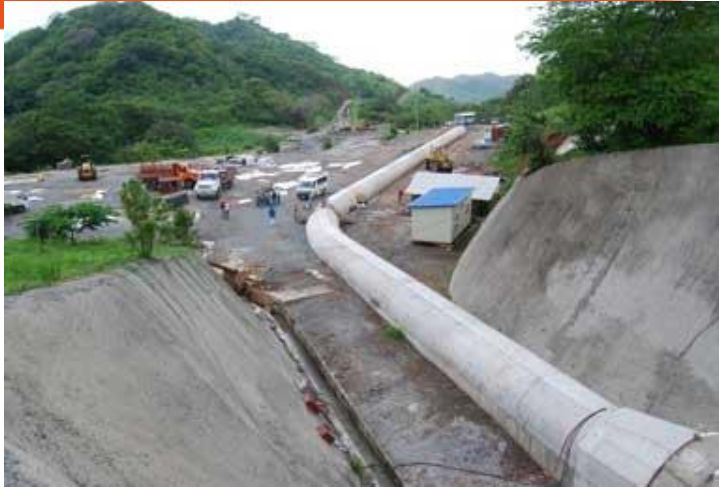
El Encanto Hydropower, Costa Rica

1750m x 2.1m diameter (July 2009)

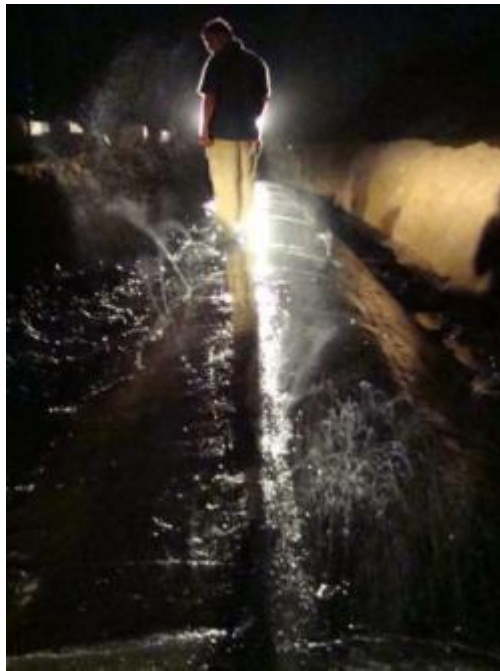
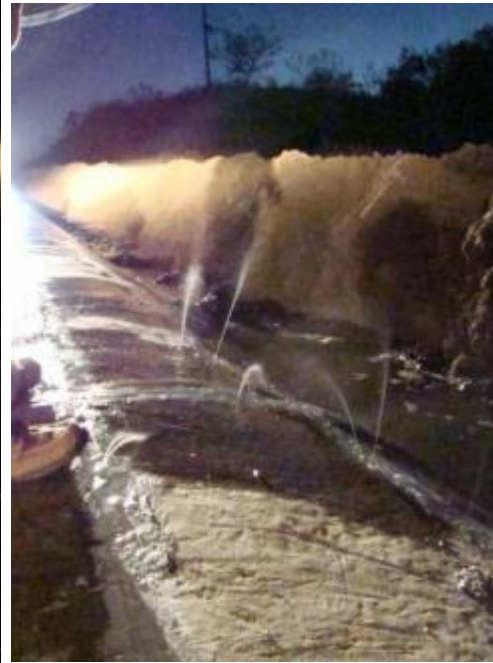
**Water seeping into
pipe**

**Leaks continued after cracks were
filled**

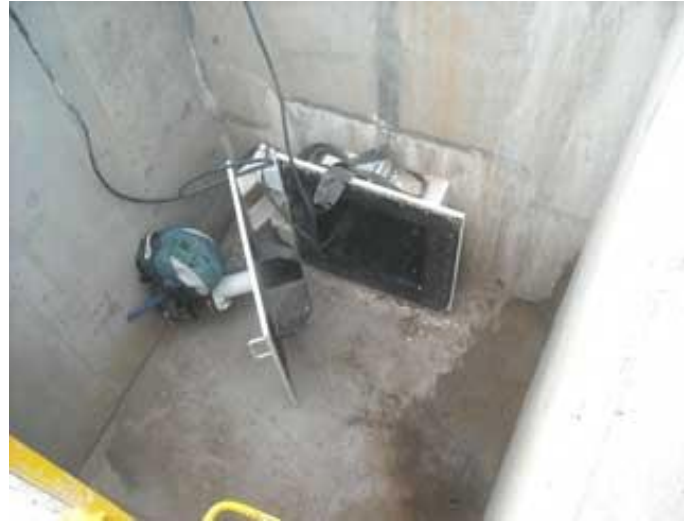
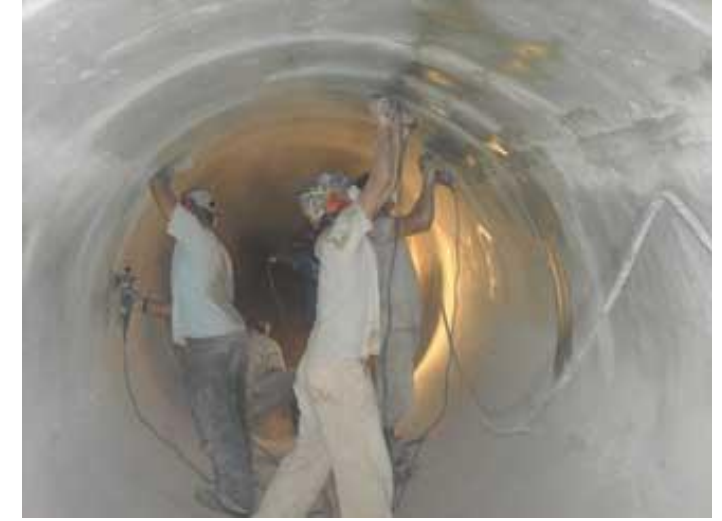
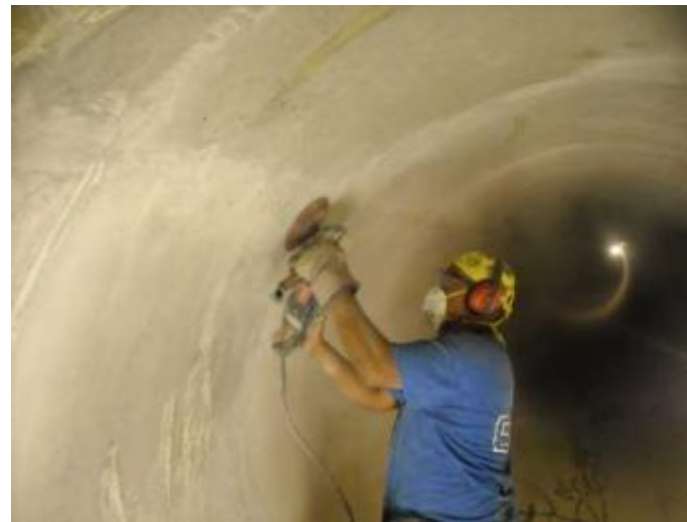
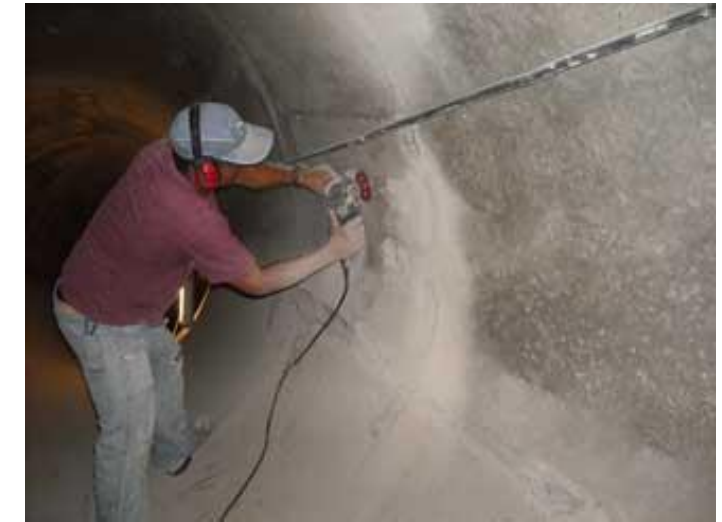
El Encanto Hydropower, Costa Rica

1.1 miles x 84-inch diameter (July 2009)

- Four 600x600mm Access Ports
- Poor surface conditions req'd much prep

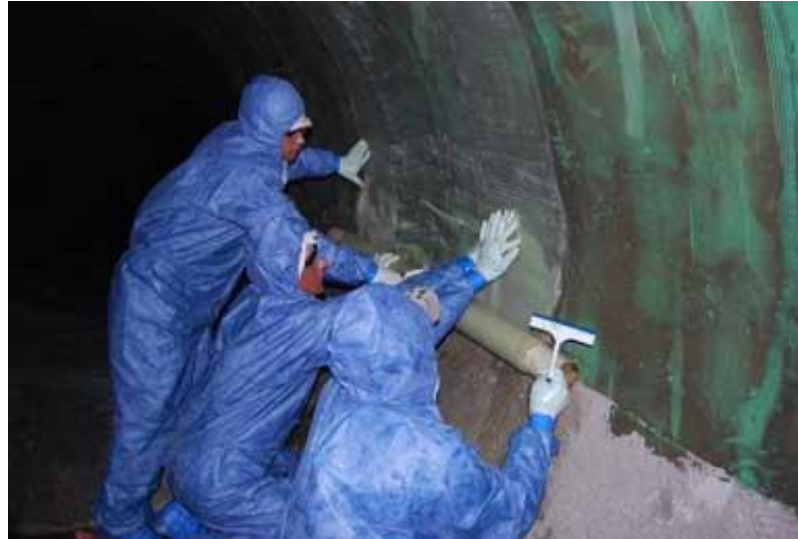
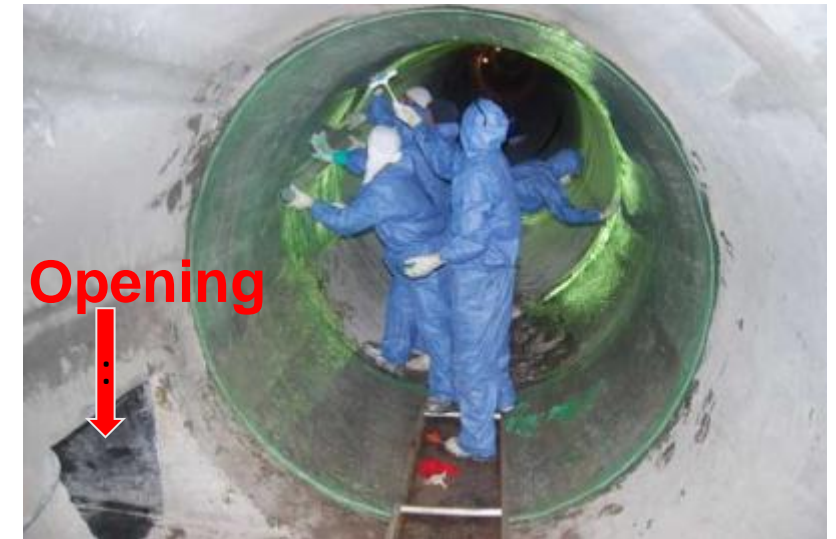
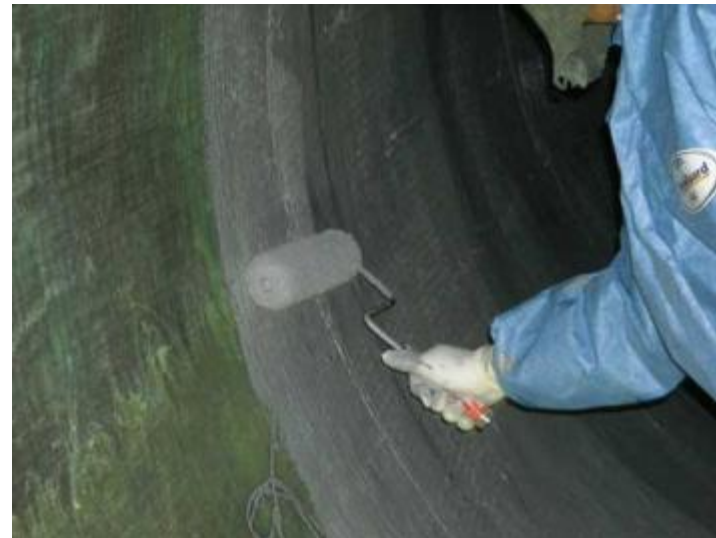
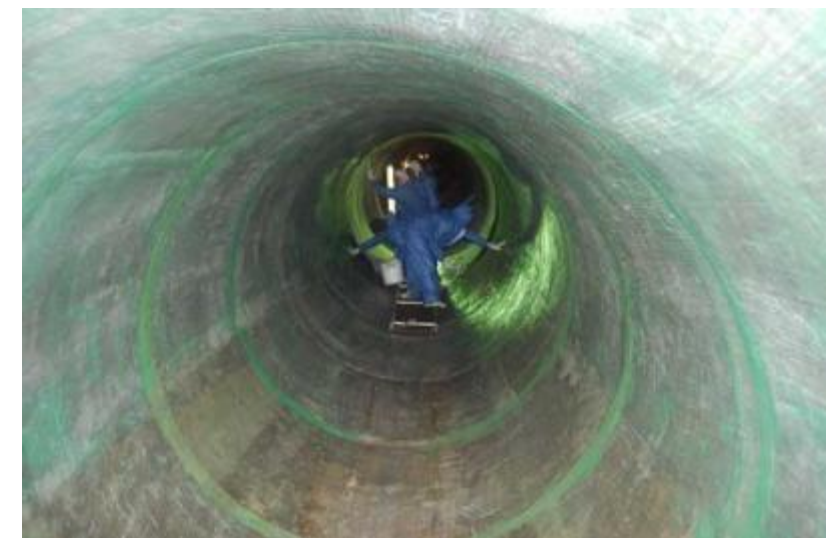
El Encanto Hydropower, Costa Rica

- Challenge: Not only strengthen but to leak proof
- Total Time: 3 Weeks
- Successful pressurization tests on July 15, 2009

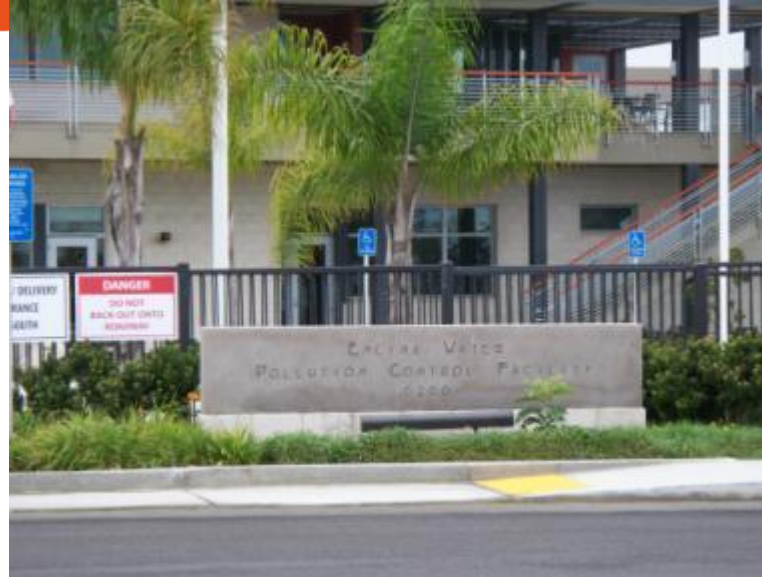
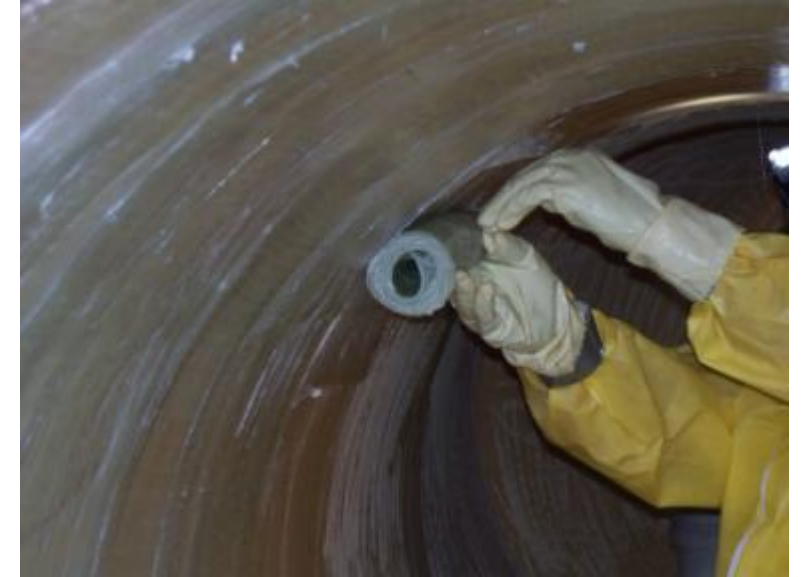
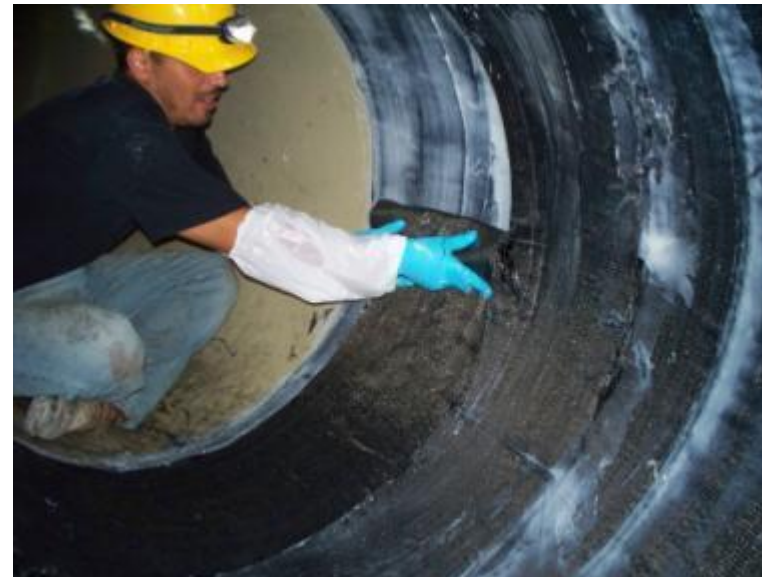
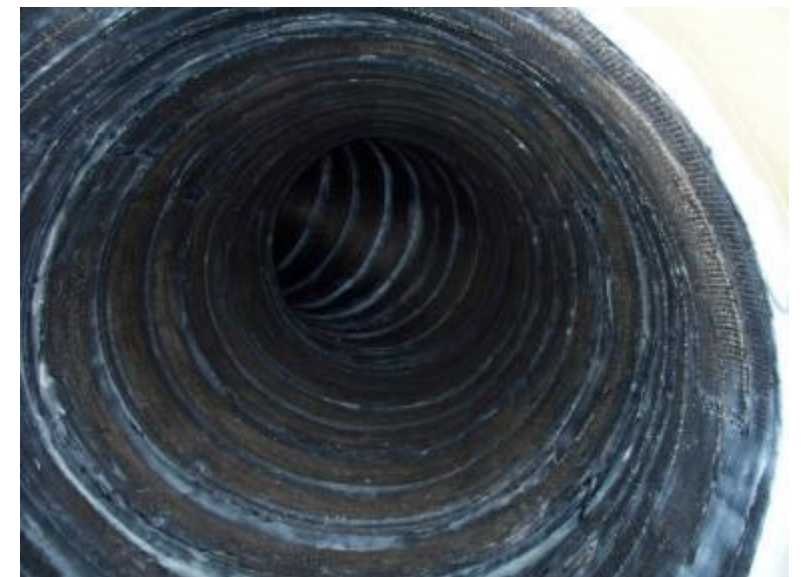
Steel Pipes for Hot Air, Carlsbad, CA

- 42-inch (1070 mm) curved steel pipe
- Galvanic corrosion
- Use glass fabric as dielectric barrier

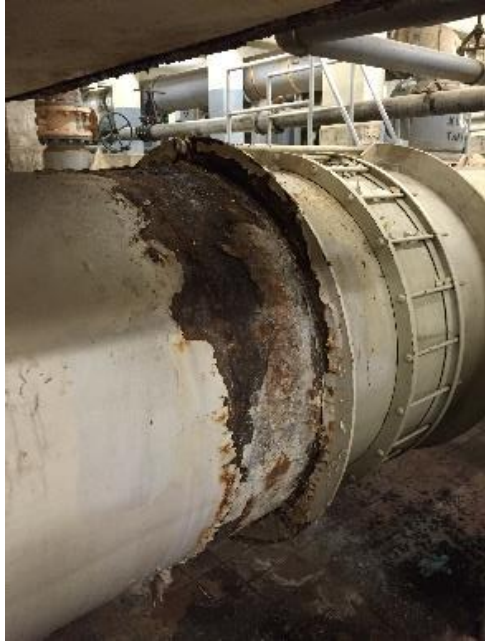
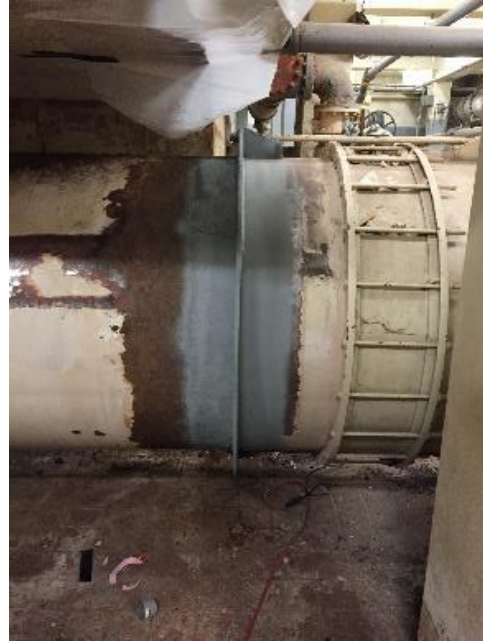
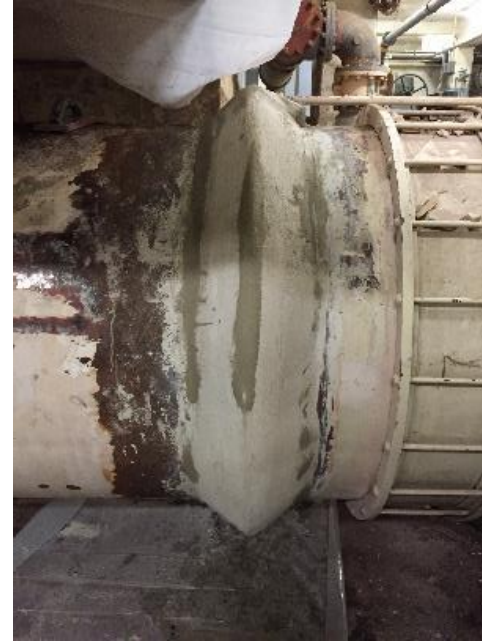
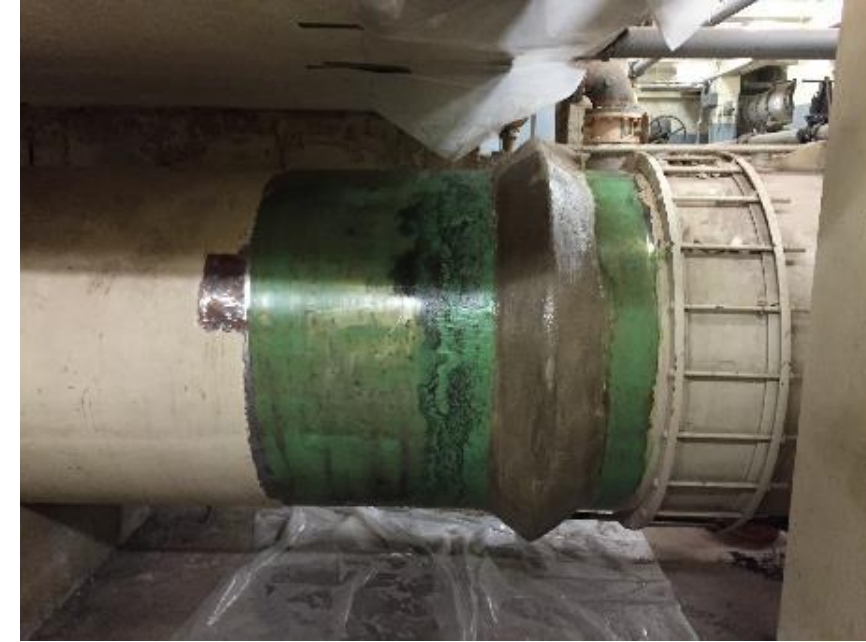
Wastewater Facility Pipe Repair

City of Atlanta

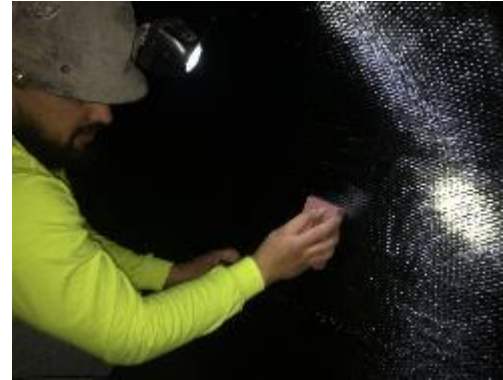
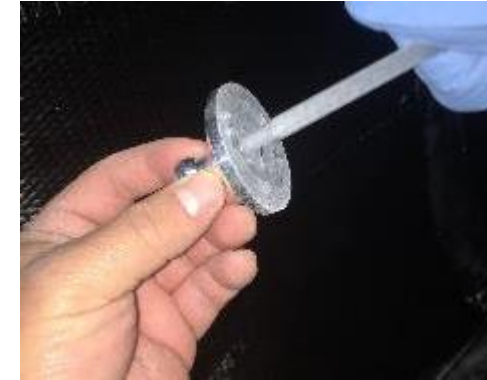
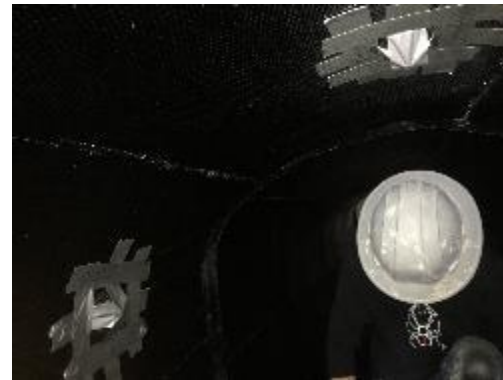
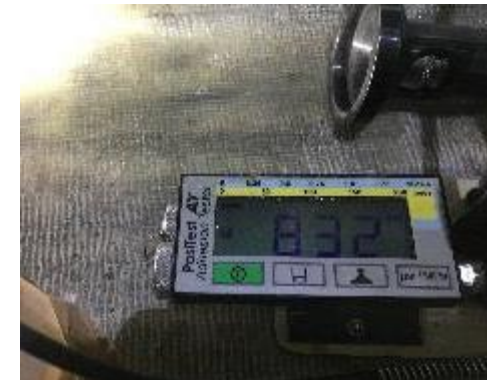
Quality Control

- Record Lot #
- Adhesion Test (ASTM D7234) (200 psi min.)
- Witness Panel (ASTM D3039); 5 glass and 5 carbon FRP coupons

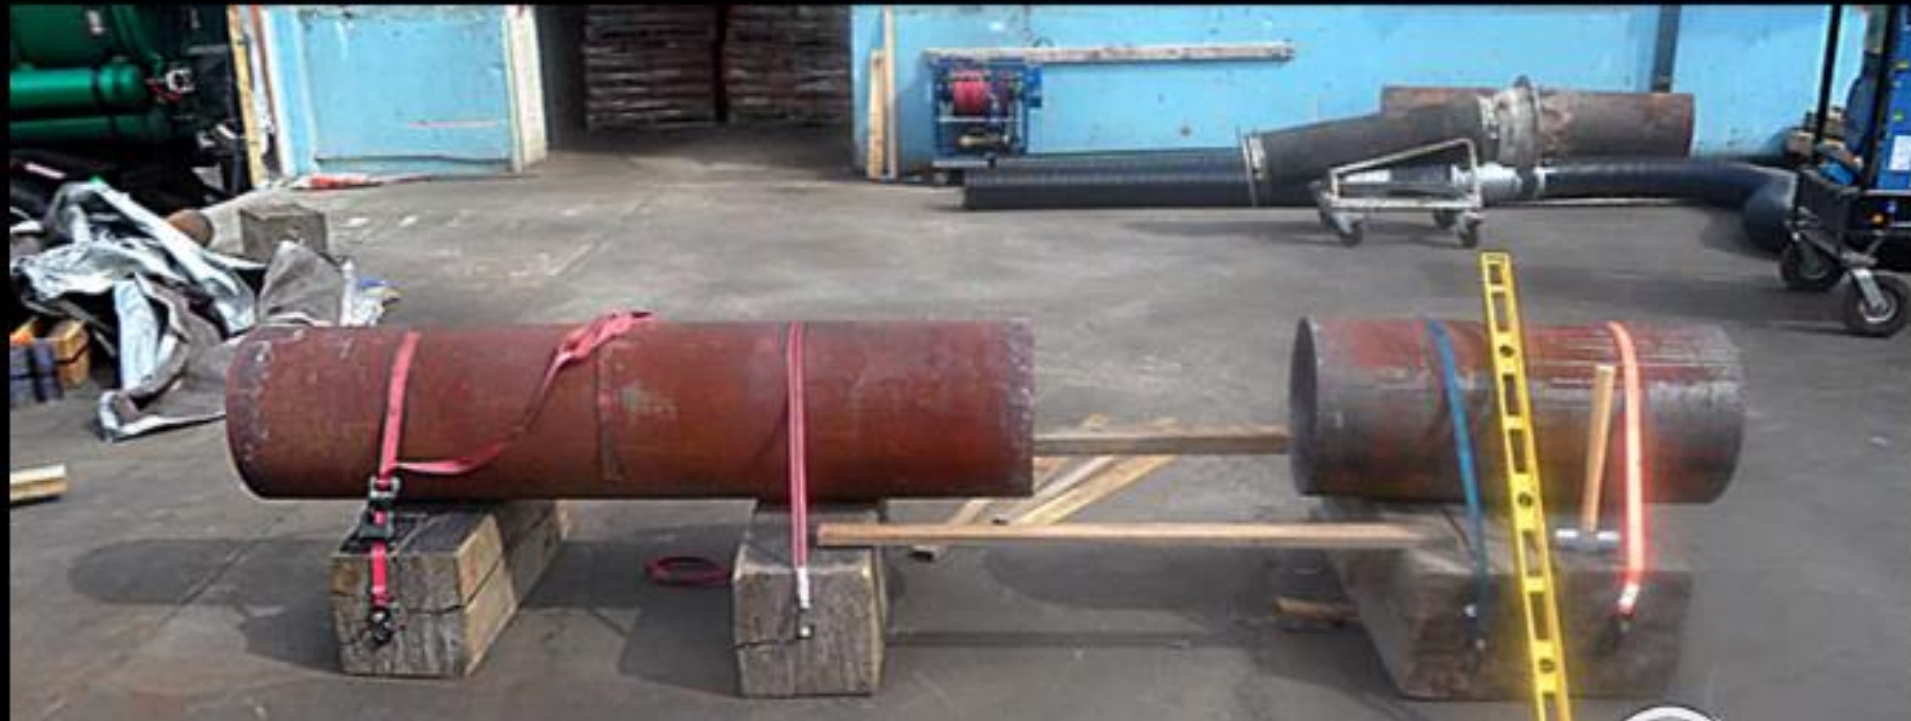
Bridging a Gap in a Pipeline

(600mm Long Gap in 400mm Diam. Pipe)

Two 16-in. diameter pipes with a 24-in. gap

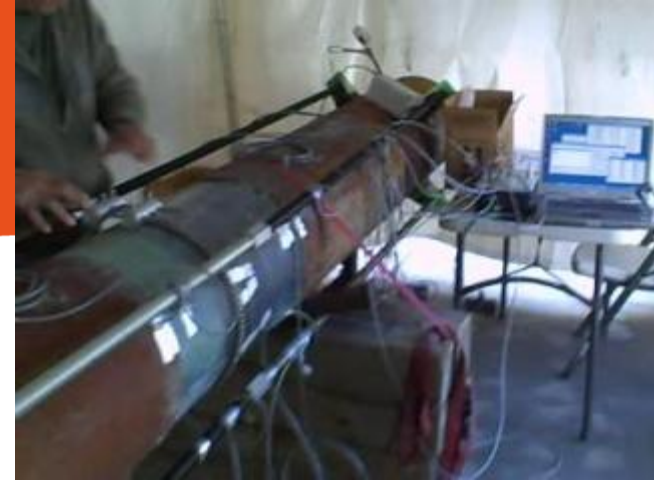
Pressure Testing

on October 16, 2010

- Gas Technology Institute
- Max Operating Pressure = 60 psi (4.1bar)
- Tested to 250 psi (17.2 bar)
- Ultimate Capacity = 900 psi (62 bar)

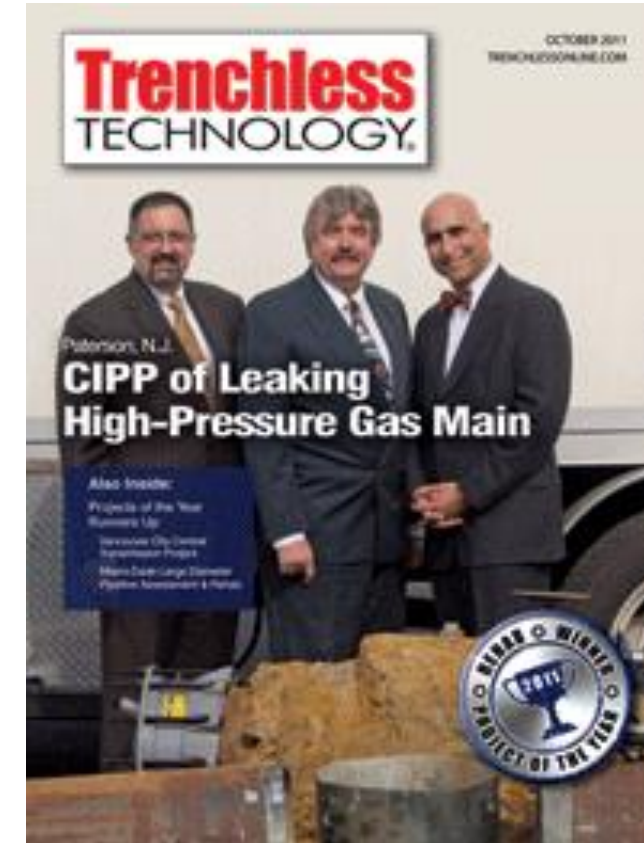
Field Application

- First Project was completed in Feb 2011
- Client: PSE&G (NJ Gas Utility)
- Contractor: Progressive Pipeline Management
- 2-ft gap in 16" cast-iron pipe
- Winner of 2011 Trenchless Technology *Project of the Year Award*
- Over 60 similar applications
