**37TH INTERNATIONAL
No - DIG
FLORENCE 2019**

The Path Forward for Pipe Bursting Asbestos Cement Pipe in the US

**Edward Alan Ambler, PE, LEED AP
AM Trenchless**

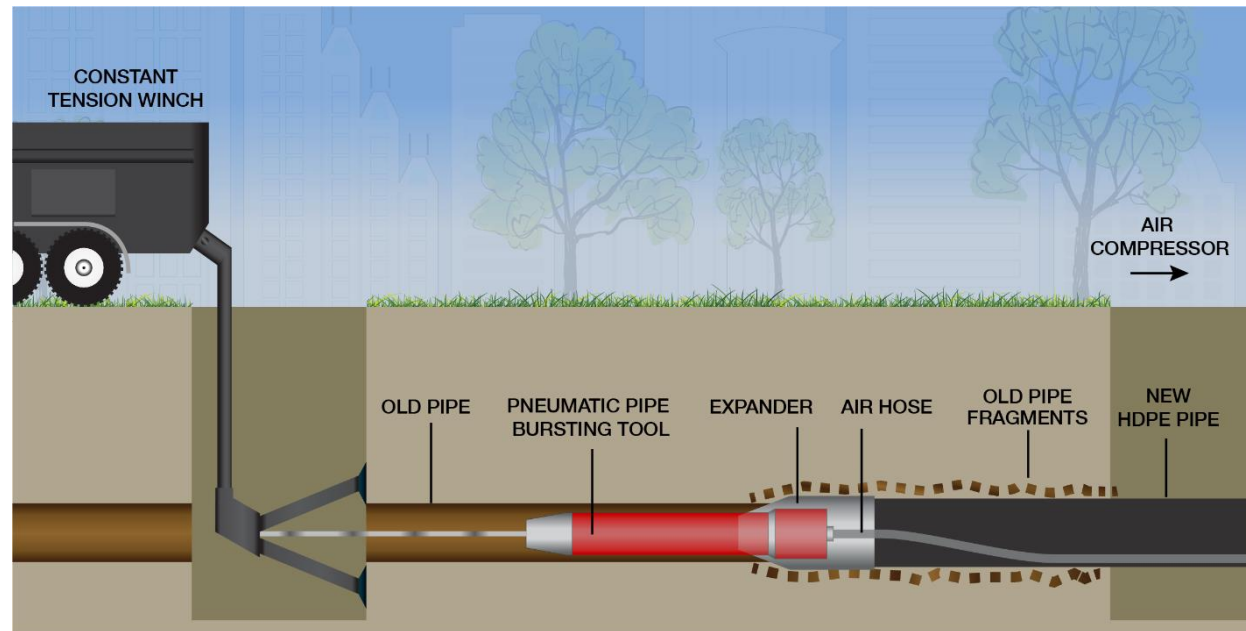
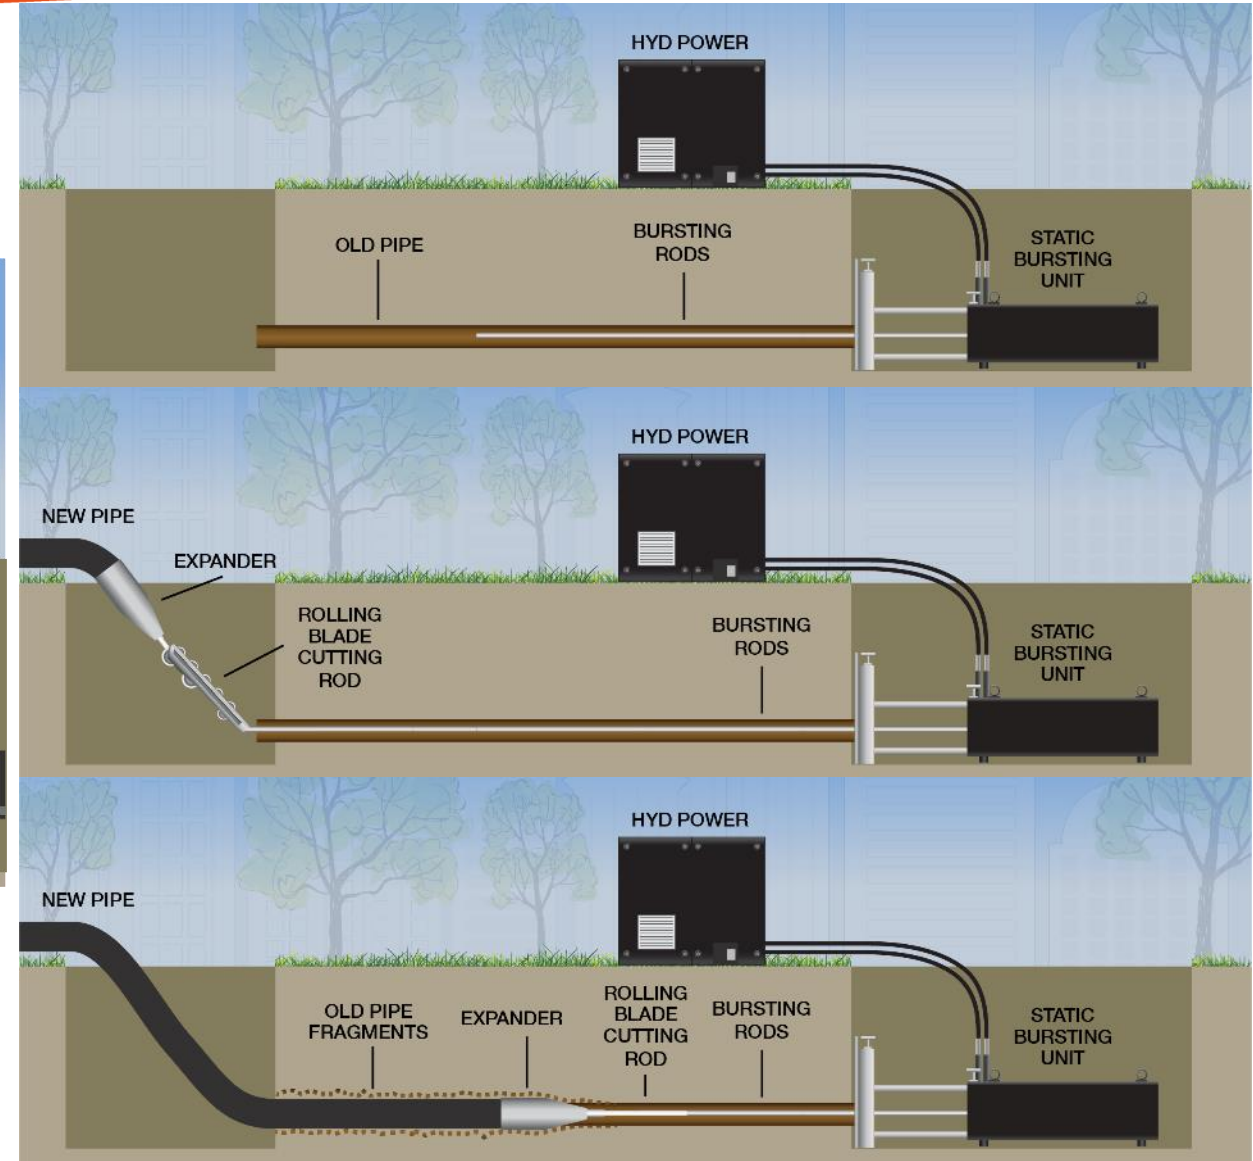
PIPE BURSTING – PNEUMATIC AND STATIC

- Pipe bursting is defined as a trenchless replacement method in which an existing pipe is fractured in place, and a new pipe with the same or larger ID is pulled into its place. The pipe bursting process uses energy from a cable or rod pulling system, hydraulic or pneumatic power. This energy is transmitted to the expander or pneumatic hammer to burst the existing pipe and temporarily expand the soil cavity surrounding the existing pipe.
- Three things are happening simultaneously
 - **(A) the existing pipe is being fractured or split**
 - **(B) the soil is being expanded to receive the new pipe**
 - **(C) the new pipe is being pulled into the place of the existing pipe.**

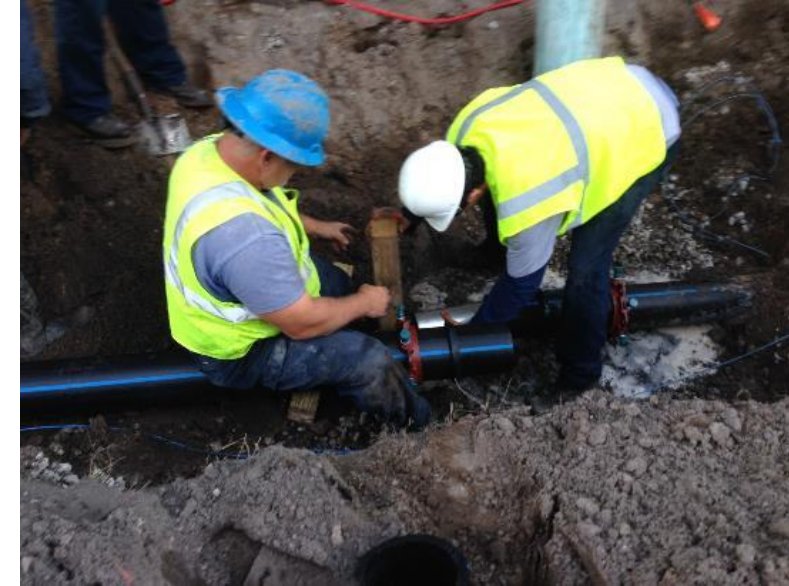
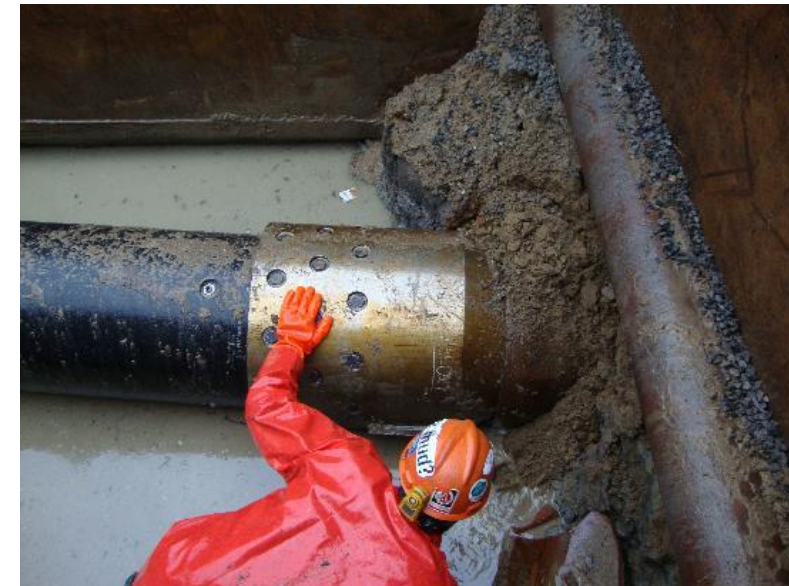
Range of Diameters and Lengths

- Typical range of diameters up to 54" but typically used for pipes smaller than 36"
- The majority of pipe bursting projects are between 6" and 12"
- Typical lengths of pipe bursting runs are between 300' and 500'
- Production levels are affected by the number of required excavations
- Much longer lengths of pipe bursting runs have been performed but take longer
- Pipe bursting typically can not pull through manufactured bends (greater than 22 degrees), valves and tees
