**37<sup>TH</sup> INTERNATIONAL  
NO - DIG  
FLORENCE 2019**

# ***FRP 101: Taking The Mystery out of Trenchless Repair of Pressure Pipes with Carbon FRP***

***Mo Ehsani, PhD, PE  
Professor Emeritus of Civil Eng., U. of Arizona  
President/CEO QuakeWrap Inc., Tucson, AZ***

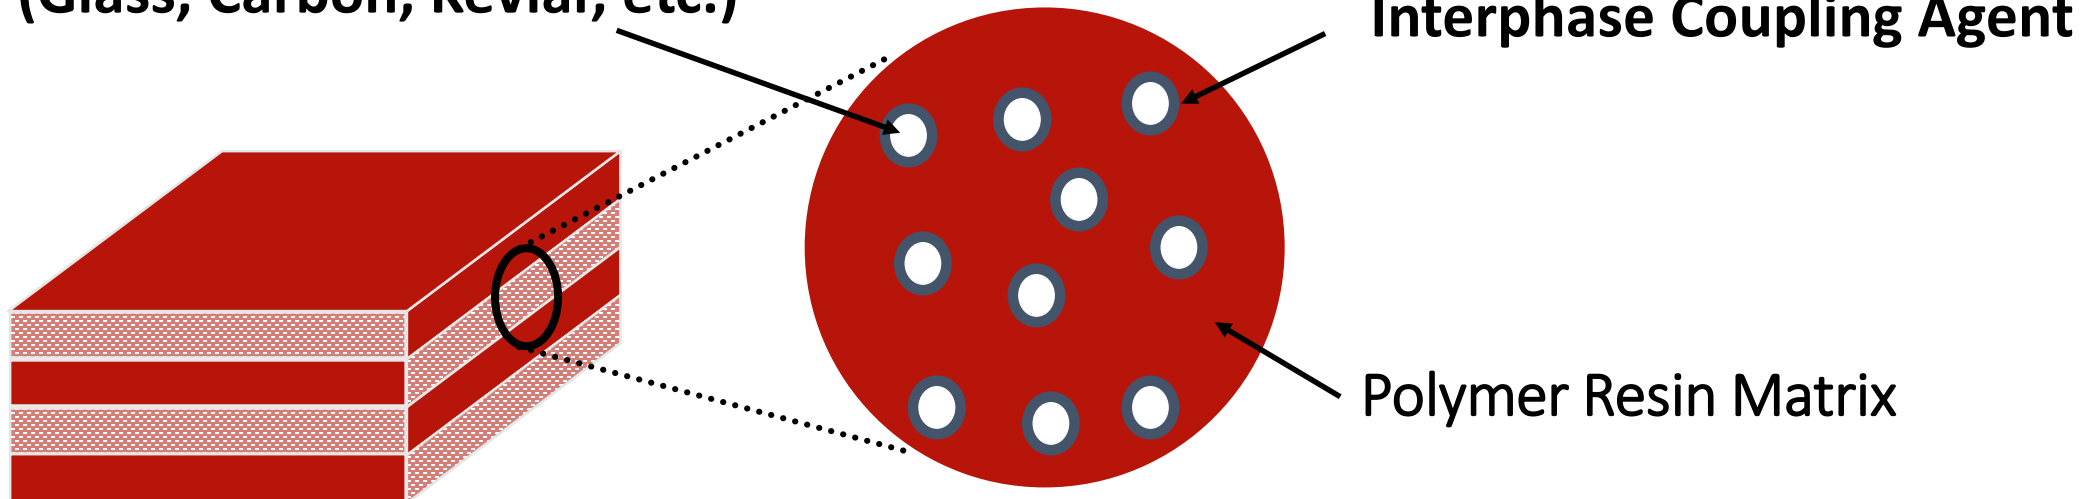
- A Polymer (i.e. epoxy, vinyl ester, etc.) reinforced with a Fiber (e.g. carbon, glass, etc.)
- FRP does not have the same strength in all directions (*anisotropic*)

**Reinforcing Fiber**

**(Glass, Carbon, Kevlar, etc.)**

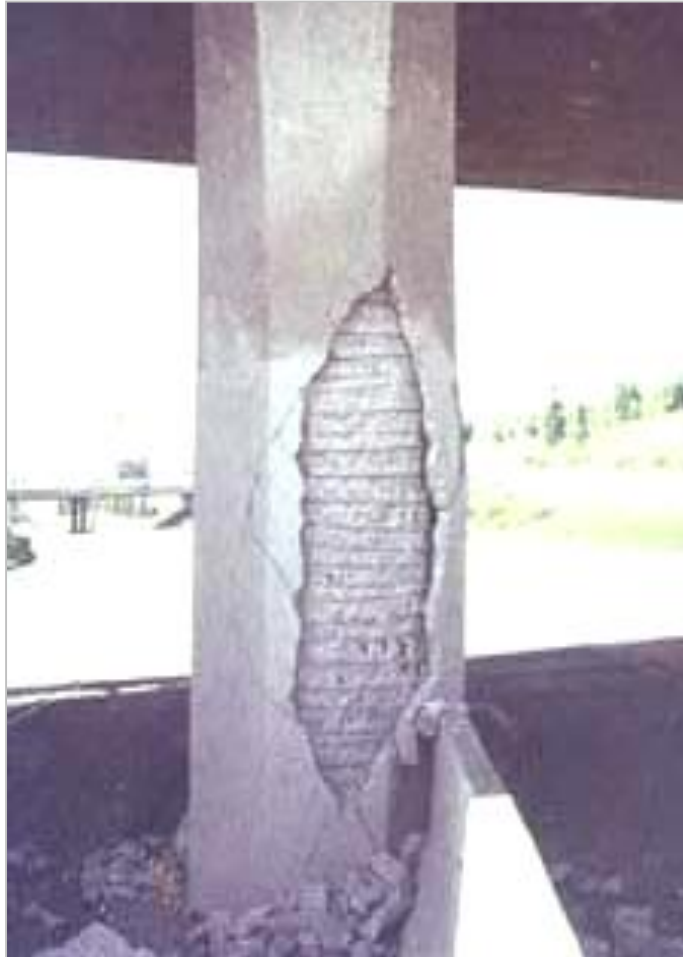
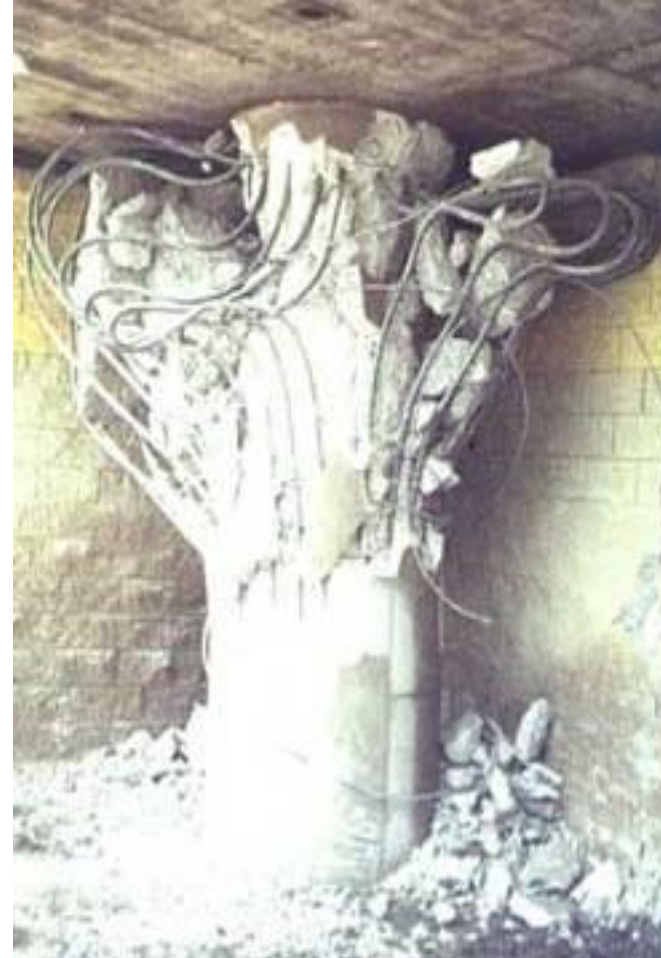
# Loma Prieta Earthquake Oct 1989

## Failure of R/C Columns

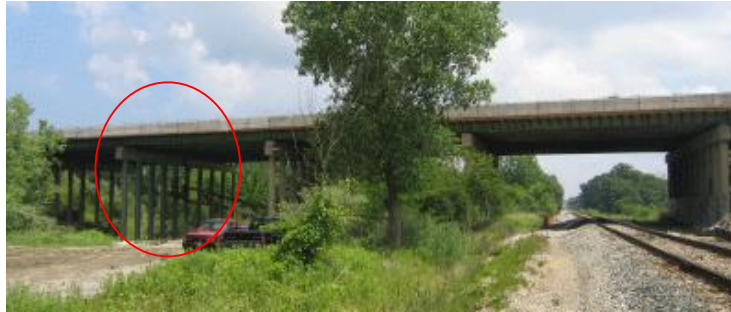
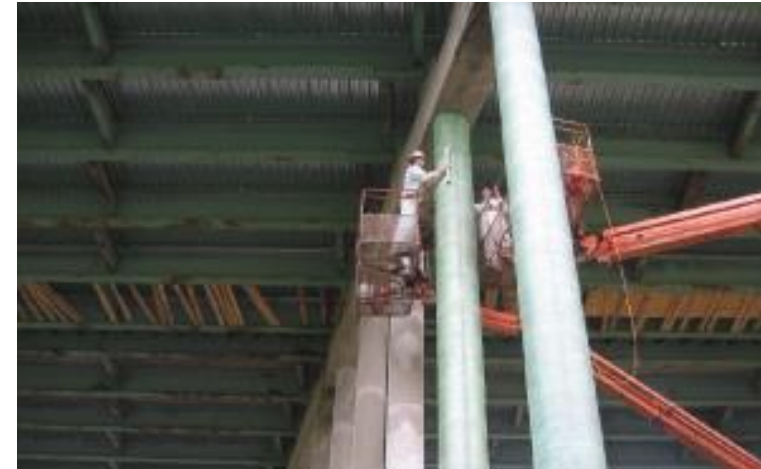
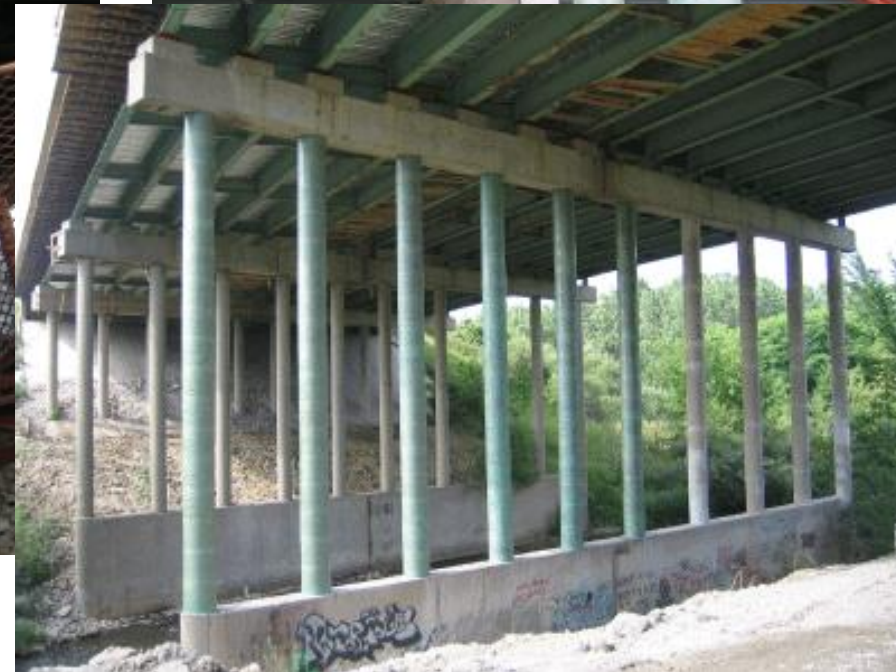
# Indiana Bridge

*Indiana Project R-27862-A – SR 49*

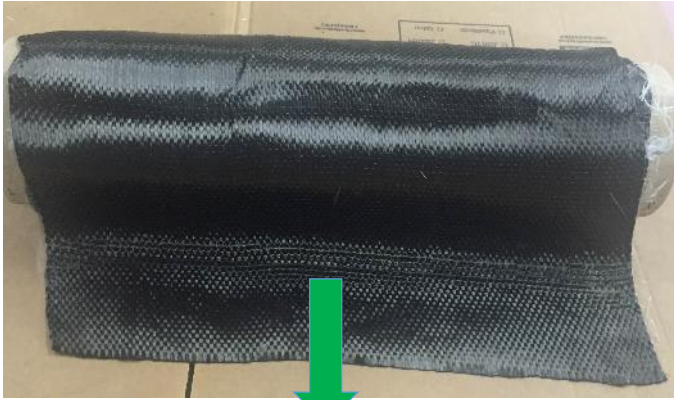
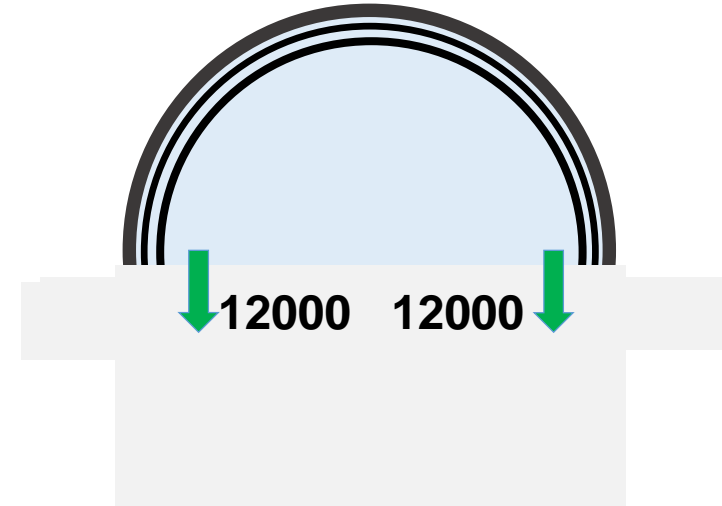
# Design for Internal Pressure

**Carbon  
Fabric**

Thickness: 0.05 in. (1.3 mm)  
Weight: 0.38 lb/ft<sup>2</sup> (1.83 kg/m<sup>2</sup>)  
T = 6000 lb/in. (1050 N/mm)

$$P = (6,000 + 6,000) / 24 \text{ in.} = 500 \text{ psi (34.5 bar)}$$

$$P = (12,000 + 12,000) / 24 \text{ in.} = 1,000 \text{ psi (69 bar)}$$

**Note: Little change in weight or thickness**  
**Smooth surface reduces friction & improves flow**

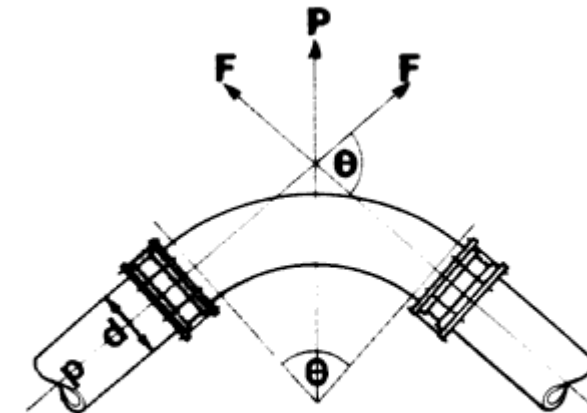
# Design for Thrust

- Align the fibers along the length of pipe
- Increase/decrease number of layers based on the thrust magnitude

$$P = \frac{\rho \pi d^2}{2} \sin \frac{\theta}{2}$$

$$F = \frac{\rho \pi d^2}{4} (1 - \cos \theta)$$

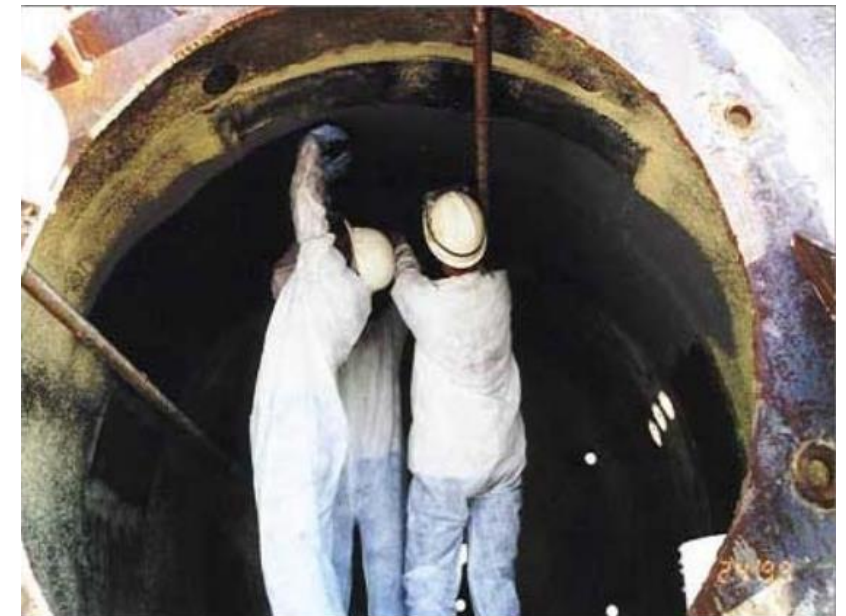
# Early Applications in 1998

- Paloverde Nuclear Power Plant, AZ
- Prestressed Concrete Cylinder Pipe (PCCP)
- Corrosion of pre-stressing cables
- High design pressures
- Replacement recommended
- CFRP liner installed
- 108 inch (2700mm) Diameter

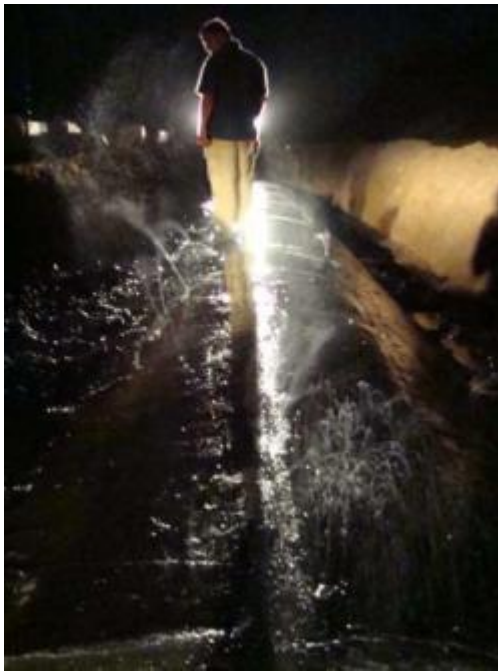
**Leaks continued after cracks were  
filled**

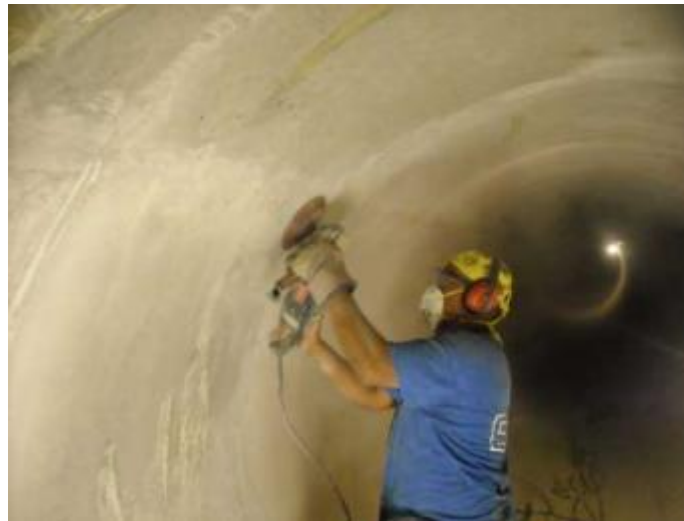
# El Encanto Hydropower, Costa Rica

*1.1 miles x 84-inch diameter (July 2009)*

- Four 600x600mm Access Ports
- Poor surface conditions req'd much prep

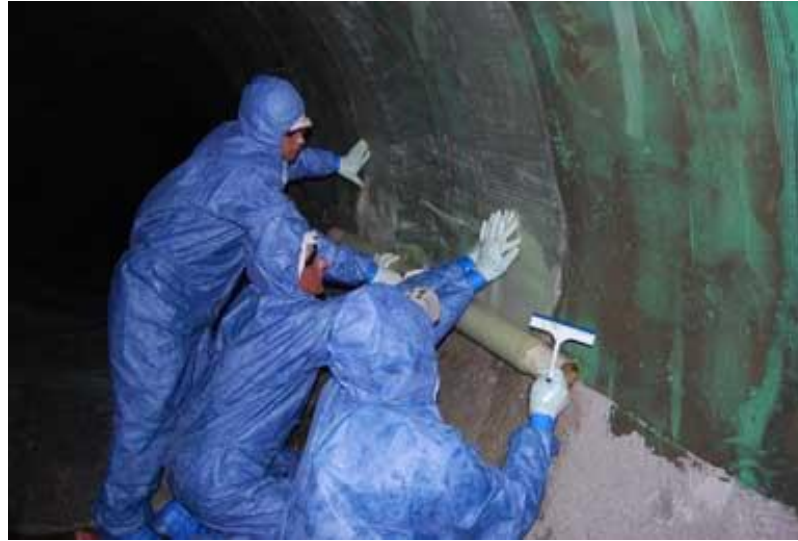
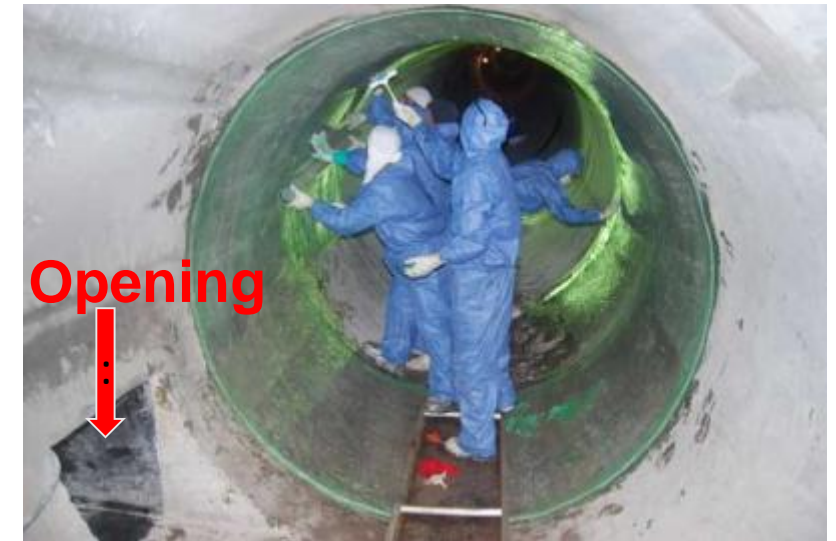
# El Encanto Hydropower, Costa Rica

- Challenge: Not only strengthen but to leak proof
- Total Time: 3 Weeks
- Successful pressurization tests on July 15, 2009

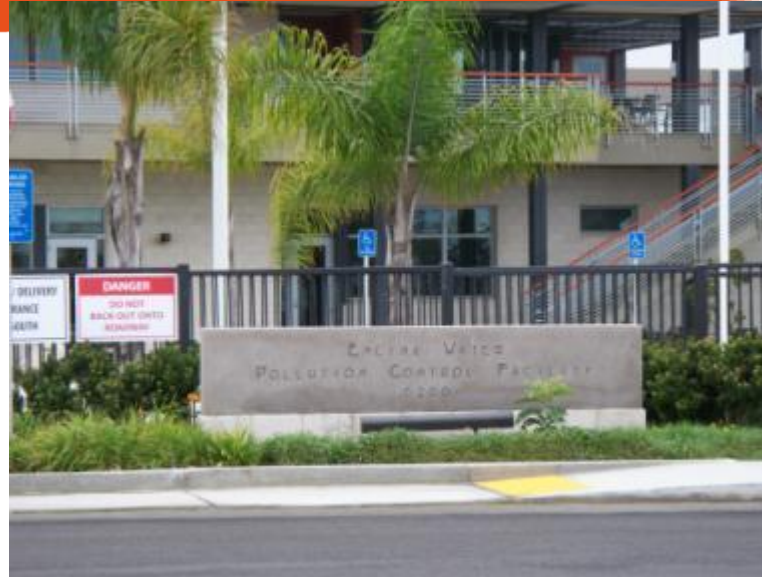
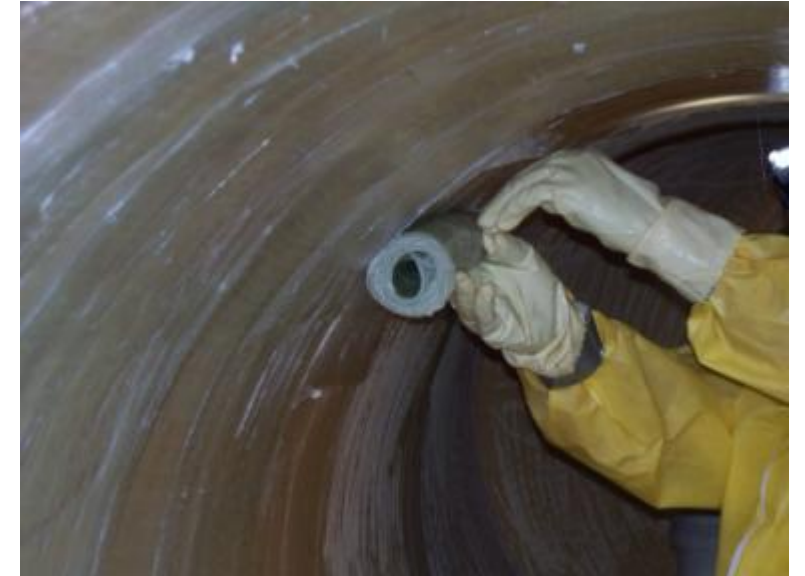
# Steel Pipes for Hot Air, Carlsbad, CA

- 42-inch (1070 mm) curved steel pipe
- Galvanic corrosion
- Use glass fabric as dielectric barrier

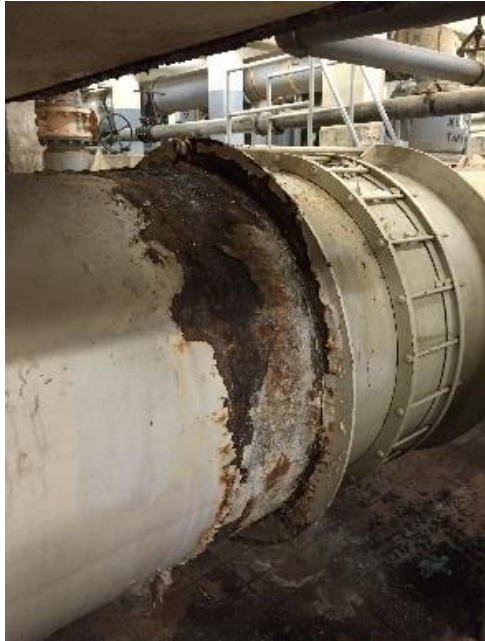
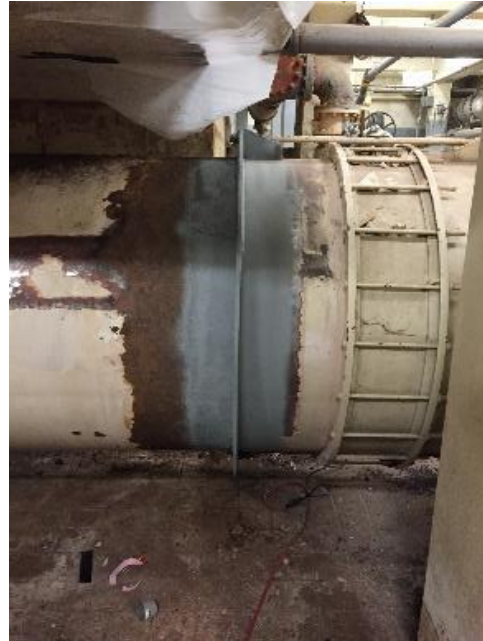
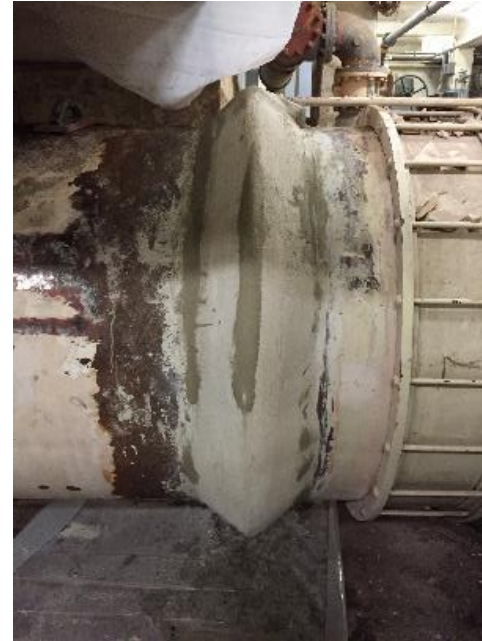
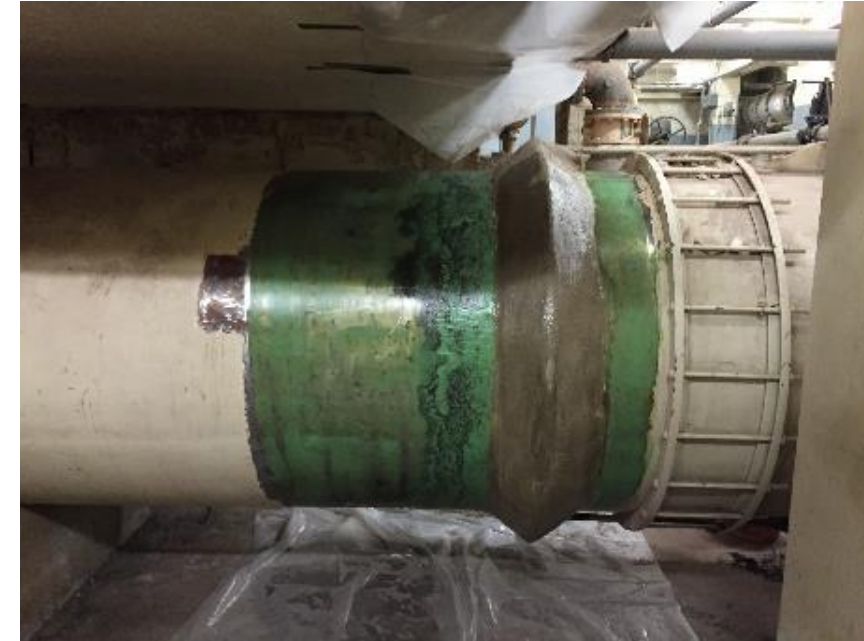
# Wastewater Facility Pipe Repair

## *City of Atlanta*

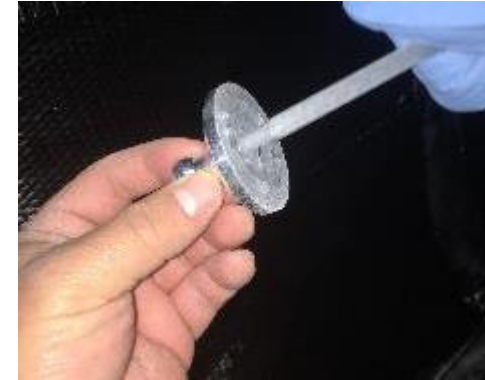
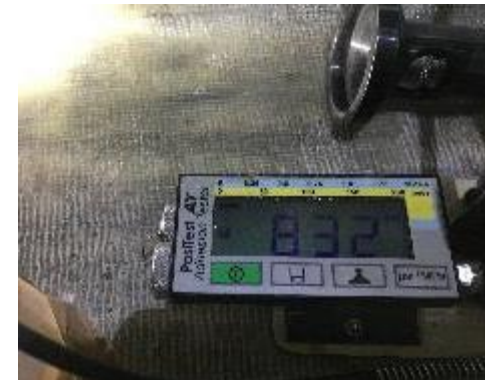
# Quality Control

- Record Lot #
- Adhesion Test (ASTM D7234) (200 psi min.)
- Witness Panel (ASTM D3039); 5 glass and 5 carbon FRP coupons

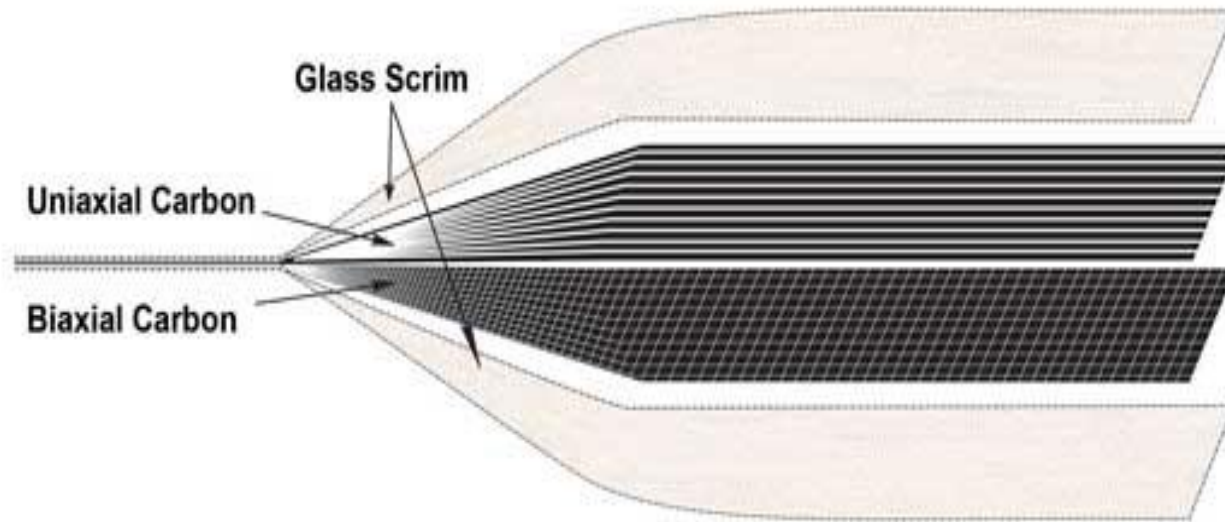
# Multi-Layered SuperLaminate™ (Patent Pending)

- **Multi-Axial Reinforcement**
- **Thickness  $\approx$  0.01 -0.025 inch (0.25-0.67mm)**
- **Tensile Strength  $\approx$  up to 155,000 psi (1030 MPa)**
- **Infinite combinations of strength & stiffness can be produced**
- **ISO 9000 Certified**

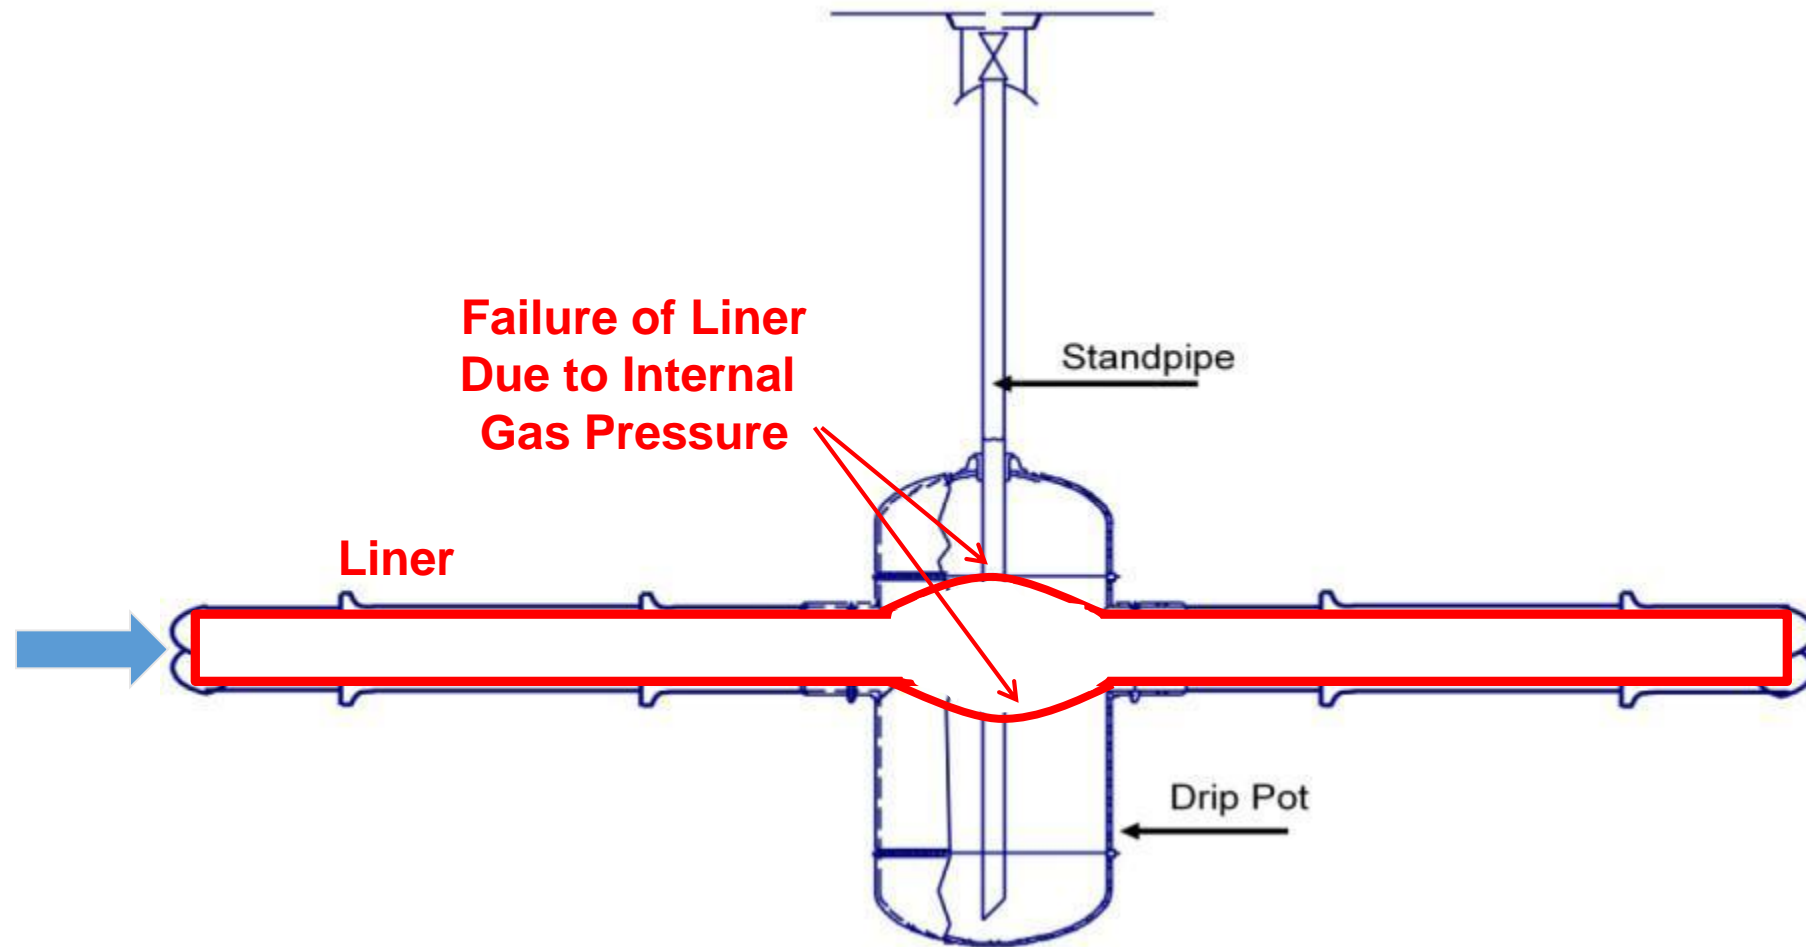
# Bridging a Gap in a Pipeline

*(Gas Technology Institute)*

How do we create a pressurized pipe?

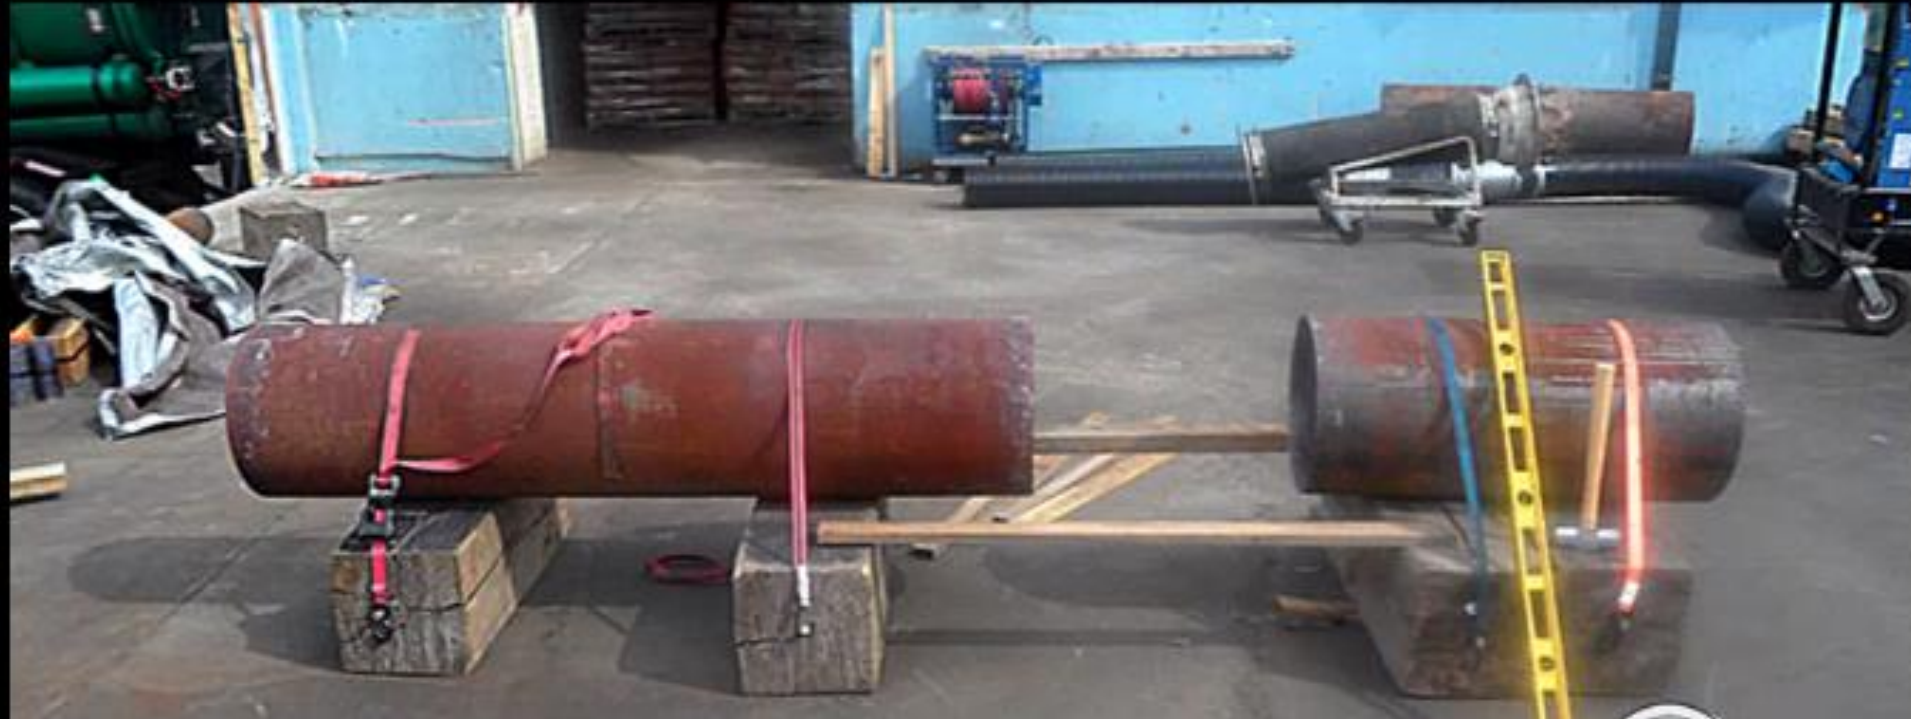
# Bridging a Gap in a Pipeline

*(600mm Long Gap in 400mm Diam. Pipe)*

Two 16-in. diameter pipes with a 24-in. gap

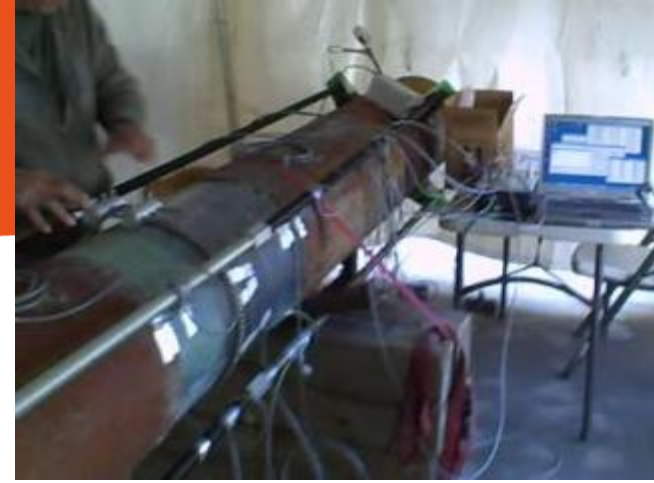
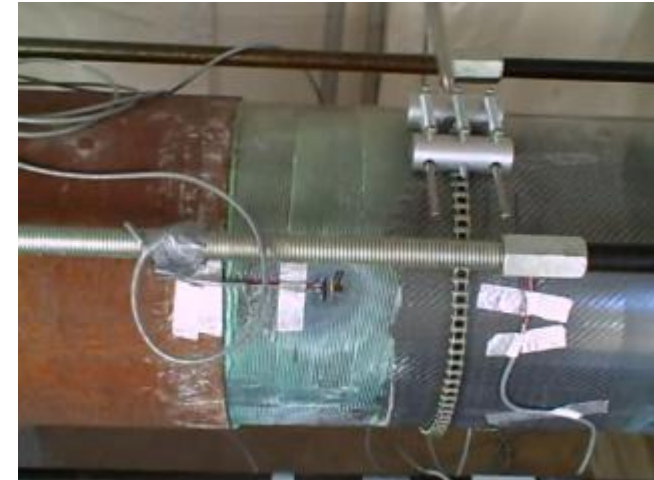
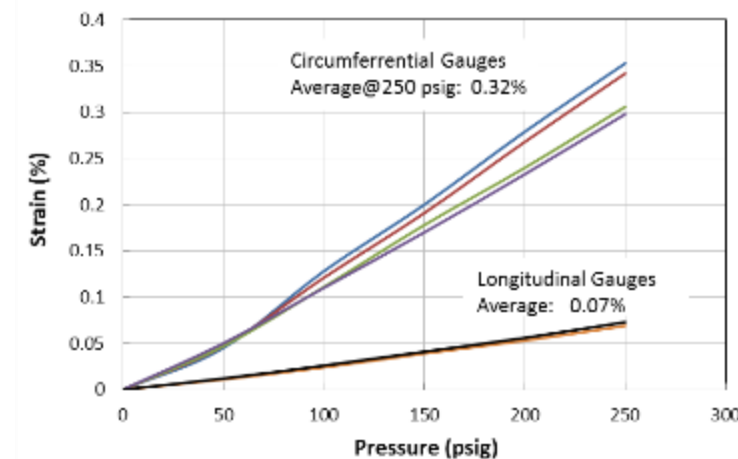
# Pressure Testing

*on October 16, 2010*

- Gas Technology Institute
- Max Operating Pressure = 60 psi (4.1bar)
- Tested to 250 psi (17.2 bar)
- Ultimate Capacity = 900 psi (62 bar)

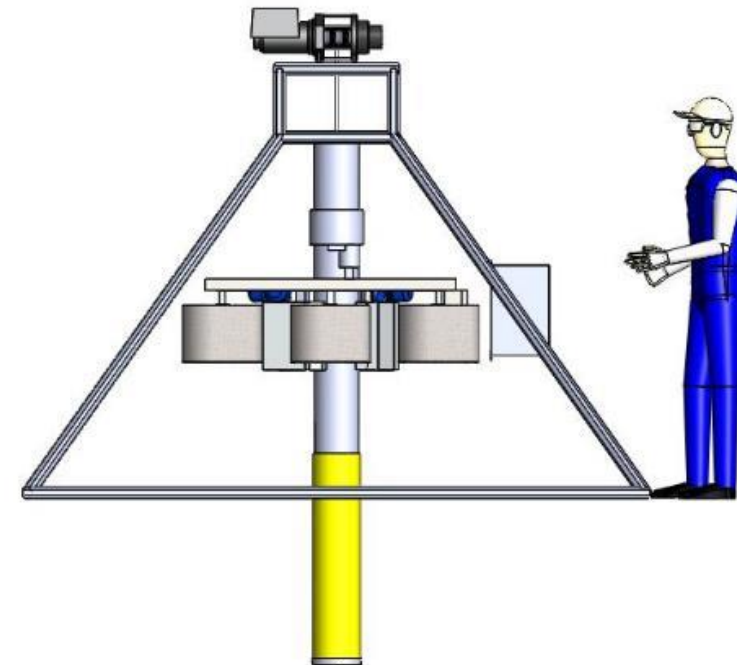
*Schematic of the in-situ mining process.*
