37TH INTERNATIONAL
NO - DIG
FLORENCE 2019

HYDROELECTRIC PIPELINE REHABILITATION BLUELINE - UV LINER SYSTEM

Dott. Ing. Matteo Vicentini, Enel Green Power - Planning supervisor – Foreman

Dott. Ing. Federica Fuselli, Rotech Srl Technical Department

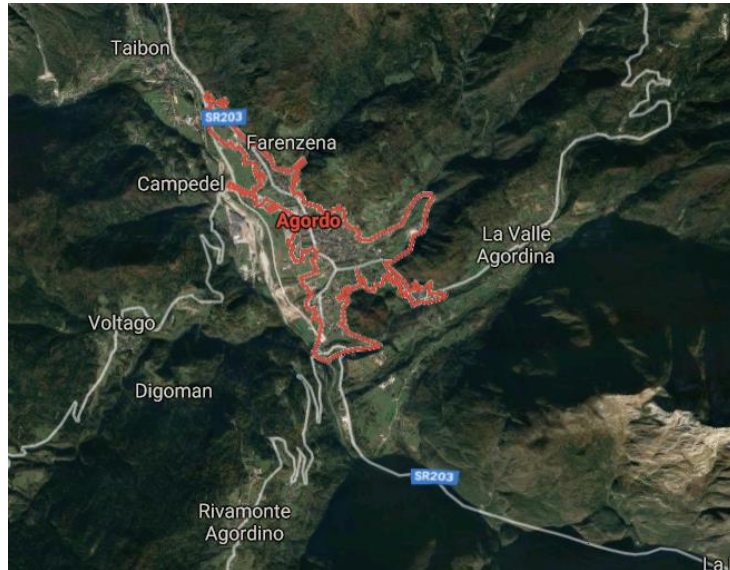
The pipeline to be restored is part of the La Stanga hydroelectric plants (Belluno) and it is the Sarzana intake; the maximum water flow rate, that the pipeline can handle, is 400 l/s, while the average flow is about 270 l/s.

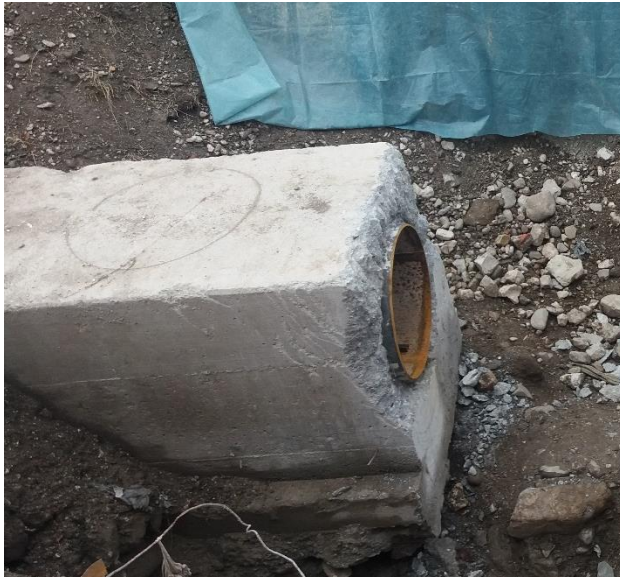
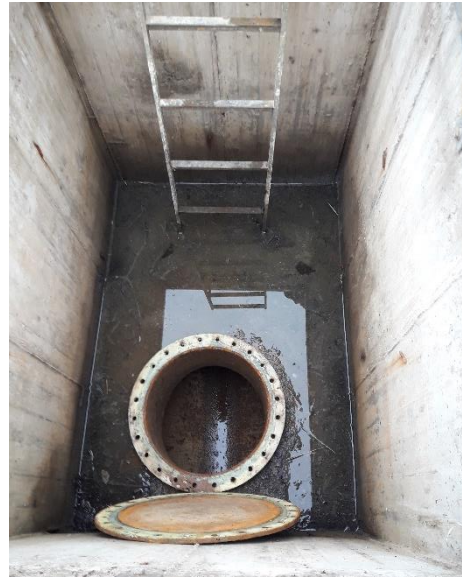
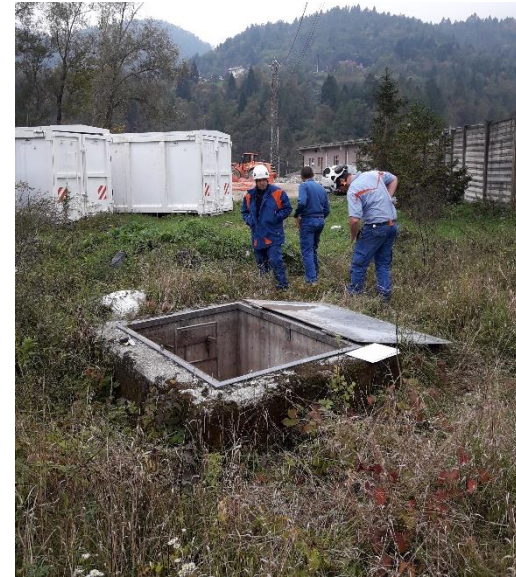
State of fact

- Existing pipe is made of reinforced concrete
- Internal circular diameter of DN 700mm
- External rectangular section of 0,94x0,90m.

The canal is accessible through a 5,5m high manholes with a circular section and there are another 11 manholes with a circular section DN 500mm at a variable distance from 50 to 230m.

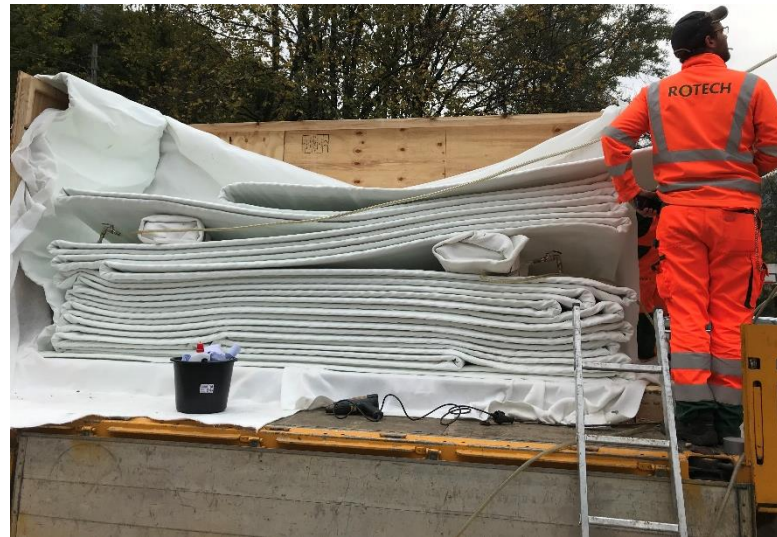
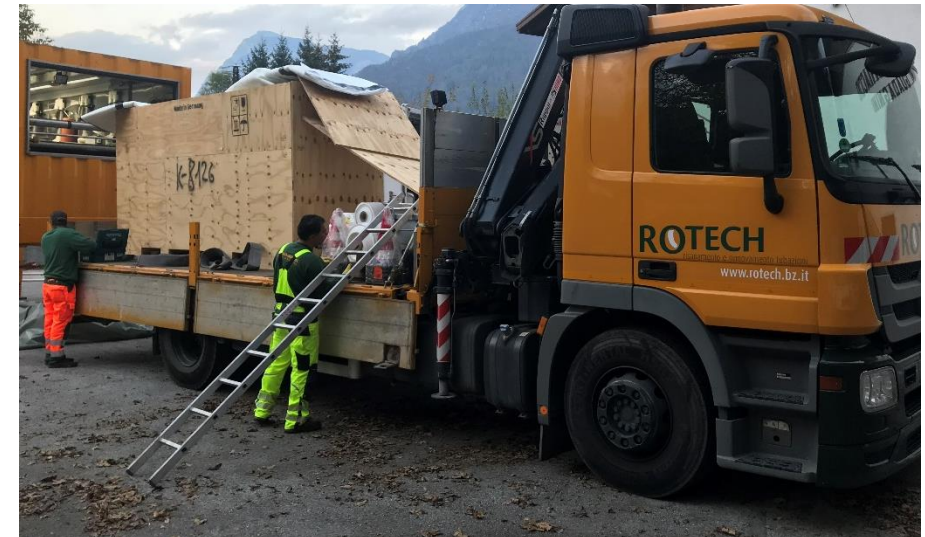
The Liner impregnated with epoxy resin for pressure pipes was requested in compliance with some design variables

- Liner totally structural
- Minimum thickness of 9.0mm
- Depression in the pipeline of 1.0 bar
- Working pressure 3,5 bar
- Road-type overloads
- Test pressure of 5.25 bar

The completely structural thickness of the Liner was verified through the static calculation carried out according to the ASTM F1216 standard and the customer was provided with all the test certificates carried out on the Liner

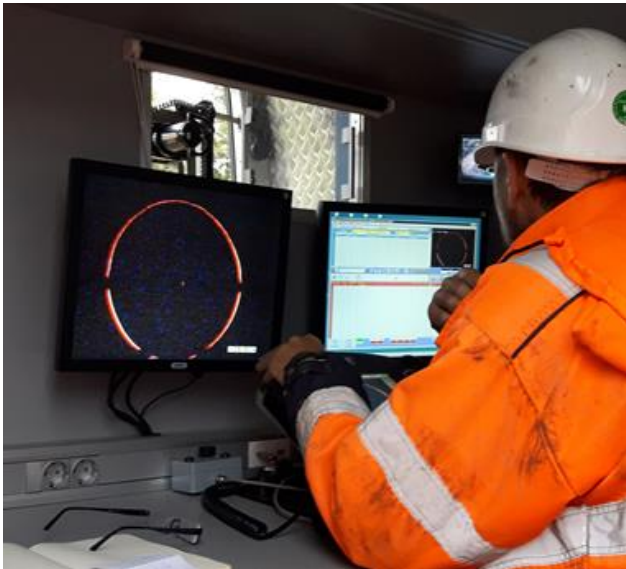
After a video inspection, the cleaning of the existing pipeline, and the internal calibration for the detection of the right diameter and the presence of any deformations, the installation phase began.

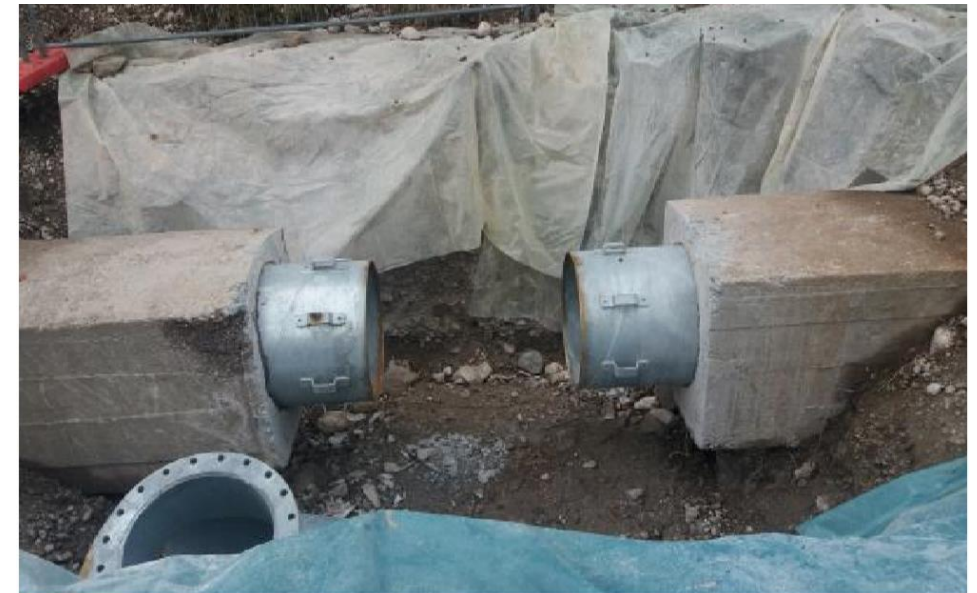
The dimensions of the manholes DN 500 mm did not allow a safe insertion of the Liner without damages. The project therefore required the rebuilding of some intermediate manholes with the insertion of a disassembly joint and a removable pipe that was 1500 mm in length.

Advantages:

- no wrinkles in the Liner (low roughness)
- improvement of the health and safety for the worker

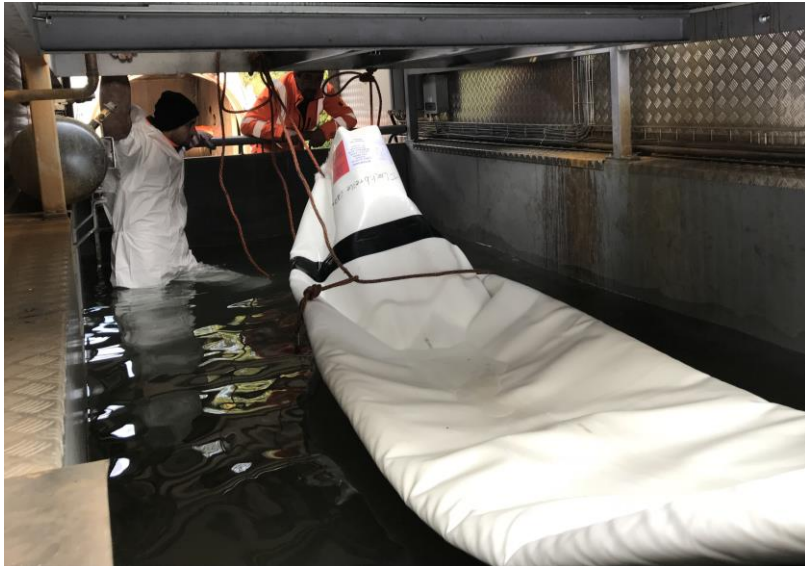
Impregnation phase

The resin impregnation phase was carried out directly on site by means of a mobile High-Tech plant, in a vacuum environment and with automated dosing and mixing systems with continuous digital control and recording of all the important data indicated by the manufacturer.

- controlled pressure inversion drum
- steam hardening equipped with a pumping tool
- digital control system for pressure

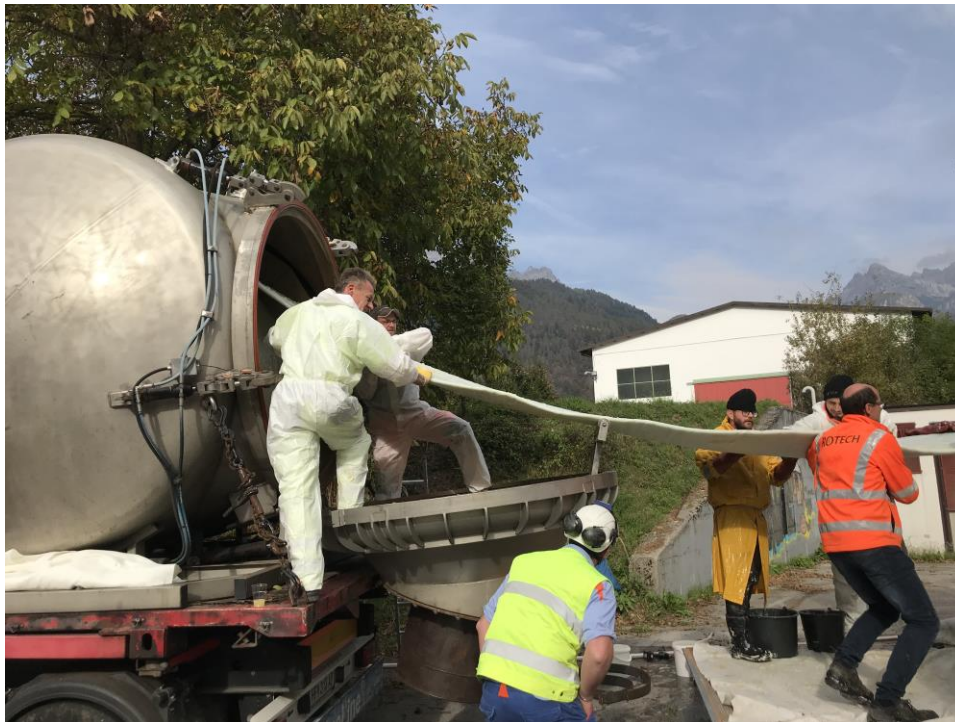
The Limit of the installation length was effectively overcome by using a special drum with a diameter of 3m, that allow an installation length of 130,00m. The insertion of the liner took place thanks to the controlled pressure inversion drum and a steam hardening equipped with a pumping tool and a digital control system for pressure, temperature and removal of condensation.

Special drum that could guarantee the fixed length of installation

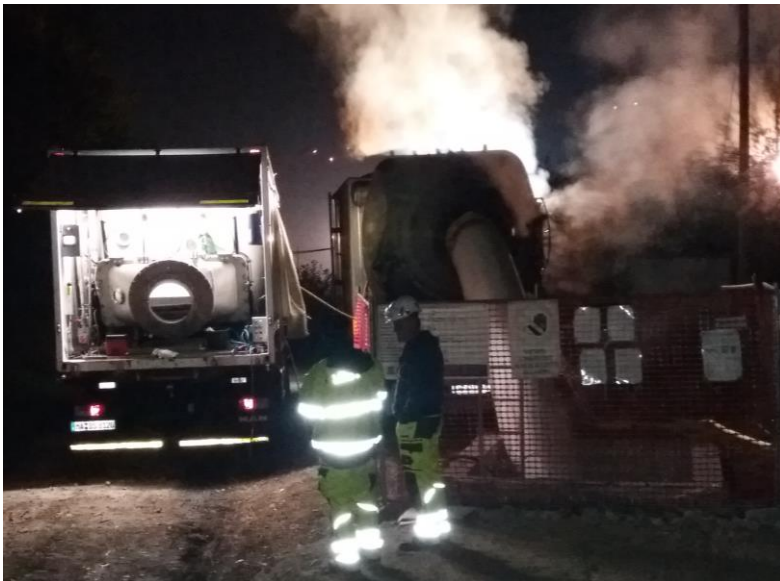
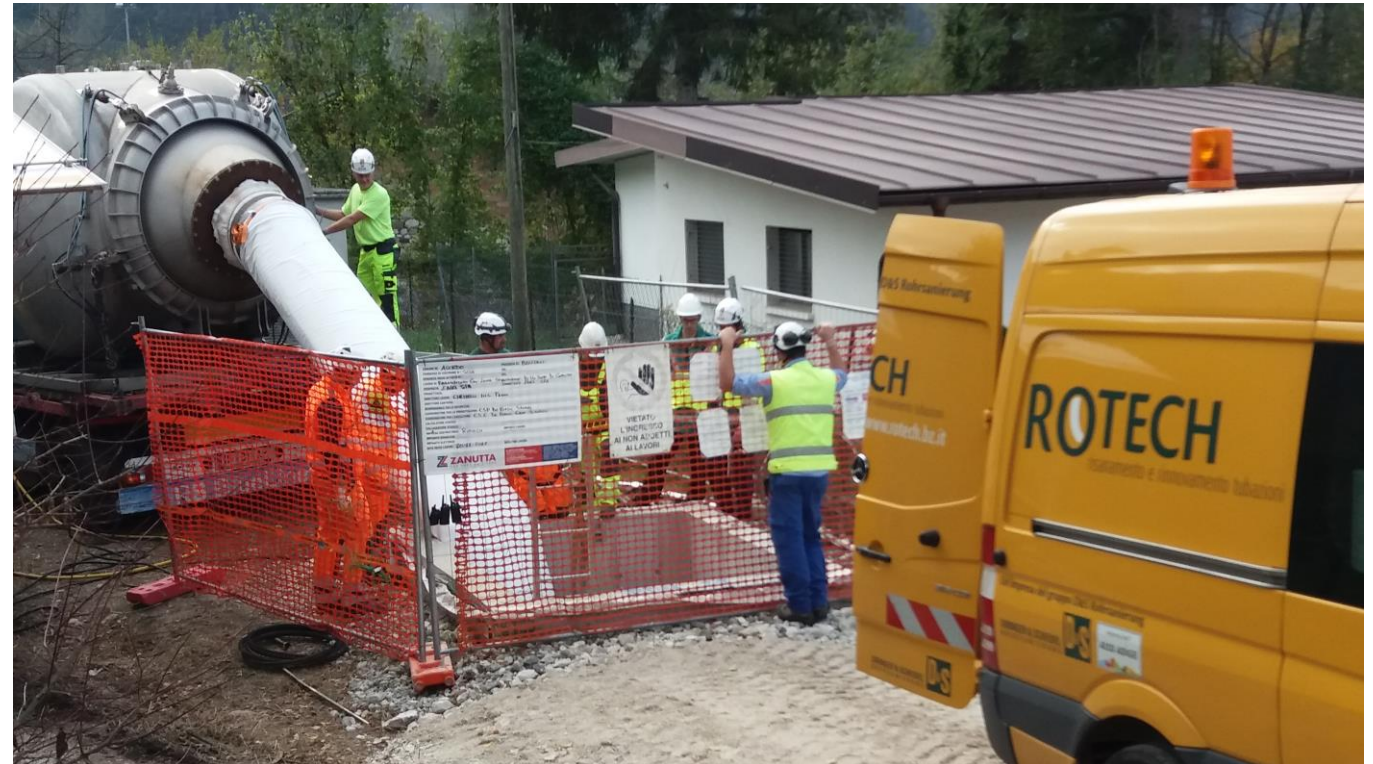
Liner insertion phase

Three installations of 125m, 125m and 105m were carried out respectively, the resin impregnation time was about 6 hours and the hardening time about 7 hours. After the polymerization of the Liner with steam, the pressure tests were performed; furthermore the vendor restored the connections to the old pipe.

- resin impregnation time – in average 6 hours
- the hardening time – in average 7 hours

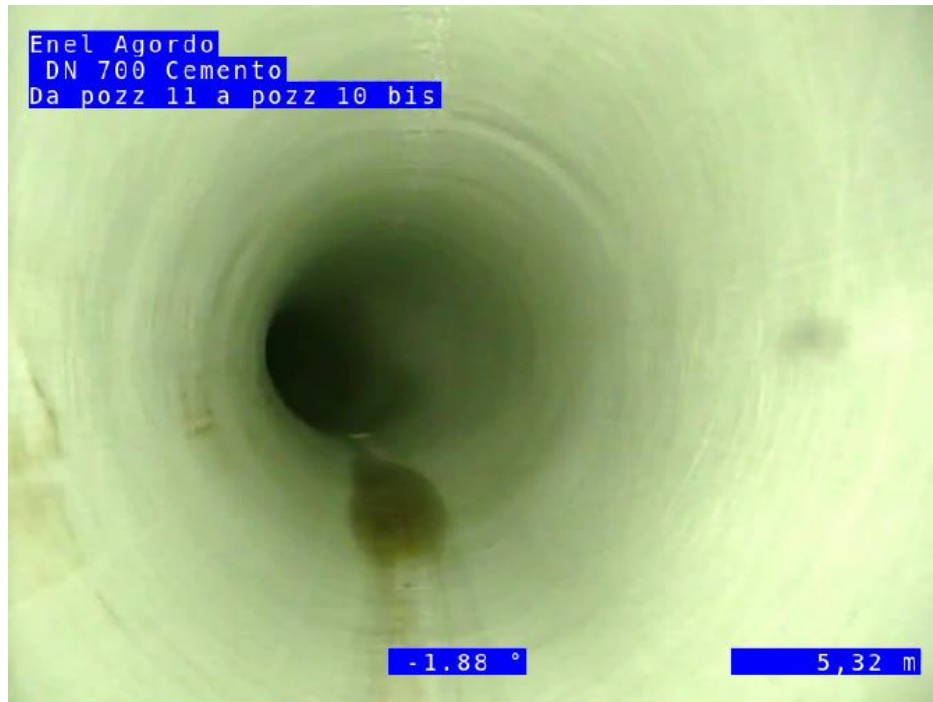
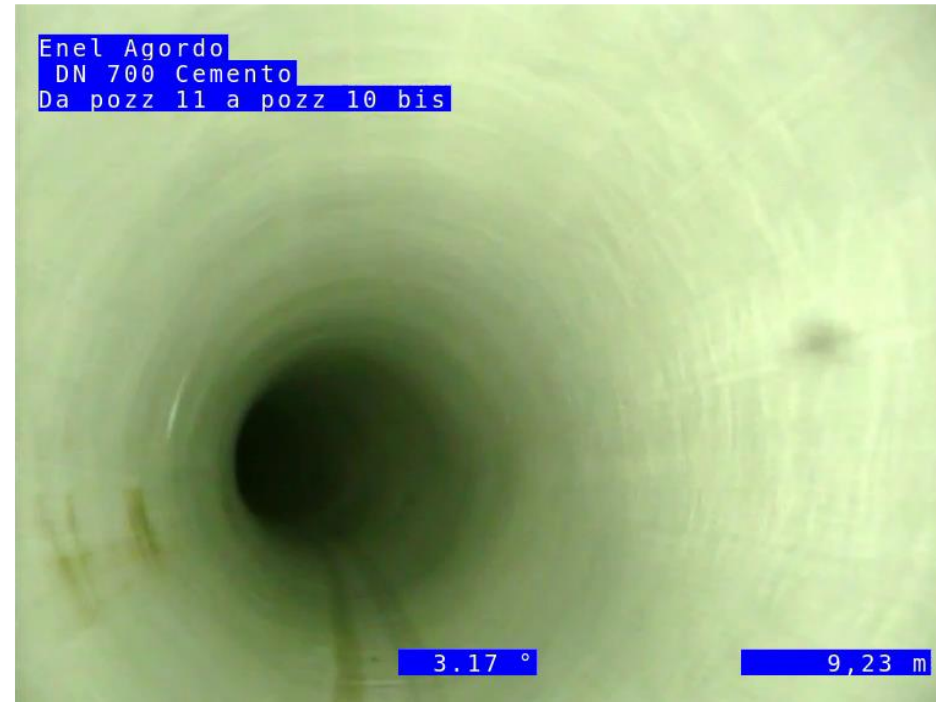
After polymerization of the liner a final video inspection was carried out

Cured Pipe
final result BlueLine

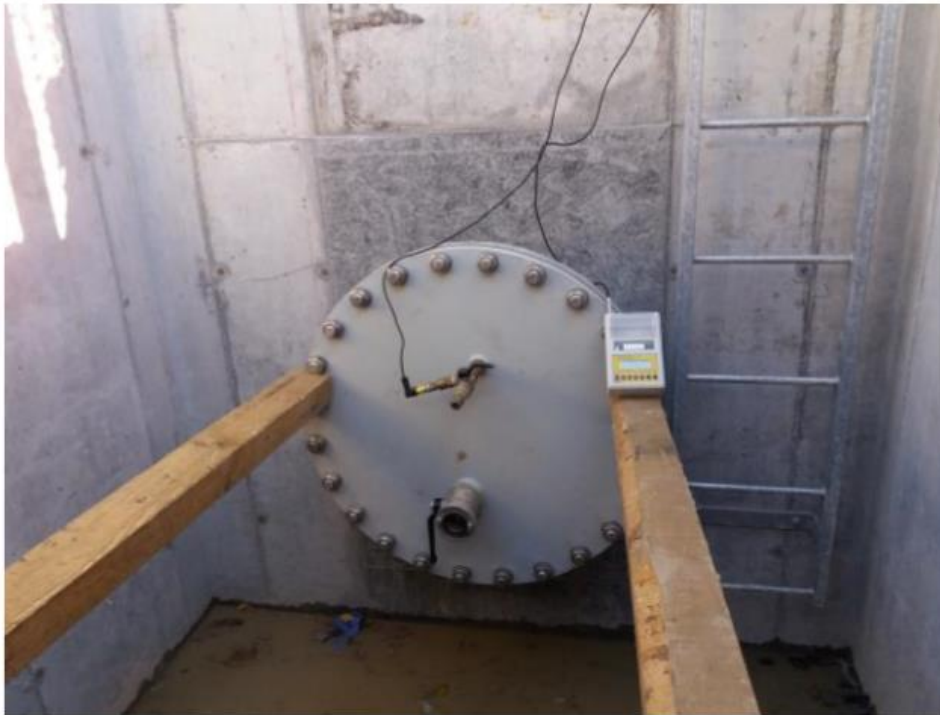
The set up for the hydraulic pressure test

After the polymerization of the Liner, all the connections were restored and the pressure tests started.
